BUILDING SURVEY REPORT

Indoor Market at xxxx

On Behalf Of

ADM
2019

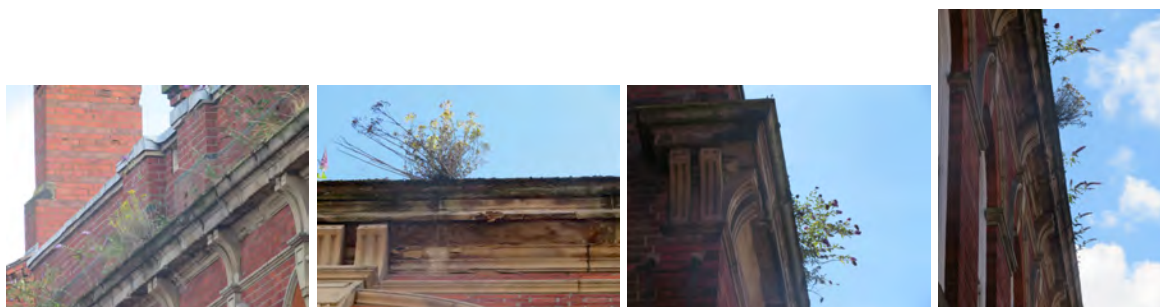
Continued deterioration to the stonework is inevitable and growth of plants, particularly buddleia, is likely to result in the destabilising of the structural integrity of the parapet coping stones and the masonry cornice. The risk of spalling stonework from the cornice is significant and immediate repairs are warranted. Removal of the plant growth is essential and thereafter repairs to spalled stonework and repointing of the joints to the coping stones must be anticipated.

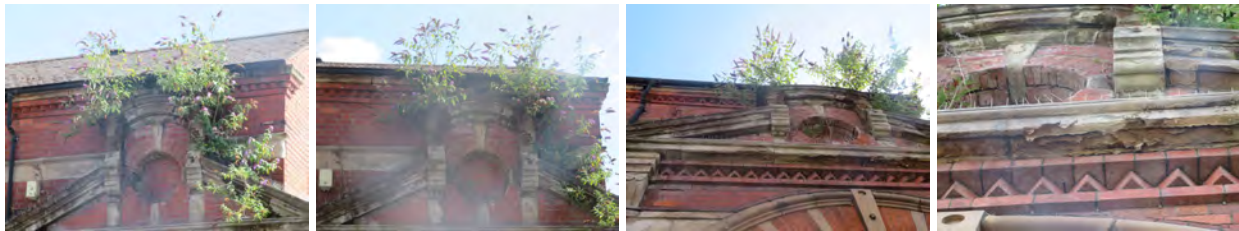
It appears that rainwater from the gutters is not adequately collected and results in saturation of the stonework, which is resulting in the deterioration and spalling and also allows the buddleia growth to develop.

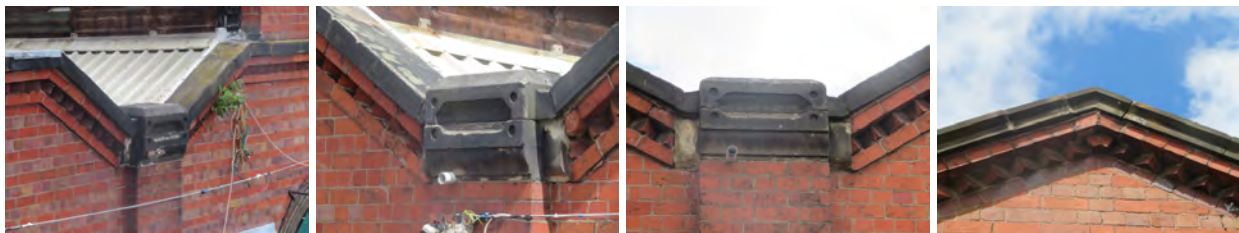
The coping stones are weathered and poorly pointed, which is allowing saturation of the masonry beneath to occur, and in this regard repointing is strongly recommended.

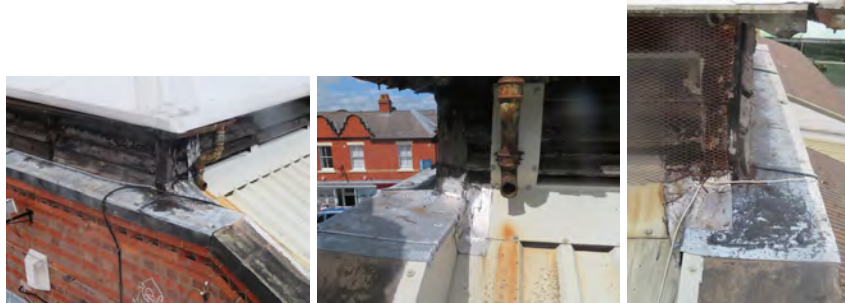
The leadwork also discharges rainwater which runs from the weathered sections onto the adjacent masonry sections, increasing the risk of saturation of these components. In our opinion, whilst it is not essential, the introduction of appropriate lead cappings with suitable welted drips to protect the parapet walls and the weatherings, in particular, is strongly recommended and works of this nature should be undertaken in the near term.

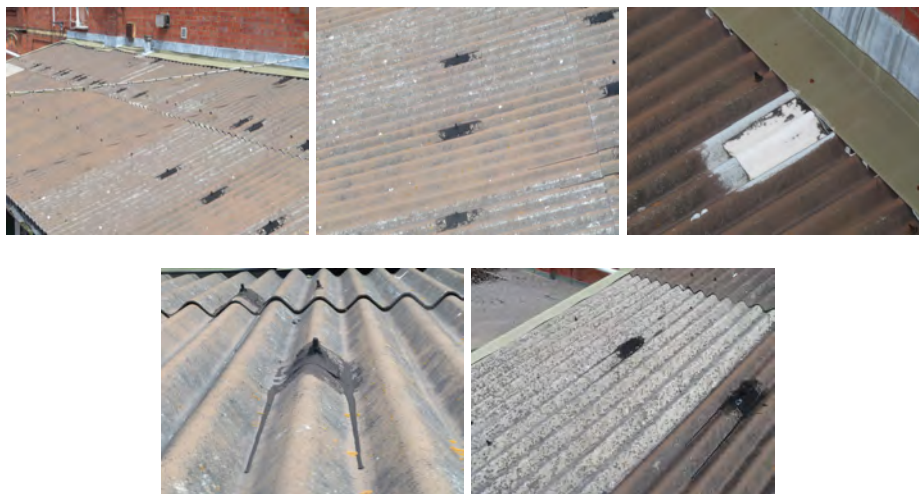
Deterioration to the extremity of the asbestos sheets however was evident below. In our opinion removal of the asbestos cement weathering's are recommended. The works should be undertaken in a controlled manner by licenced contractors and the asbestos material disposed of to a licenced tip. Works of this nature are not of the most urgent form but, in our opinion, it would be good management and appropriate to remove all asbestos components and asbestos cement sheeting from the site.

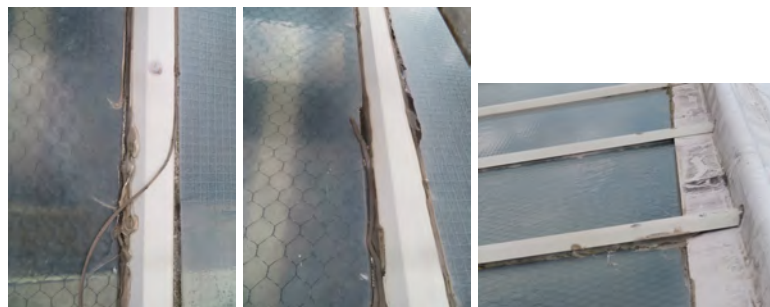
The glazing incorporates many sections of different wired glass, as well as the perspex components. In our opinion replacement of all perspex with new Georgian wired sections is strongly recommended. A number of cracked and broken panes were also identified and these should also be replaced.

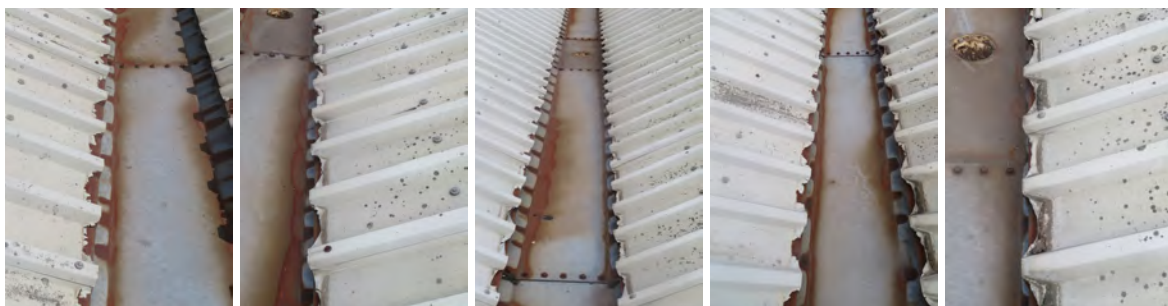
Continued deterioration is likely to result in extensive corrosion, perforation and ultimately water penetration internally into the building. Plastisol repairs can be carried out to the edge of the sheeting and works of this nature are recommended in the near term to extend the life expectancy of these components.

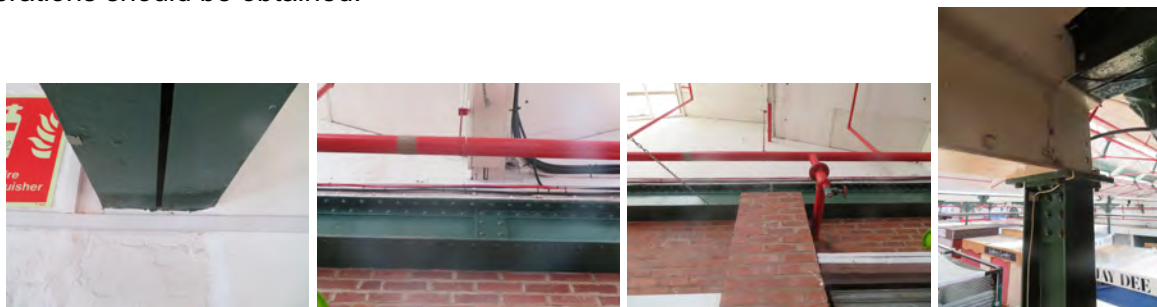
In some areas circular columns are bricked in at low level, as illustrated below. It is possible that corrosion of the lower steel sections has occurred, although we cannot confirm our suspicions in this regard. The latter photograph certainly suggests that the column base has been removed previously.

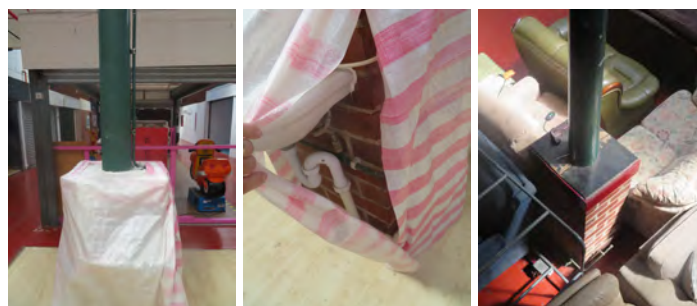
Similar columns exist within the partially covered market area to the far right hand section of the site and in these areas' superficial corrosion of columns at the base at the junction of the floor was also recorded, as illustrated below. We cannot confirm our suspicions therefore that alterations have been carried out to the columns given the possible corrosion at their base, particularly within the main hall. It is possible that the bricking around the columns could have been undertaken for other reasons rather than structural deficiencies.

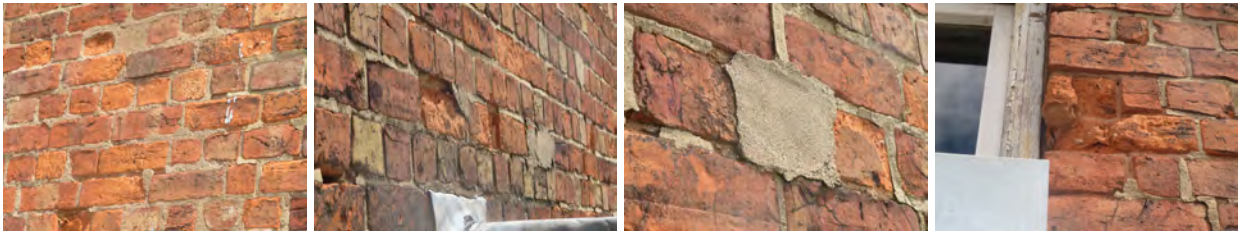
Extensive repointing and repairs to spalled brickwork are therefore necessary and strongly recommended.

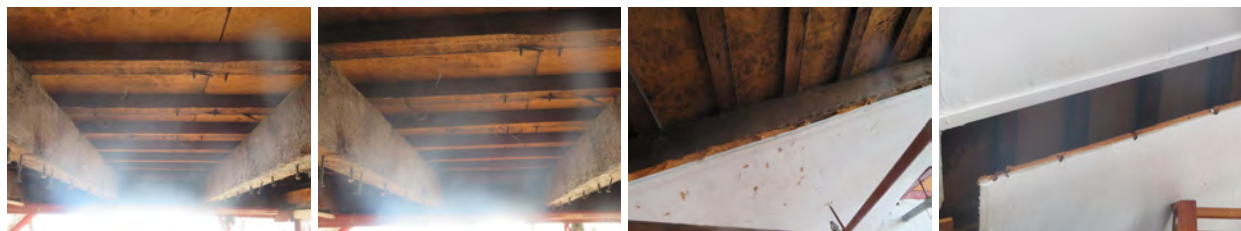
It is likely that significant leaks from the roof has caused damage in this regard. Staining and other deterioration indicative of water penetration has caused further damage to these fibreboard linings, which do not survive well following water penetration.

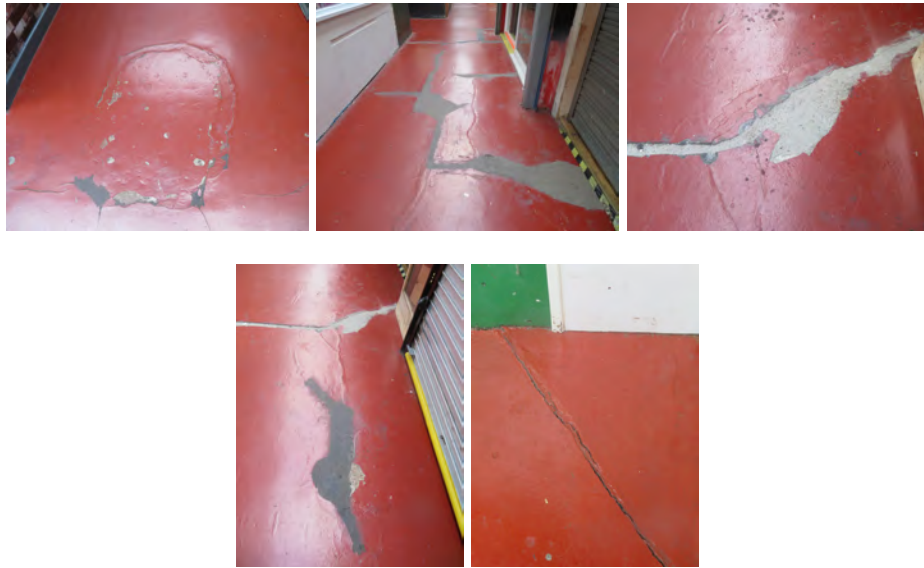
The coating in some instances is also beginning to deteriorate and in other areas it has been removed, as illustrated below.

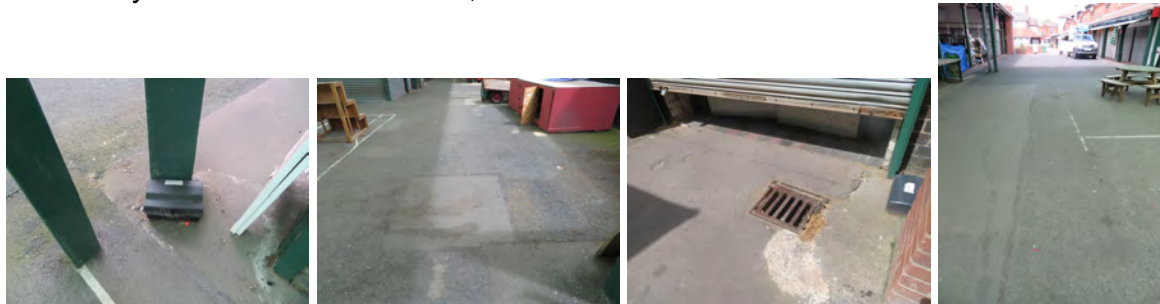
The tarmac is beginning to deteriorate with cracked, blown and uneven sections evident by reference to the following photographs.

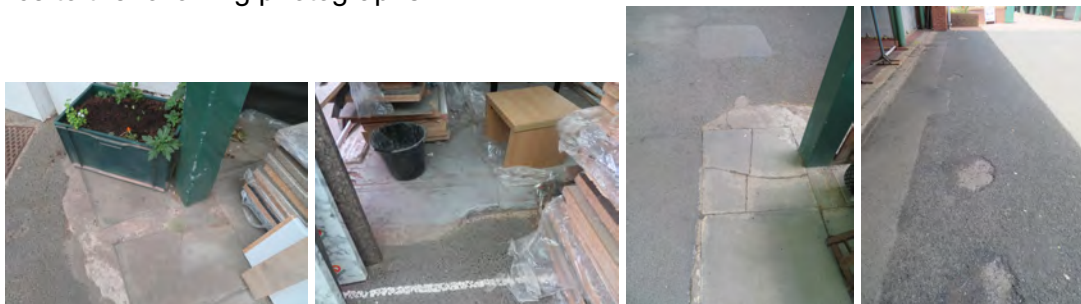
Misaligned and uneven surfaces also exist around drainage gullies and inspection chambers, as illustrated below.

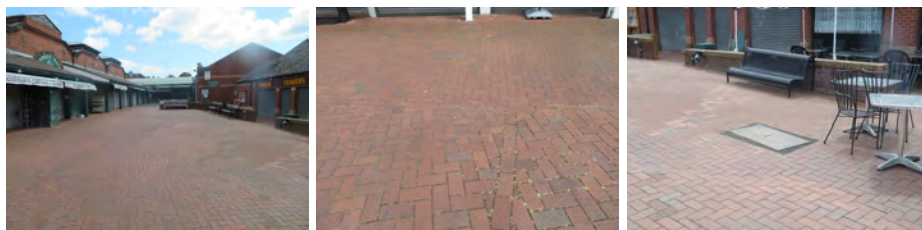
There are some areas where the surfaces are beginning to deteriorate and uneven paving sections were recorded, as illustrated below. Overhauling and re-sanding of the joints to the brick paviours is recommended and would enhance its overall condition.

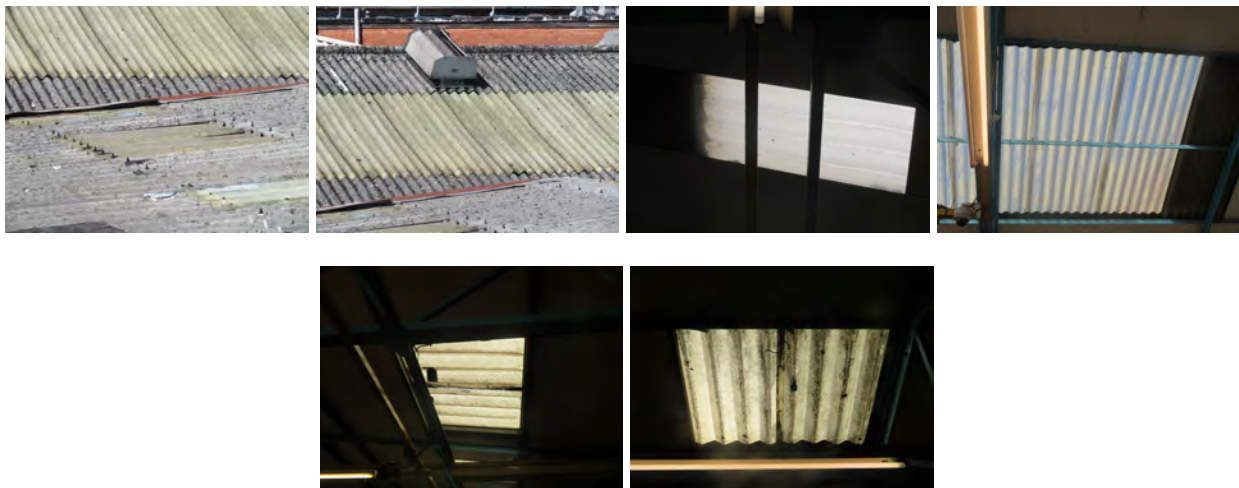
The bolt fixings which secure the sheets to the metal frame are generally aged and corroded and missing caps were recorded, which will hasten deterioration and also facilitate water penetration.

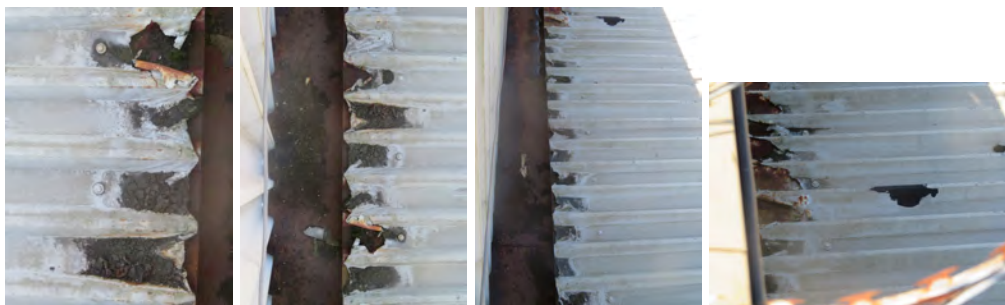
At present the Plastisol coated detailing remains serviceable, however its overall condition is deteriorated and cut edge corrosion, if allowed to persist and develop further which will be the case, will result in corrosion and perforations within the sheets which will clearly allow water penetration to occur.

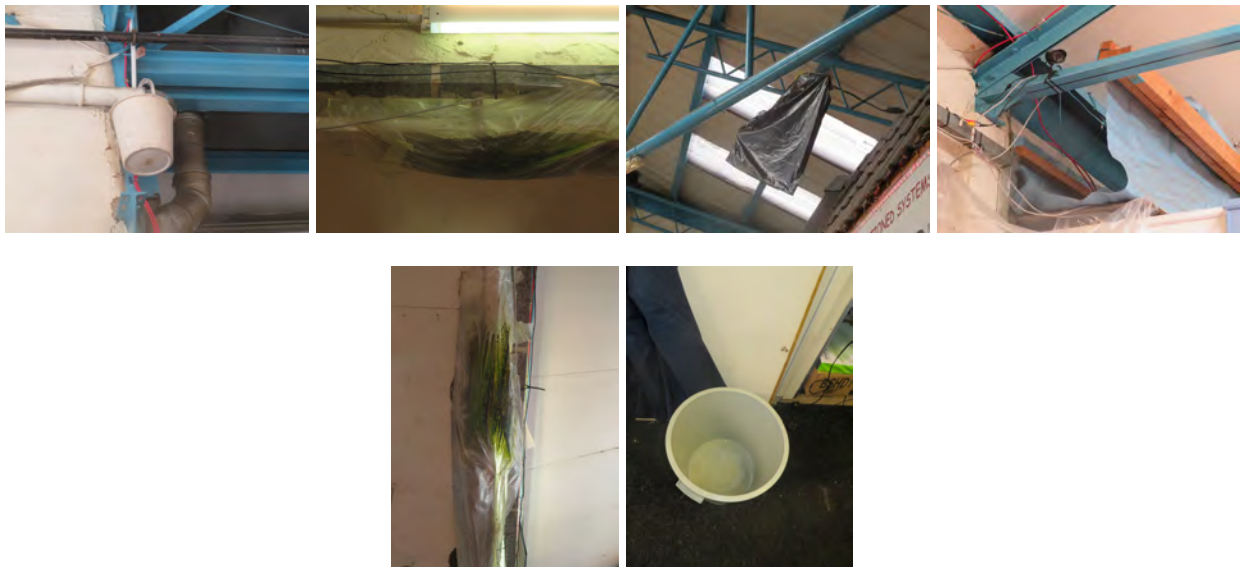
Clearly this suggests that water penetration has been ongoing for a significant period. The collection of water penetration in this manner does not constitute a satisfactory solution, in our view, and clearly continued water ingress must increase the risk of damage internally.

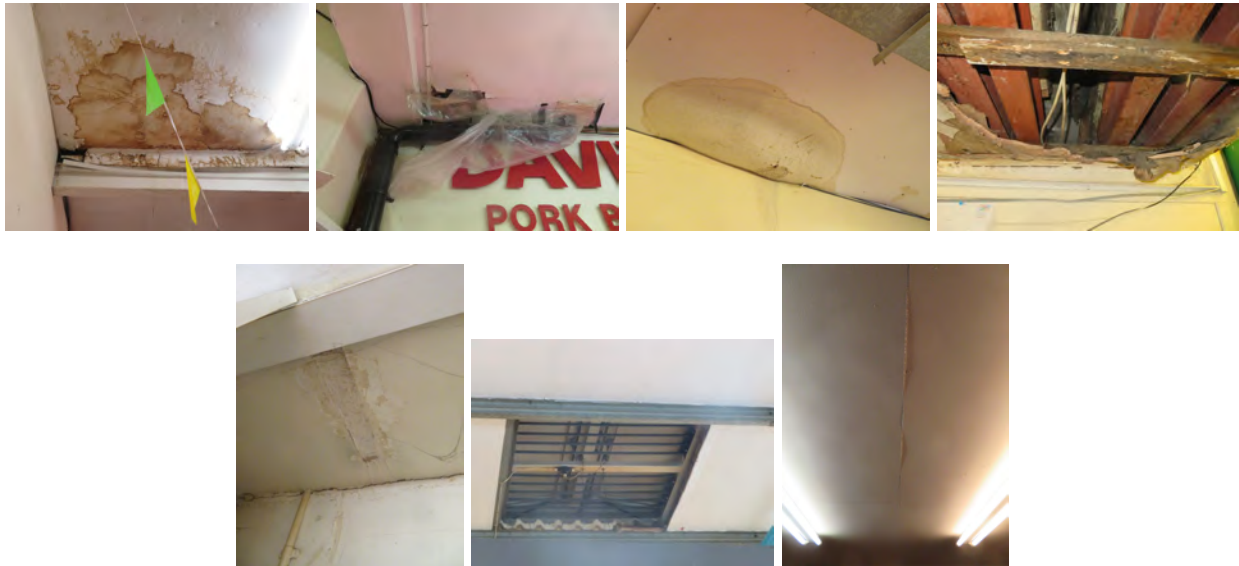
Continued water ingress is inevitable until such time as extensive, if not complete, replacement of the roofs over the main market area are undertaken.

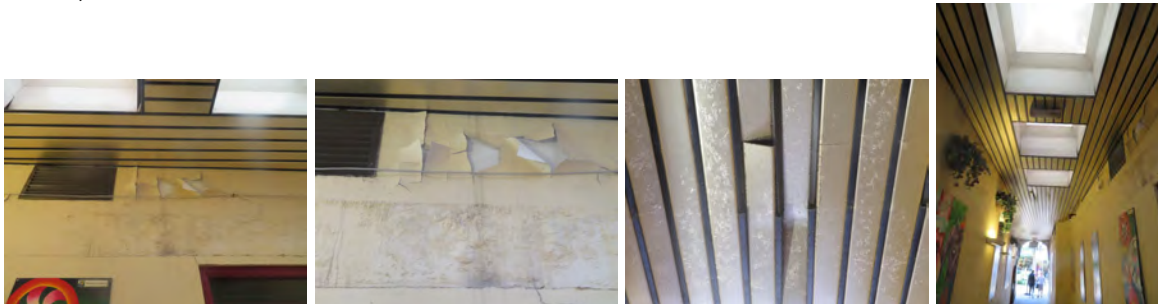
It is likely therefore that the roof is approaching the end of its useful life and recovering is required. Given the water penetration the likelihood of rot to the deck and structure is high and replacement of much of the structure should therefore be anticipated.

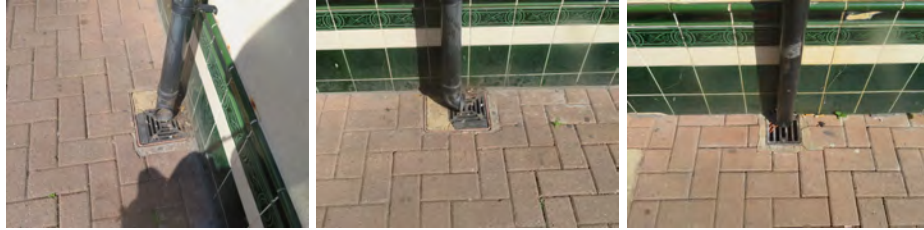
Reconfiguration of the rainwater downpipes and discharge in this area is recommended. The downpipes remain serviceable, although clearly leaks have occurred and some replacement and remedial works are recommended.
