BUILDING CONDITION SURVEY REPORT

XXXX

ADM
June 2019

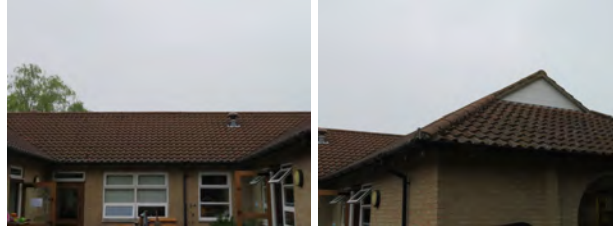
The property has numerous intersecting roof pitches, which are generally weathered with concrete interlocking tiles. Based on a visual inspection the ridge and hips to the roof hold good alignment with little evidence of any undue movement or deflection and on this basis therefore we are satisfied that they remain structurally stable, as illustrated below.

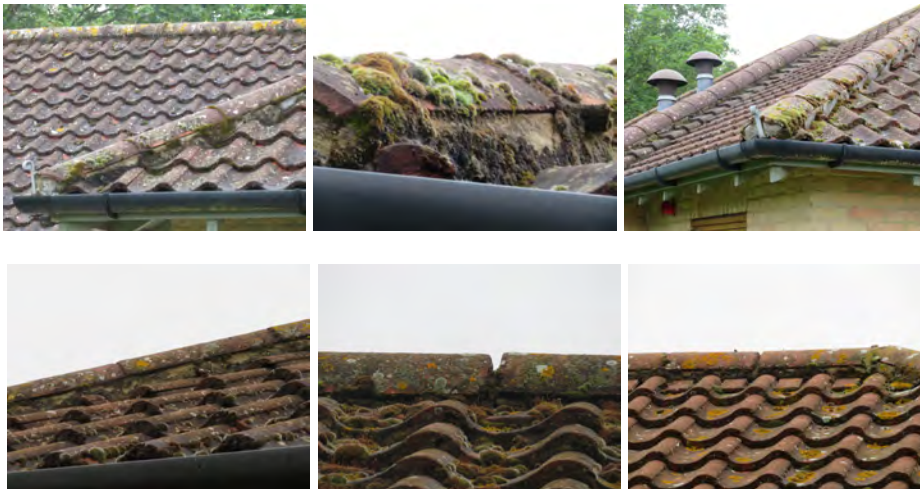
The tile coverings appear to be the original installations and remain generally in fair condition, considering their age and nature. It is apparent, however, that maintenance is now required and the ridge and hip tiles in particular are poorly pointed as illustrated below.

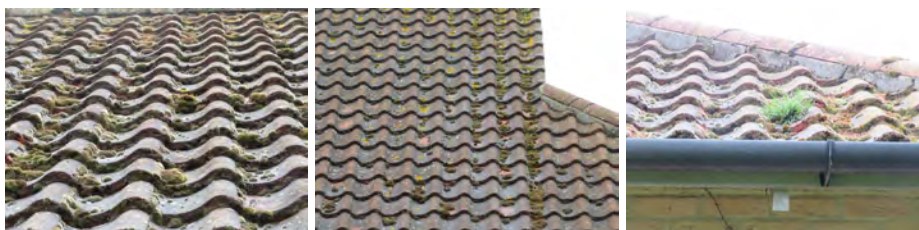
Overhauling of the tiled roof sections are therefore essential to conserve the integrity of the property and cleaning of moss growth and weeds, which are evident to many roof slopes as illustrated below, should be undertaken shortly.

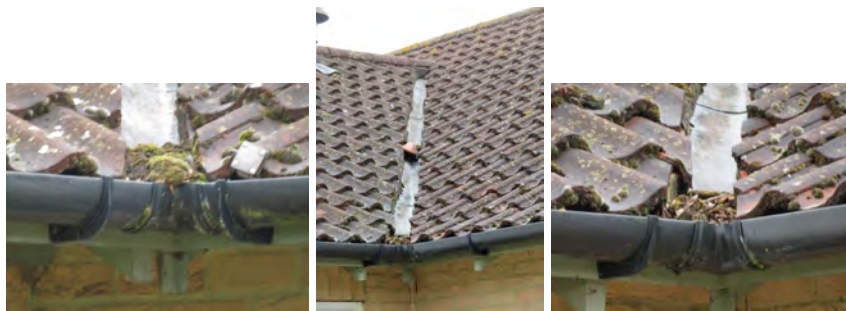
It is apparent, however, that debris is becoming entrapped within the valley gutters, particularly at the junctions with the main uPVC gutters, as illustrated by reference to the following photographs. Blockage of the gutters is causing overspilling to occur during periods of rainfall and as part of the works in overhauling the roof cleaning of the valley gutters and replacement of the parging to the tiles and valley gutter junctions should be undertaken.

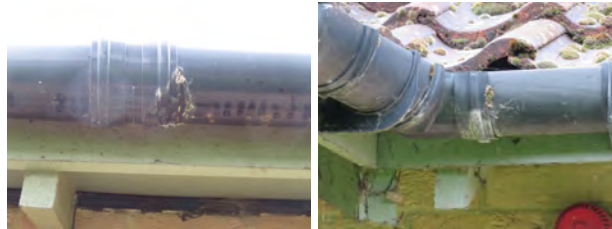
The guttering appears to be the original installation and there is evidence of numerous leaks to joints, as illustrated particularly by reference to the following photographs.

Clearly failure of gutters results in leaking which can cause damage and saturation to the brickwork and result in water penetration internally and much increase the risk of rot developing. We recorded no particular evidence of this; however it is essential that the gutters are cleaned, overhauled and all leaking joints sealed.

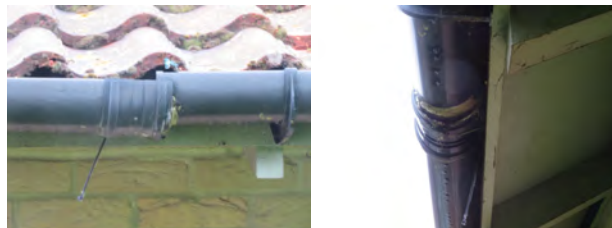
In a number of instances the gutter sections have become disconnected at joints which will also result in leaks occurring during periods of rainfall, as illustrated below.

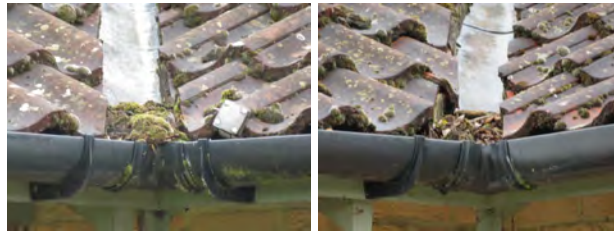
Over spilling has also occurred beneath valley gutters where a build-up of debris has been identified and recorded previously but illustrated again by reference to the following photographs.

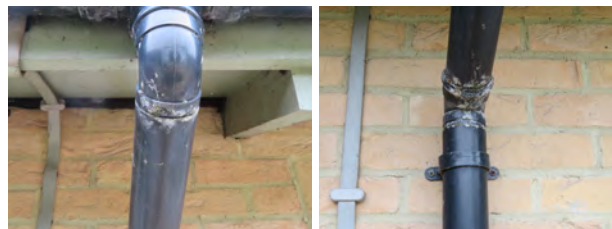
Where connections and spigot outlets remain intact there is evidence of leaks to the joints within the downpipes, as illustrated particularly by reference to the following photographs. Overhauling of the gutters and downpipes is therefore essential. Works of this nature should be undertaken in the near term to prevent over spilling of water and leaks, which could cause damage to the building.

Replacement of the gutters with powder coated aluminium or better quality uPVC components may well be considered prudent to minimise long term maintenance costs. We anticipate that the rainwater goods are approximately 20 years of age and in our opinion they are approaching the end of their useful life and replacement may well be considered more cost effective over a longer period than repairing and maintaining the existing installations.

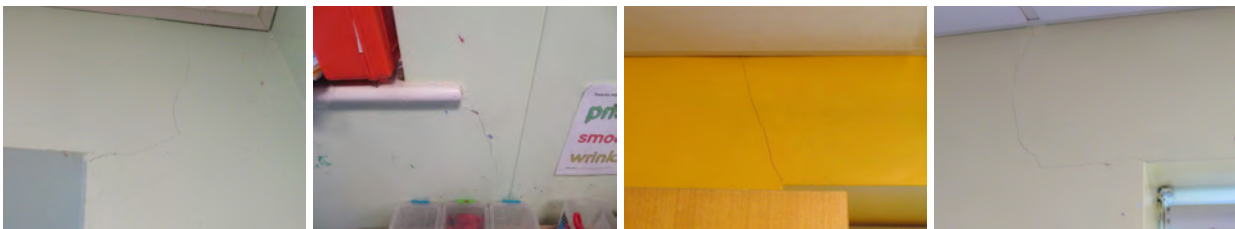
In various sections of the property we recorded minor hairline cracking above and below window openings, as illustrated by reference to the following photographs.

The extent of movement, in our opinion, is in accordance with normally anticipated parameters for buildings of this type, age and nature. The movement indicates perhaps slight bedding down or settlement of the foundations and also differential movement and thermal expansion at the junctions of the lintels over the windows and also beneath the window openings which represents the weakest part of the wall.

The movement appears not to be progressive and it is our view that the building remains structurally stable. Repairs to the fracture and the damaged plasterwork internally is to be anticipated, although continued minor movement to the extent of that recorded at the time of our survey must be anticipated thereafter for the foreseeable future.

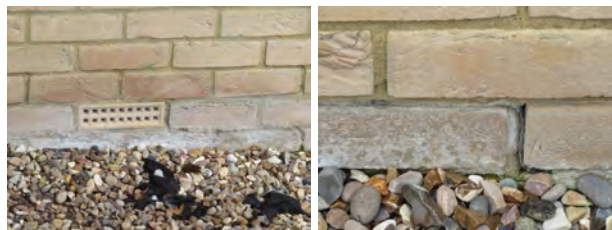
Steps in the damp proof course were evident in various locations, as illustrated below. Again the external damp proof course is at lower level than we would prefer to see.

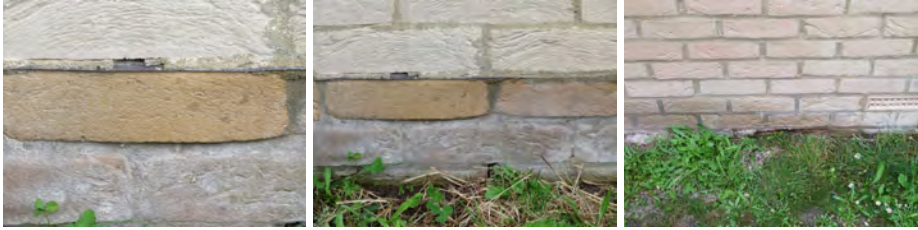
The damp proof course, as illustrated by reference to the following photographs appears to be a plastic or Visqueen based product which provides good life expectancy and is generally of good quality. Reference to the previous and following photographs suggests that the damp proof course remains in good condition with no evidence of dampness and deterioration to the brickwork above the damp proof course, whilst below damp proof course deterioration is clearly evident.

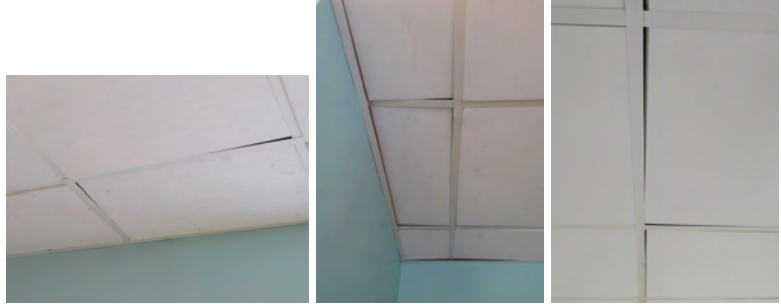
We recorded evidence of minor damage and poorly seated tiles within the suspended ceilings, as illustrated by reference to the following photographs. Minor repairs and improvements to the ceilings may therefore be warranted and replacement of the water damaged tile within the kitchen area should also be undertaken in the near term. Beyond this, significant improvements to the ceilings are not warranted within the foreseeable future and in our view they remain structurally stable.

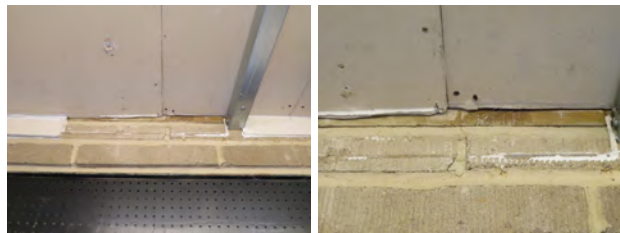
Fire protective strips have been incorporated to the extremities of the ceilings to protect the roof structure above, which is generally considered to be acceptable. In one instance a section of the fire protective strip was missing, as illustrated below. Reinstatement of the plasterboard should be carried out in this regard.

We would also advise that the plasterboard utilised in the construction is not now considered adequate to provide half hour fire resistance. Upgrading of the ceilings within the plant rooms to incorporate 15mm fireline board is therefore recommended, as an improvement to the overall ceilings within the plant rooms.

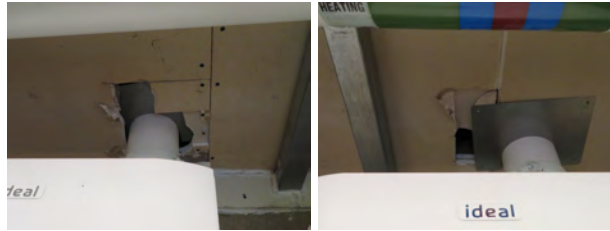
It would appear that boilers have recently been replaced and the fire protective ceiling around the flues has been damaged, as illustrated below. Replacement of the ceiling and the incorporation of new 15mm fireline board overboarding the existing is therefore recommended.

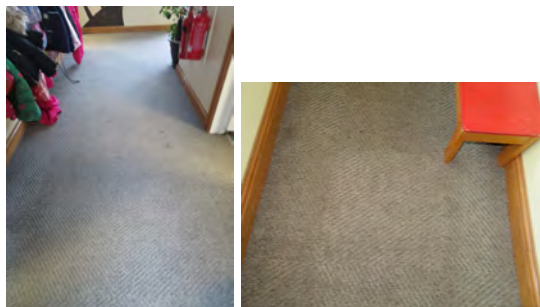
Internally the floor coverings remain in fair condition, however the carpets within the main corridor area are becoming a little worn and stained, as illustrated by reference to the following photographs. Whilst it is not essential replacement of carpets may well be anticipated in due course.

Repairs to floor coverings and renewal of carpets may therefore be considered prudent and could be undertaken within the foreseeable future.

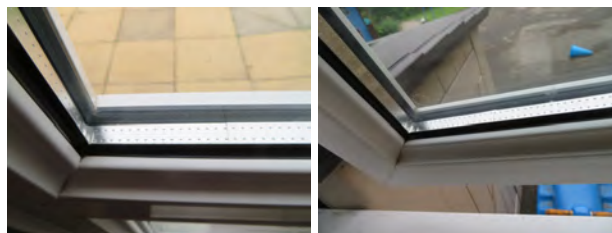
The energy efficiency of the windows and the air gaps are not strictly compliant with current standards and heat loss therefore will be in excess of that currently considered appropriate, as illustrated below. The windows are approximately 20 years of age and whilst they remain in good condition replacement must be anticipated within the next 5 to 10 years. We recorded no evidence of failure of the hermetic seals, but this may well be anticipated in due course.

Repair and maintenance will extend the life expectancy of the windows, but replacement within a 10 year time frame is likely to be anticipated.

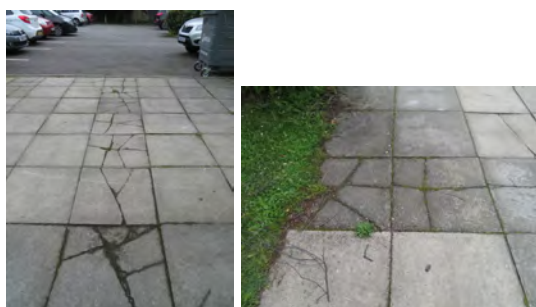
Access to Burwell Early Learners is gained from the communal parking area via a concrete paved pathway, which exhibits many cracked, blown and uneven slabs as illustrated below.

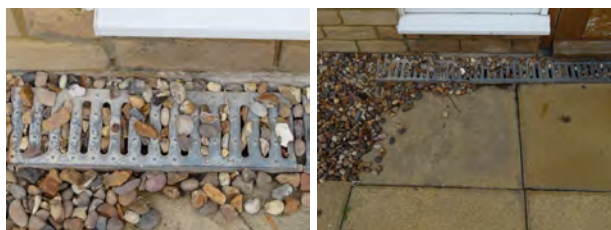
A French drain runs around much of the extremities of the building and the shingle in this area is facilitating weed growth, as illustrated below. Treatment of the shingle with weed killer is recommended to prevent growth within the French drain area. An ACO drain has been incorporated in front of the main entrance, however this is in poor condition and is extensively choked with debris, as illustrated below. Cleaning of the drain is therefore required.

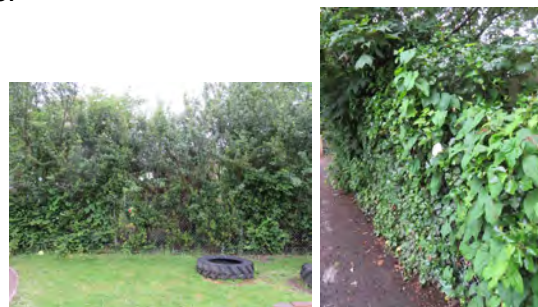
Many of the fences are overgrown with creeper and shrubbery in front, as illustrated by reference to the following photographs.

Improved cultivation and maintenance of the fences is required. In one area the wire is loose, and a timber fence located in front of it is missing sections of the panelling, as illustrated by reference to the following photograph. Minor maintenance is therefore recommended.

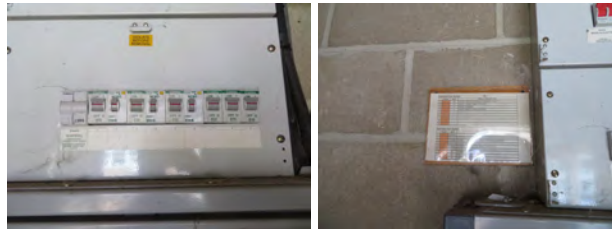
Some circuitry notification was provided but, in our opinion, this could be improved as illustrated below.

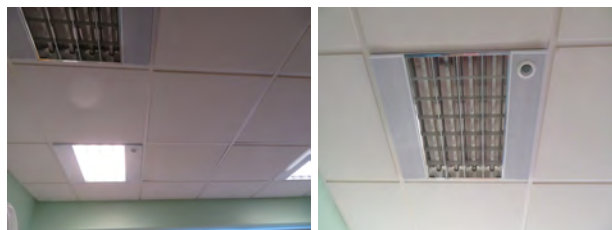
Internally within the property we recorded a number of light fittings which were inoperable at the time of our inspection, as illustrated below. This may be due to failure of the motion sensors or individual bulbs within fittings and repairs should be carried out as part of normal maintenance. The introduction of more energy efficient LED lighting should also be considered.
