BUILDING SURVEY REPORT

XXXX

ADM
January 2020

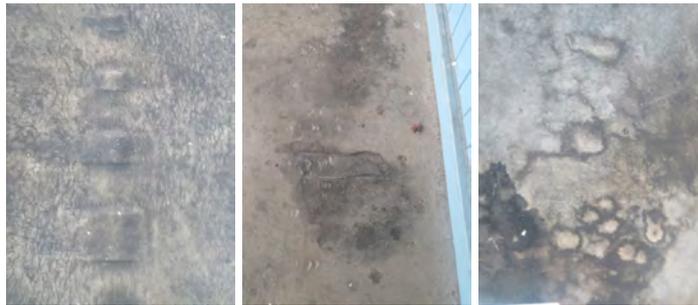
Surface indentations and damage to the asphalt by use were also evident generally, as illustrated by reference to the following photographs.

Expansion within the building has also caused rippling or crazing within the asphalt surface which, over time, is likely to result in splits developing and consequential water ingress into the flats beneath.

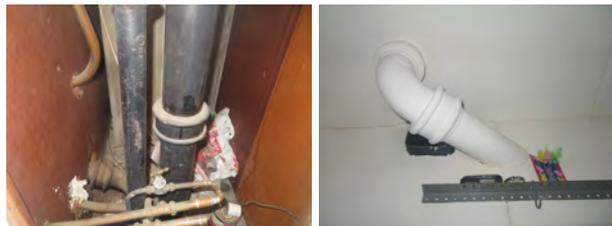
Rainwater from the main roof appears to discharge via gully's into cast iron downpipes. We had not access to the main roof and therefore cannot confirm our suspicions in this regard; however, within a service riser internally within the property, cast iron downpipes descend from the roof above, as illustrated below.

Leaks have clearly occurred in and around the gulley's historically, causing damage to the cladding and corrosion of reinforcement within the concrete slab and ducting, as illustrated by reference to the following photograph. We recorded no evidence of water penetration at the time of our inspection. Making good of the downpipes and gulley's is to be anticipated and replacement of down pipes must be anticipated within the foreseeable future.

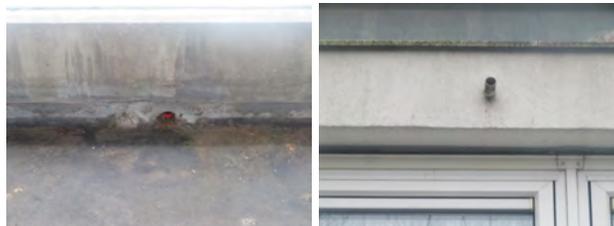
Rainwater from the balconies is discharged via small overflow pipes which, if surcharged, would discharge onto the pavement below. The overflow pipes are illustrated generally by reference to the following photographs and are serviced by internal openings within the asphalt and balcony weatherings.

The design of the outlets and the details is somewhat poor and water ingress could occur in these vicinities.

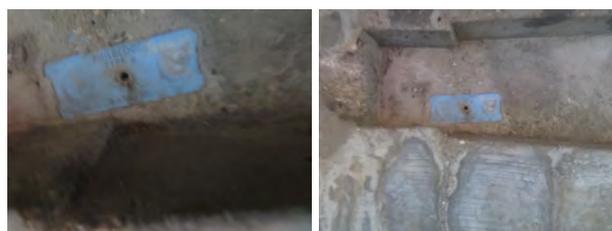
To the exposed balcony walkway at second floor level, closer inspection of the concrete cladding panels forming the balustrade railing was possible. The panels appear to have been of good quality, although pre-cast structures of this nature can be prone to tolerance issues and poor quality control in their manufacture. Labels attached to the inside of the panels indicate use of a Phil-block component, as illustrated below. We are not aware of this manufacturer and an internet search revealed no details of this company.

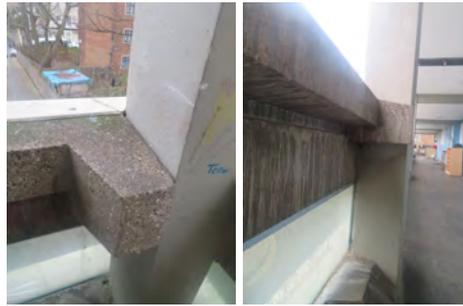
The panels again appear to suspend or hung from the concrete frame, with the junction evident as illustrated by reference to the following photographs.

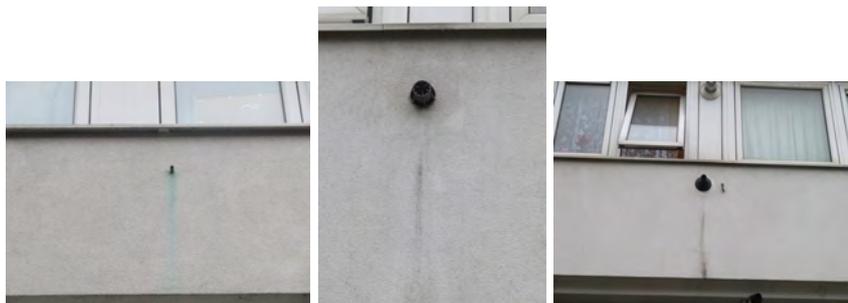
Leaks from boiler flues and overflows have also caused staining to the pre-finished render, as illustrated by reference to the following photographs. Such deterioration may hasten the need to carry out repairs or replacement of the rendering over time.

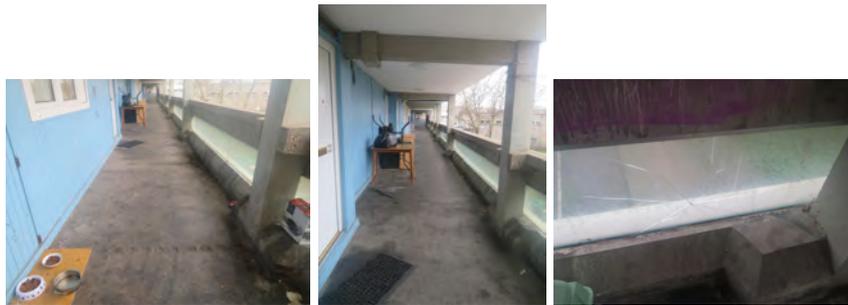
The thermal insulation which has been applied at first floor level is also limited in effect in that this does not entirely wrap the cold external frame in thermal insulation and the inside of the framework to the walkway is effectively uninsulated and thus cold and exposed to the elements, as illustrated by reference to the following photographs.

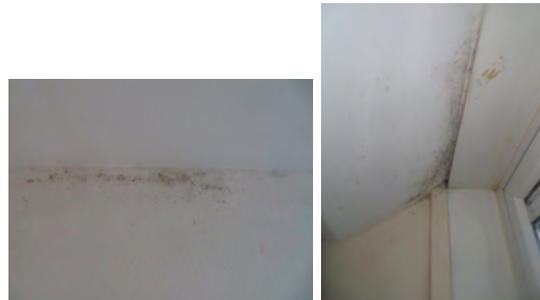
As a consequence, cold bridging is likely to occur and internally we recorded evidence of condensation, which is in keeping of defects and failure in this respect, as illustrated by reference to the following photographs.

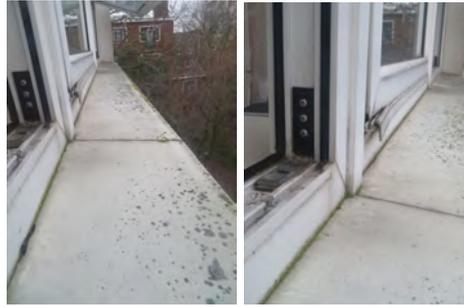
Similar capping details have also been introduced to window cills to weather the junction between the original cladding and the insulation, as illustrated below.

There is evidence of water penetration and deterioration to these capping's, which could undermine and affect the overall condition of the insulation in due course and also cause failure of the render. The trim details and capping's, where these have been introduced in various locations, do not adequately discharge rainwater clear of the render beneath, resulting in saturation in various sections, as illustrated previously and also by reference to the following photograph.

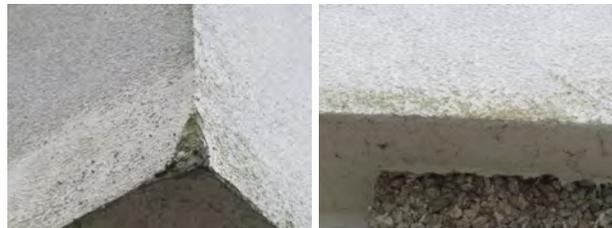
Some weathering and deterioration to the render has occurred and minor sections have been impact-damaged, as shown below.

The first photograph perhaps illustrates deterioration due to water penetration to the rear of the render. The render is pre-finished and ought not to be decorated as part of a normal maintenance process; however, often this can become necessary as the surface to the render deteriorates and ages. Replacement of the render, and possibly reformation of the insulation to the panels, must be anticipated within the future and indeed it is recommended so that the detailing can be much improved and thus the overall energy efficiency of the building enhanced.

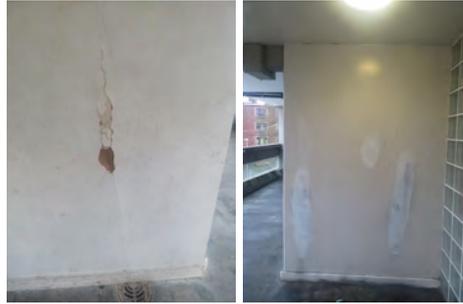
At first floor level, similar claddings are also evident; however, sections appear to be of plasterboard formation, at which point cracking was clearly evident close to the entrance to the communal parts, as shown below.

Within the construction we recorded evidence of expanding metal lathing which has been utilised presumably to enhance the security of the cladding. Improvements in this regard and the addition of thermal insulation is strongly recommended and must be anticipated.

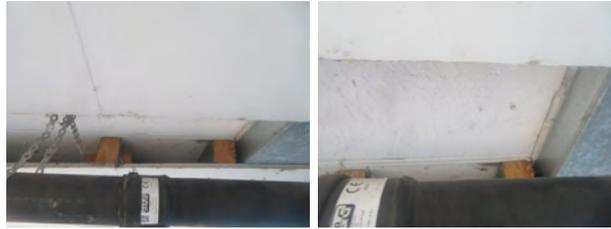
In both instances the ceiling appears to have been formed by a weather resistant boarding secured to the underside of the concrete floor slab above by means of timber battens, illustrated previously and again by reference to the following photographs. In no areas that could be exposed did we identify any thermal insulation.

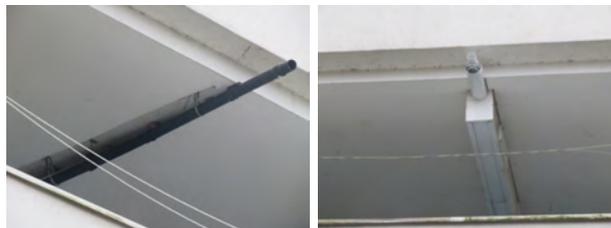
Sections of the ceilings at second floor level have been compromised by the introduction of claddings around boiler flues and additionally where boiler flues have been amended or replaced, as illustrated below. Replacement of the ceilings may well be necessary, therefore, from time to time.

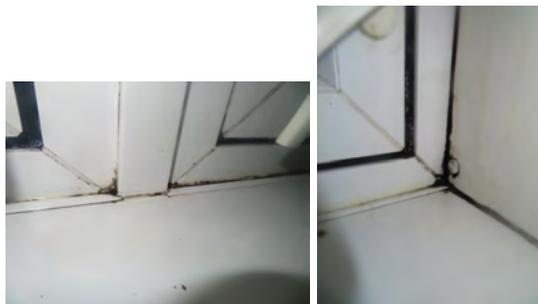
There is evidence also to suggest that the thermal break or insulation value of the frames is substandard and condensation was evident internally to Flat 8 to the frames of the windows, as shown below.

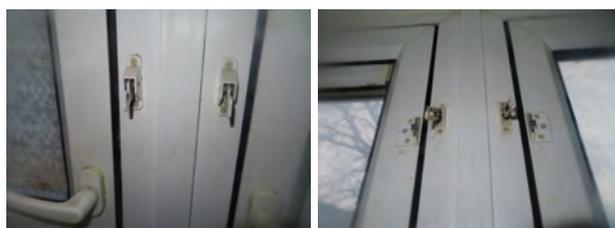
Internally within the flat, many of the restrictor stays, catches and security devices to the windows are also broken, as illustrated below. Similar deterioration is evident in other areas.

At present, remaining life expectancy does exist to the windows; however, in our view, these are of an age whereby replacement could perhaps be contemplated within the next 5-10 years. Clearly replacement of the windows throughout the block represents significant expenditure which, presumably, will be carried out by the Landlord with costs recovered from the various long lessees.

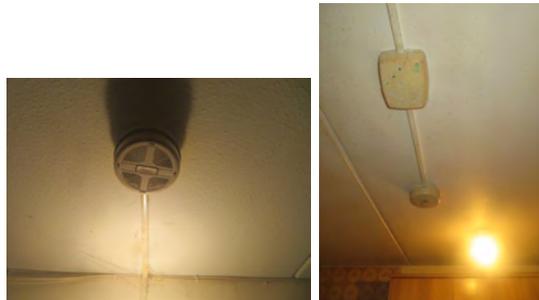
The property has a basic smoke detection system as illustrated below. No heat detector was recorded within the kitchen. Accordingly we would recommend that a new fully compliant smoke alarm system is fitted within the flat as soon as possible.

The property has a smoke detection system which appears to incorporate a combined carbon monoxide detector, although we cannot confirm our suspicions in this regard. Our recommendation is to upgrade the smoke detection system within the property, so it is fully compliant with current regulations, and incorporate a heat detector within the kitchen.

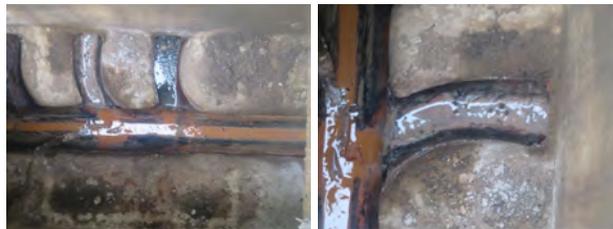
The main soil stacks, we believe, discharge directly into the underground drainage installation and many inspection chambers were recorded during the course of our survey. The majority of the inspection chambers were heavy duty covers that could not be lifted; however, where possible, lids were removed to reveal the underground drainage installation to be of vitreous clay formation, in keeping with buildings of this age and nature, as illustrated by reference to the following photographs.

The photographs illustrate a build up of limescale within the pipework and descaling and cleaning of the underground drainage installation is strongly recommended and should be undertaken on a regular basis.
