# BUILDING SURVEY REPORT

**XXXX**

## xxxx – Building Survey

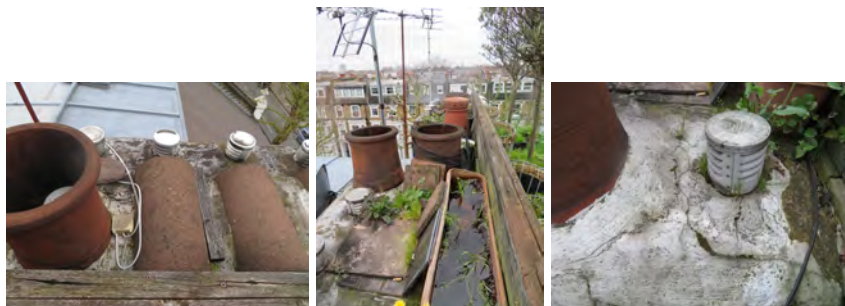
The pointing to the chimney stacks is a little loose and recessed and some repointing is to be anticipated. To the top sections of the various chimney stacks the majority of flues are capped, sealed and vented and are not therefore suitable for use. The overall condition of the flaunching and upper sections of the stacks to both the front and rear part of the building are poor, as illustrated below.

There have been no adequate maintenance of the stacks in recent times, particularly the cappings, and some water penetration may well occur. Replacement of the flaunchings and appropriate sealing of the flues is strongly recommended.

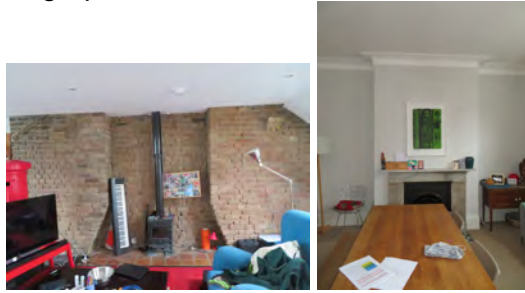
Internally within the property chimney breasts were recorded generally in all salient locations and within the top floor the exposed brickwork to the flue structure was evident and is illustrated by reference to the following photographs.

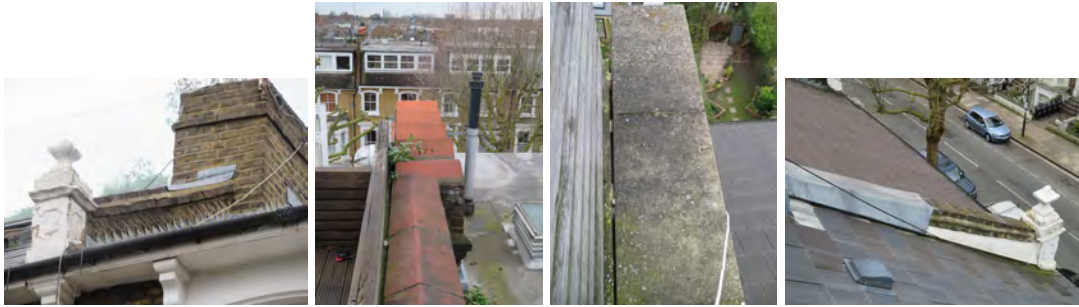
The property has solid 9" brick parapet walls constructed between the various chimney breasts and evident to the front of the property by reference to the following photographs. In general the parapet walls hold good alignment with little evidence of any undue movement or deflection and on this basis we are satisfied that they remain structurally stable.

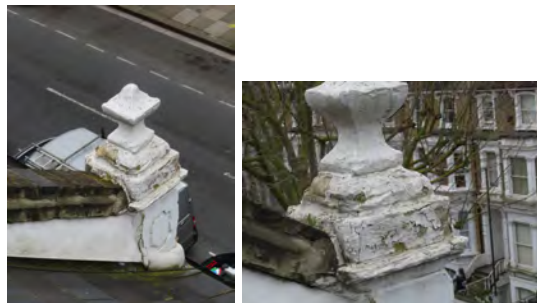
Rendered and brick on edge capping details are badly weathered with cracked and blown mortar evident and additionally the stone embellishments to the front of the building are badly weathered, as illustrated below.

In our opinion the parapet walls at upper levels would benefit from repair and maintenance, although this is generally in keeping with what we would normally anticipate in buildings of this age and nature. The parapet walls generally appear to be structurally stable but failure to maintain and carry out regular repairs will potentially undermine their integrity and works of this nature are therefore essential.

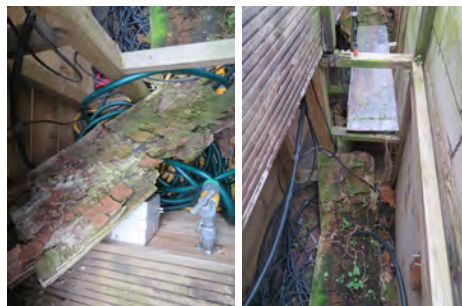
The upper areas have clearly been poorly neglected and timber decking and areas around the extremities of the roof terrace and rotten and generally in poor condition, as illustrated below. Significant refurbishment of the upper areas is necessary, in our opinion.

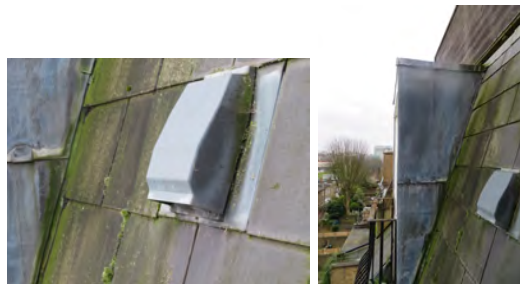
The rear mansard which has been formed, presumably as part of the loft conversion, we anticipate is also of timber construction and utilises similar man-made slates and again ventilating tiles are incorporated, as illustrated below.

Again, deterioration to the Eternit slates is evident and whilst these remain in sound serviceable condition at this time replacement within the foreseeable future, perhaps the next 10 years or so, must be anticipated.

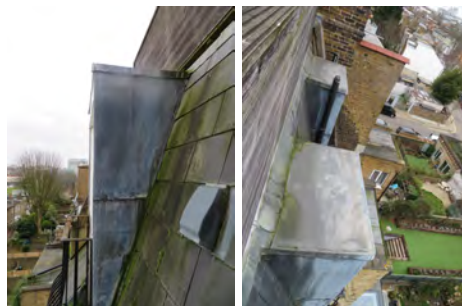
Timber dormer structures have been installed to the rear and are lead weathered, as illustrated by reference to the following photographs. The quality of workmanship appears not to be of the highest order, but we recorded no ongoing water penetration at this time. Reformation of the lead weathering to the dormers is to be anticipated in conjunction with recovering of the roofs in due course.

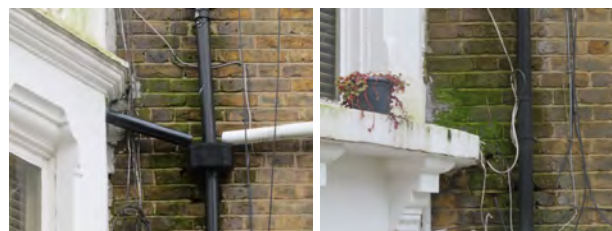
The downpipes discharge and run to serve hoppers and it is clear that flooding and leaks do occur from the hoppers, presumably as they are choked with debris. This is causing saturation of the brickwork in various levels, as illustrated below. The dampness appears, at this time, more likely to affect the lower ground floor flat than flat B, however immediate improvements are strongly recommended. Such saturation of masonry can lead to the development of dampness internally and wet and dry rot to timbers.

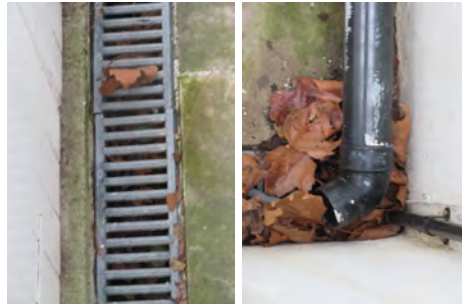
To the front of the property downpipes discharge into a slot drain, however the drain is choked with debris as illustrated below. Clearly the drains have not been maintained on a regular basis and flooding of the lower ground floor area could occur. Clearly this will not affect the upper levels of the building but maintenance is necessary and should be carried out in the near term.

Cleaning and maintenance will extend the life expectancy of the rainwater goods however replacement and reconfiguration are recommended.

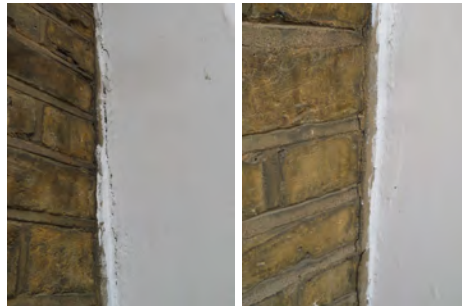
Vertical cracking was evident at the junction of the front bay and the main walls of the house and a large pointed joint has been incorporated previously, as illustrated below.

Differential movement between the bay structures of the house and the main walls of the property are typical in buildings of this age and nature. The foundations to bays are often far shallower than those of the main walls of the house and this coupled with differential movement, thermal expansion and lack of tie between the bay and the main walls of the house results in the movement which is evident. The extent of movement is well within normally anticipated parameters and in our opinion is of no significant structural concern. Repairs and repointing may well however be required over time. Movement to the bay is unlikely to significantly affect the upper flats, however repairs would be anticipated as part of the communal service charge expenditure.

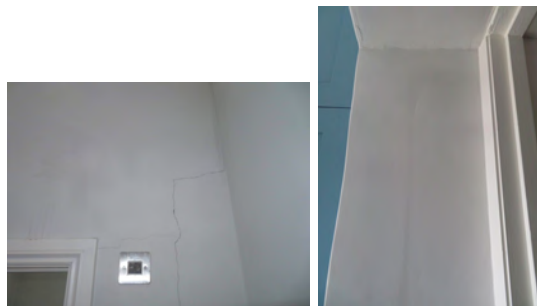
Internally within the property we recorded evidence of cracking at the junction of the rear addition and the main walls of the house in various locations, as illustrated below.

Differential movement often occurs in this location and in addition the extensions and further loading may well have caused some initial bedding down and movement between the main section and the rear additions. In our opinion, the extent of movement is slightly in excess of what we would normally anticipate. Removal of the plaster and assessment of the fractures should be carried out and perhaps some minor structural improvements undertaken with the introduction of Helifix bars if necessary. We cannot rule out the possibility of further movement in this area and to some extent continued minor differential movement is to be anticipated.

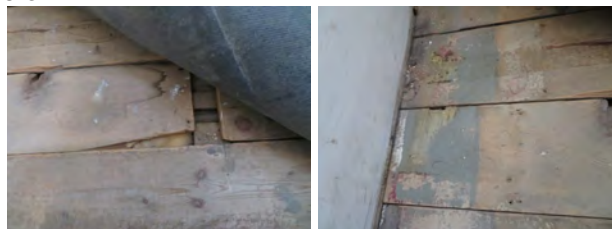
Where possible lifting of mats and carpets revealed cracked, blown and poorly fitted floorboards generally, as illustrated below.

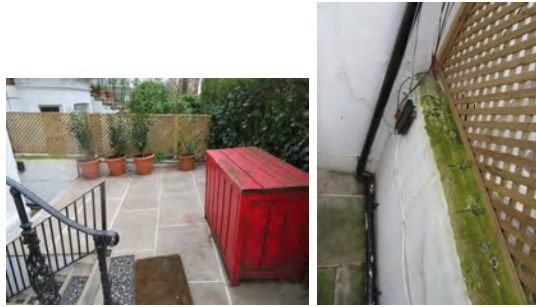
Similar walls exist to the right hand side, although a boundary fence has been raised on top of this, as illustrated below. The failure to adequately protect the top section of the surface is leading to saturation of the render work, which may cause deterioration in the future.

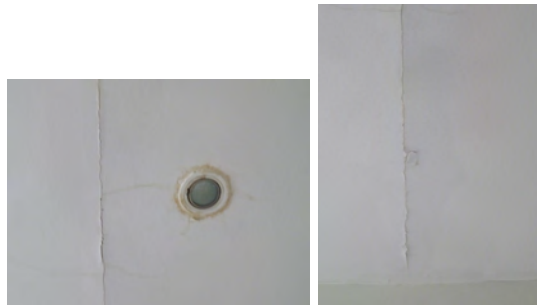
Occasional ceilings at lower levels within the unit have also been replaced with plasterboard, particularly within the small front bedroom on the floor beneath. The ceiling has been damaged by water penetration around lights and as a result cracking to board joints were evident, as shown below. It is possible, in our opinion, that the roof hatch was left open during heavy rainfall which caused the damage. Repairs and making good of the ceiling are required.

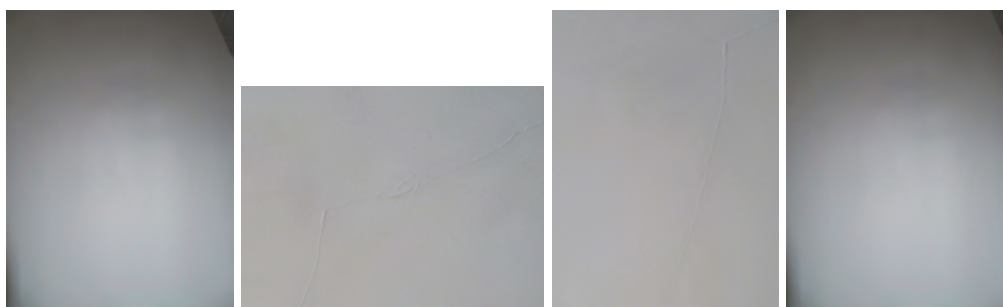
The majority of ceilings within the flats, particularly to the larger rooms, are of lath and plaster formation. In general the ceilings hold fair alignment, however cracked, blown and uneven plasterwork was evident in many rooms, as illustrated below.

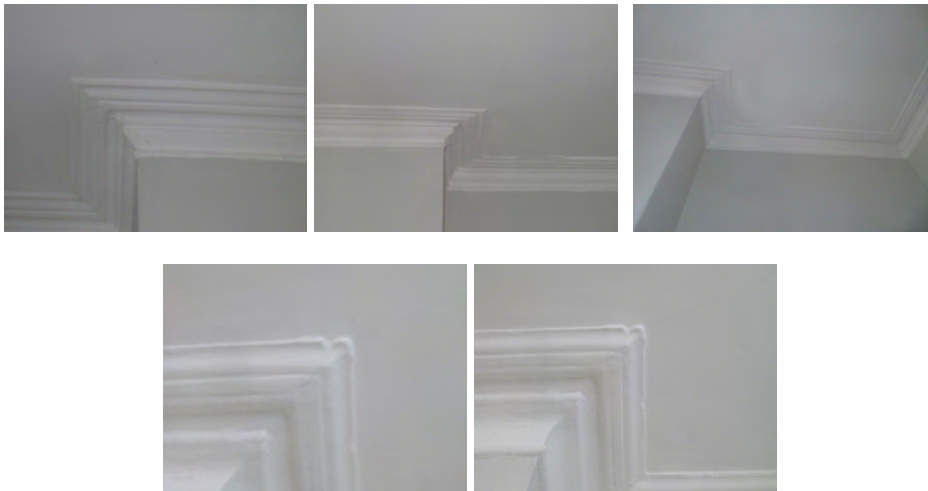
In a number of rooms original cornicing is retained which is also cracked, aged and damaged in many areas, as illustrated below. The retention of the cornicing and the old lath and plaster ceilings adds to the historic amenity of the building; however the ceilings and cornicing are in poor condition and have been badly maintained previously.

We must also advise that ceilings of this nature have been known to fail and collapse without warning. We recorded no evidence of the imminent likelihood of such failure, however we cannot rule it out. Repairs, maintenance and overhauling of the ceilings and cornices will improve their overall integrity and condition, however replacement in conjunction with renovation and refurbishment of the flat may well be considered prudent and indeed is recommended. The introduction of modern ½ hour fire resistant plasterboard ceilings would improve the overall condition, particularly if replacement cornices to match the existing were formed.

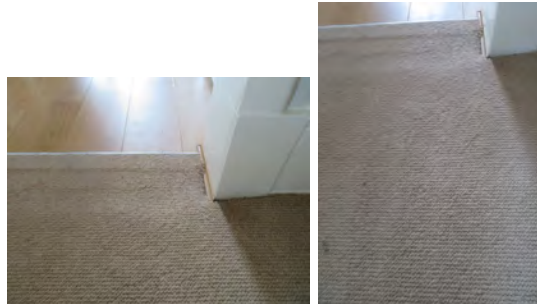
Many of the floorboard surfaces are uneven and we recorded evidence of cracked, blown and damaged floorboards, which are largely concealed by carpeting. Within the living room, in particular, close to the junction with the kitchen unevenness to the floor was recorded, as illustrated below. Extensive overhauling and refurbishment of the floorboards are to be anticipated.

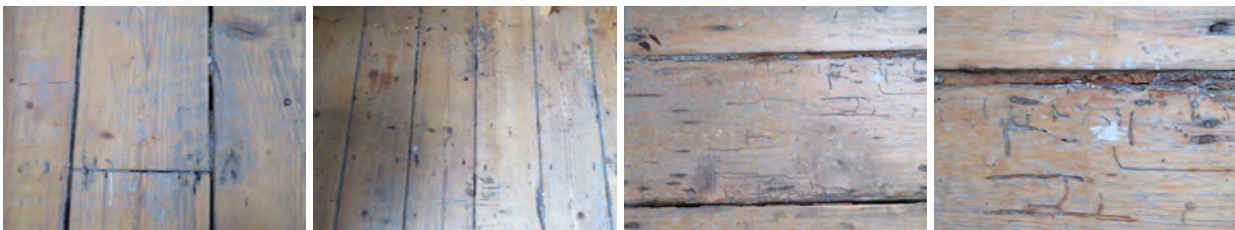
In many areas exposed floorboards were evident which revealed these to be aged and in poor condition with evidence of historic worm and beetle infestation identified, as illustrated below.

Much of the worm and beetle infestation is likely to be aged and deceased, however some live worm and beetle infestation may be identified within floor joists, particularly at lower levels within the building. The installation of modern central heating systems generally creates environments whereby worm and beetle infestation cannot flourish. Treatment of any live infestations may well be required.

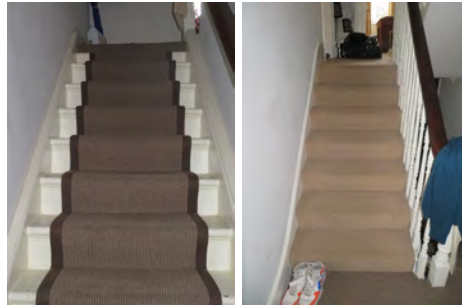
Access between the various floors of the flat is gained via staircases, ½ landings and small sections of steps as illustrated below. A new staircase has been installed to provide access to the roof terrace. In general the staircases held good alignment with little evidence of any undue movement or deflection and we are satisfied that they remain structurally stable. Significant remedial works are considered unlikely.

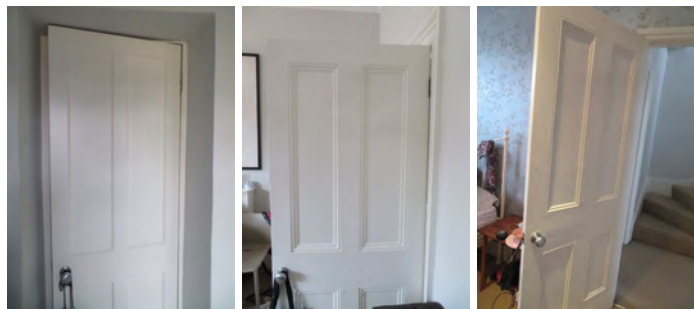
The doors internally within the flat are generally of timber formation with panelled units evident by reference to the following photographs.

The doors remain in fair condition, considering their age and nature, however a number are ill-fitting within the openings and many of the door frames and door heads are misaligned as a consequence of the movement within the building historically, as illustrated below. The extent of movement in this regard is well within normally anticipated parameters and is considered to be of no significant concern.

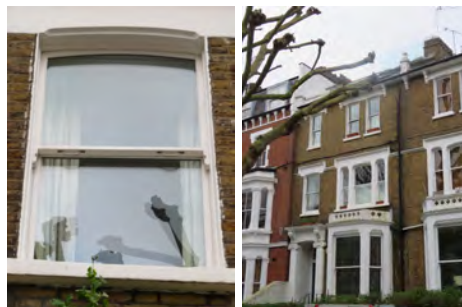
The windows to the flat are generally of replacement timber double hung sash units installed to match the original style, as illustrated below.

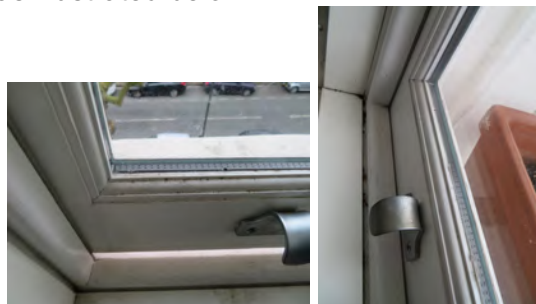
The sealed double glazed units within the windows are relatively slender in nature and do not offer the most energy efficiency, as illustrated below.

Condensation may develop on the windows during particular climatic weather conditions, however the energy efficiency of these slender double glazed units is greater than any single glazed units. Upgrading of the windows with modern energy efficient double glazing could be contemplated but is not considered cost effective at this time. The new windows generally remain in good condition and subject to regular repair, maintenance and cleaning have significant remaining life expectancy.

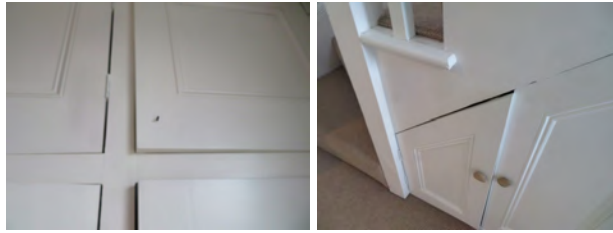
The secondary joinery components within the property remain in fair condition and a number of built in cupboards have been formed. The cupboards beneath stairs and in other locations are generally of fairly basic form and whilst these remain serviceable improvements and adjustments are necessary to return these to a serviceable condition, as illustrated below.

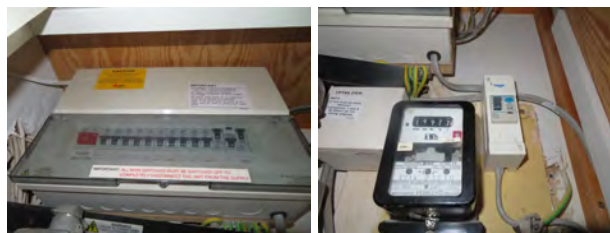
From the meter supplies run to a relatively modern miniature circuit breaker, as illustrated below. The circuit breaker is not strictly compliant with current standards but is of relatively modern origin. Upgrading of the installation with a metal cabinet based miniature circuit breaker is recommended and works of this nature should be undertaken in due course.

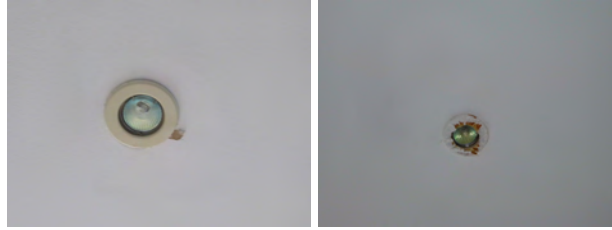
The lighting within the property consists generally of aged recessed halogen based spotlights which are inefficient and in addition the units have no intumescent hood and effectively compromise the fire resistance provided by the ceilings, as illustrated below. The lighting units are aged and a number are inoperative. Replacement of the lighting units with modern LED units incorporating an intumescent hood is strongly recommended to upgrade the lighting so it is more compliant with current standards.

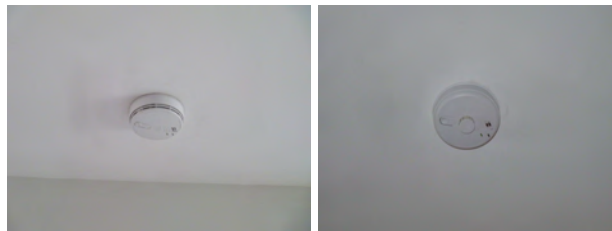
The upper parts have a smoke detector system which appears to be hardwired, as illustrated below and is of relatively modern origin and remains in good condition. A heat detector within the kitchen was also recorded. Testing of the system is essential to ensure that it is fully compliant with current Regulations. This system is essential to ensure that adequate means of escape facilities are provided.

Upgrading of the doors leading onto the common areas at ground level is also essential and improvements to the fire protection provided by the existing lath and plaster ceiling and partition linings should also be contemplated.

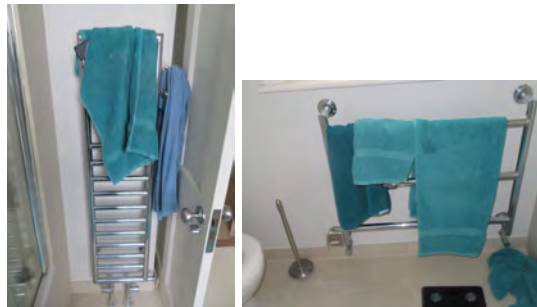
Towel rails supplement the heating within bathrooms, as illustrated below.
