## SAMPLE BUILDING SURVEY REPORT

## 1.00 INSTRUCTIONS.

## 2.00 INSPECTION.

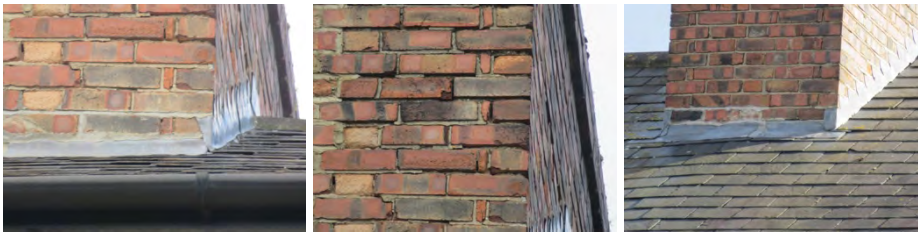
The overall condition of the chimney stack is fair, however there is evidence of deterioration and loose and recessed mortar pointing in various areas as illustrated below.

Repointing of the stack is required and in addition the flaunching or weathering to the top section of the stack appears deteriorated and this has resulted to the failure of the pointing, as illustrated below. Reflaunching of the stack is therefore to be anticipated and required in the relatively near term.

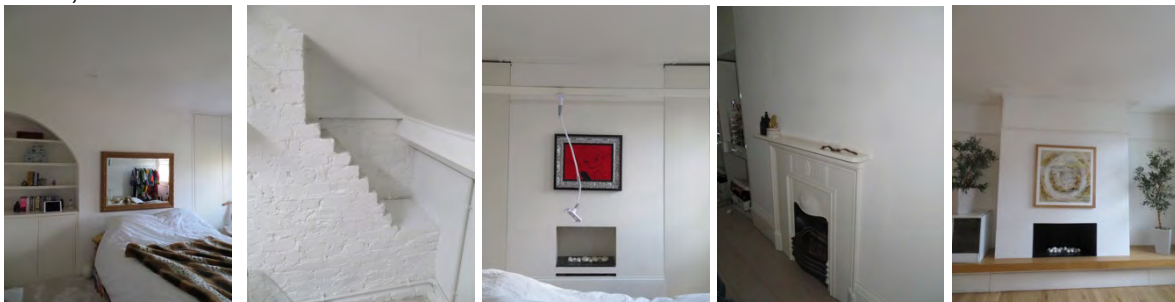
It is evident that the majority of the flues to the stack are sealed and vented, although we anticipate some are utilised for internal fireplaces and various cowls for gas fires are evident in the previous photographs. Internally within the property the chimney breasts are generally retained in all locations, as illustrated below.

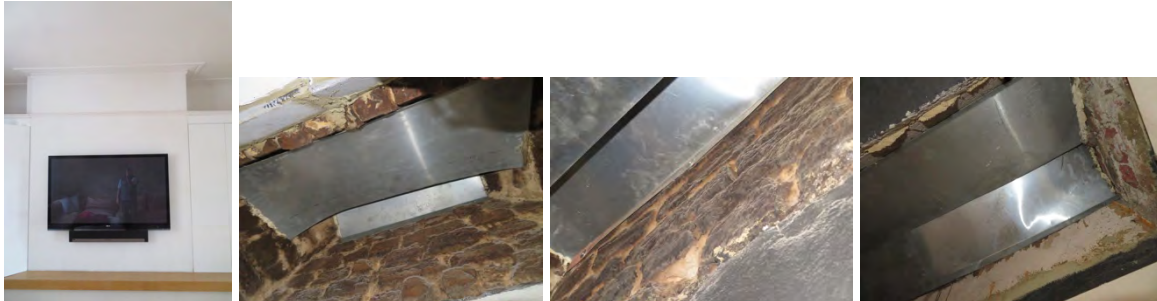
Within various areas, particularly the kitchen, the main living room and master bedroom, inset modern fires have been formed which we believe are gas powered. It was not possible to gain sight of the chimney flue, as these appear to have been sealed with plates, as illustrated by reference to the following photographs. The workmanship and condition of the opening within the fireplace is poor, in our opinion, and we are not satisfied that the installation of the fireplaces is adequate and that these remain in safe, serviceable condition.

In our opinion testing of all the fires by a Gas Safe registered engineer and additionally servicing and testing of the flues by a HETAS engineer are strongly recommended to ensure that the installations remain in a safe, serviceable condition. Remedial works may well be required to rectify matters in due course.

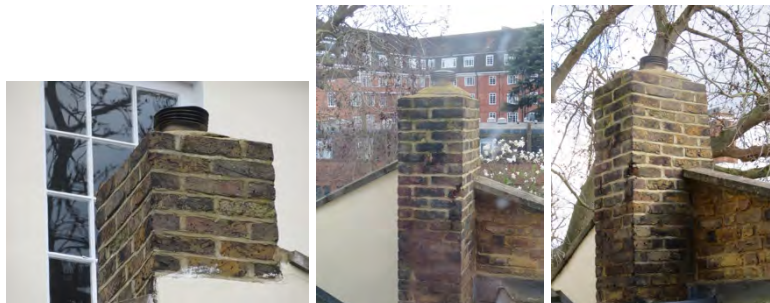
To the rear a small separate chimney stack is evident above the lower rear addition roof levels, as illustrated below. The chimney stack generally holds good alignment with little evidence of any undue movement or deflection and we are satisfied that it remains structurally stable. Once again, the condition of the brick structure is a little weathered and repointing, whilst not essential at this time, is recommended and should be undertaken in the foreseeable future. Similarly, reflashings of the upper sections should be contemplated as part of regular maintenance of chimney stack structures.

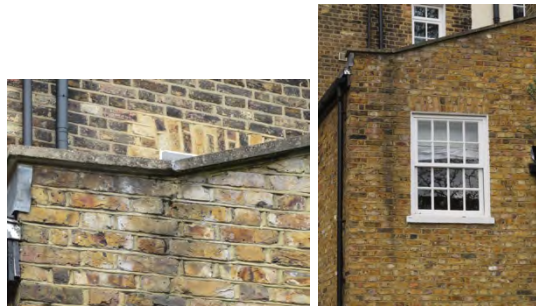
The parapet is weathered by means of concrete coping stones which slope downwards. As often happens with details of this nature rainwater run off is not adequately discharged where the sloping section meets the flat section of the parapet and also due to poor pointing of the joints saturation is occurring of the brickwork beneath, as illustrated by reference to the following photographs.

This is unlikely to cause any significant water penetration internally, however repointing of the coping stone joints is recommended. The coping stones appear not to incorporate a suitable drip, which is allowing the water to saturate the brickwork beneath. Replacement of the coping stones, whilst not essential, is however strongly recommended with once weathered twice throated stones being introduced. These should be of a suitable size to prevent saturation of the brickwork beneath. Failure to carry out the works could result in dampness developing internally, although we recorded no evidence of it.

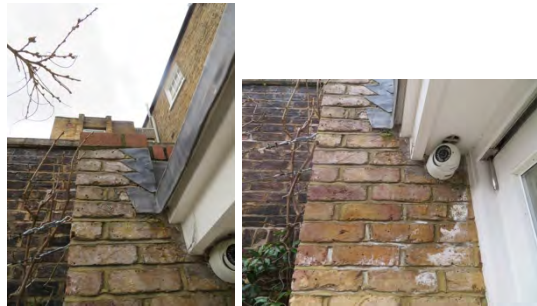
The pointing to the engineering bricks is poor and there is no adequate drip to the parapet and as a consequence saturation of the brickwork beneath the parapet, particularly to the rear garden area is evident, as illustrated below. We recorded no evidence of dampness internally, however this could develop over time. Replacement of the capping to the rear or the introduction of a creasing tile drip is strongly recommended to prevent saturation. Rainwater run-off from the parapets will result in failure of the pointing. The brick on edge capping's should be repointed and ideally replaced with a coping stone of suitable size, which should be once weathered and twice throated as detailed previously.

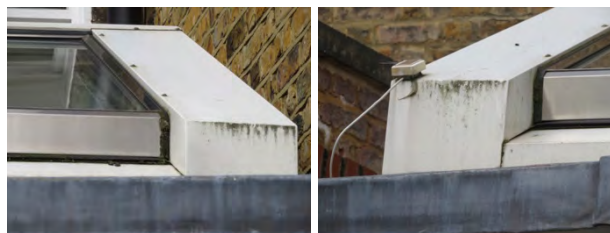
The aluminium and powder coated roof light remains in fair condition but there is some evidence of deterioration and moss growth to mastic seals, as illustrated below. We recorded no evidence of water ingress or defects to the lantern light at this time, however maintenance is to be expected within the foreseeable future which may well incorporate replacement of mastic seals to return it to a sound watertight condition.

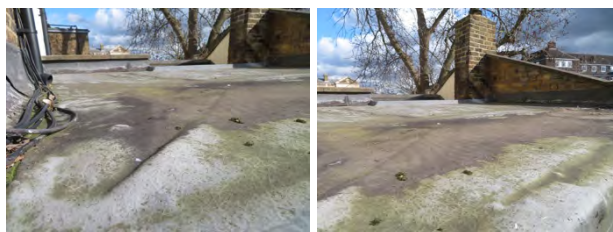
The waterproof material covering the roof is believed to be asphalt however this has been overcoated with a liquid applied waterproof membrane, suggesting that the roof has leaked historically, although we recorded no evidence of water penetration at the time of our survey. Water ingress clearly much increases the risk of rot, worm and beetle infestation to the roof structure and there is evidence of rippled asphalt and depressions which can indicate rot in the structure beneath as shown below. We cannot rule out the possibility of the development of wet and dry rot in the timber roof structure, although this is considered unlikely.

In our view the roof is of an age and condition whereby stripping and recovering in entirety is strongly recommended and should be undertaken in the near term. This would offer the opportunity of establishing if any rot exists and carrying out appropriate repair works as necessary.

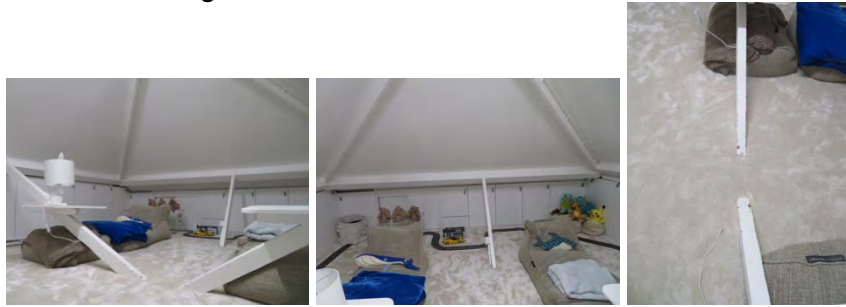
Much of the timber structure was concealed from view as a consequence by plasterboard linings; however, the hips and purlins which support the roof structure are evident, as illustrated below. Similarly bracing struts provide support at the midpoint to the purlins and transpose load to the internal structures of the building.

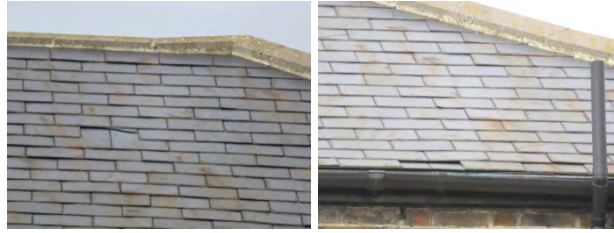
We recorded occasional broken and slipped slates within the roof covering, as shown by reference to the following photographs.

Replacement of broken and slipped slates should therefore be carried out but significant remedial works are not anticipated in the near term.

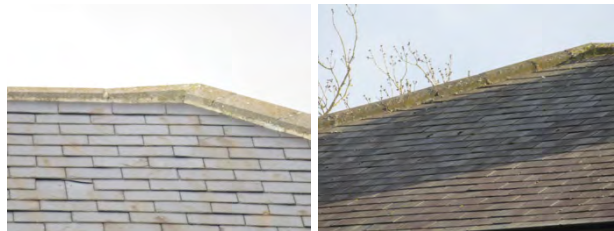
The ridge and hips are weathered by means of concrete tiles which appear to be bedded on a thick mortar base, possibly to take out undulations and misalignment within the roof structure, as illustrated below. Repointing and rebedding of the tiles may well be required in due course as part of normal maintenance; however, at present we are satisfied that the roof remains in sound watertight condition.

Improvements to the flashings to the main chimney stack and repointing of the ridge and hip tiles together with occasional replacement of broken slates will be required as part of regular normal maintenance for a building of this type, age and nature.

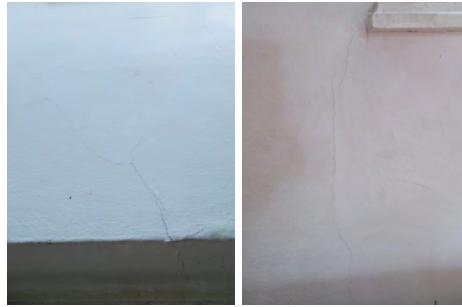
In general the front elevation held good alignment with little evidence of any undue movement or deflection; however, we did record some minor cracking within the renderwork beneath window cills, as illustrated by reference to the following photographs.

The foundations in buildings of this age and nature are generally relatively shallow and will be prone to changing ground moisture conditions. The area is known to consist of shrinkage clay sub-strata and movement and foundation instability, particularly during periods of drought or growth of trees in close proximity to the property is much increase. Movement can also occur as a result of drainage failure. Desiccation to shrinkable clay sub-strata can occur as a result of drought and growth of trees which offers less support to the foundations which settle downwards as a consequence. The window openings and the building generally is well aligned and we are satisfied that no significant evidence of subsidence has occurred; however, foundation instability is evident, albeit in our opinion this is well within normally anticipated parameters for a building of this type, age and nature.

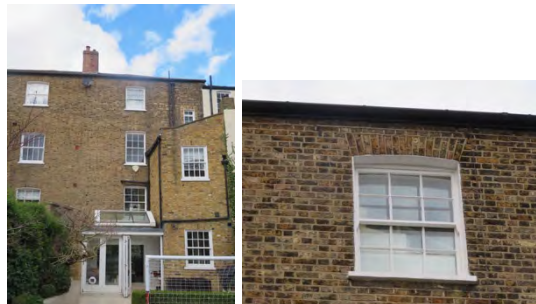
Similar movement appears to have occurred to the rear of the property historically, although again the window arches to the rear elevation are generally adequately aligned, as illustrated below.

We cannot rule out the development of subsidence in the future and some foundation instability is, in our opinion, to be anticipated. It is imperative therefore that building insurance with appropriate levels of subsidence cover are placed immediately on your purchase of the house in the unlikely event of the development of this defect. Continued minor movement to the structure of a building of this type, age and nature is inevitable, in our opinion; however, we have not identified any circumstances which, in our opinion, would result in a significant increase in the extent of movement recorded.

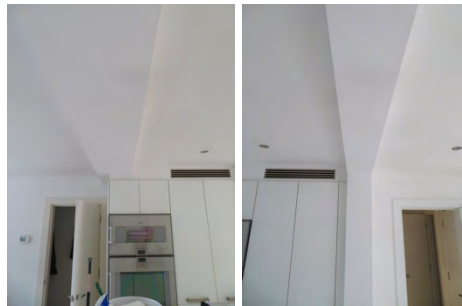
The main load bearing structure of the house is provided by the solid external and party walls and additionally internal partitions form part of the load bearing structure and transfer floor and roof loads down through the building to the foundations. Clearly many alterations have been undertaken to the property and a number of load bearing walls have been removed to create open plan areas. Downstand beams appear to have been introduced, although these were concealed by plasterboard linings. Where visible, the downstand beams held good alignment and are illustrated below.

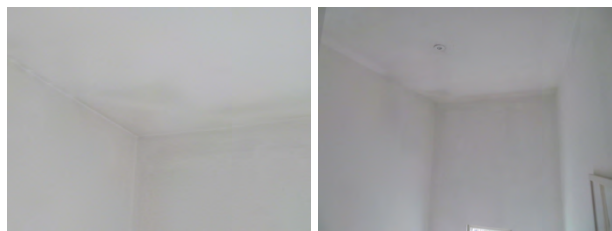
To the rear addition we recorded evidence of cracking at the junction of the party wall and the rear addition wall, particularly within the staircase well area, as illustrated by reference to the following photographs.

Movement in this area is not uncommon in buildings of this age and nature, particularly due to the lack of tie given the stairwell. Bonding between party walls and rear addition walls can often be limited in buildings of this age and nature, resulting in the vertical cracking which is evident. Cracking is also evident at the junction of the ceilings and the rear wall, suggesting of some slight movement in this area. In our opinion, the extent of movement is within normally anticipated parameters and does not significantly undermine the overall structural integrity of the building; however, it may be necessary over time to incorporate concrete knee ties to provide a suitable bond between the party wall and the rear addition.

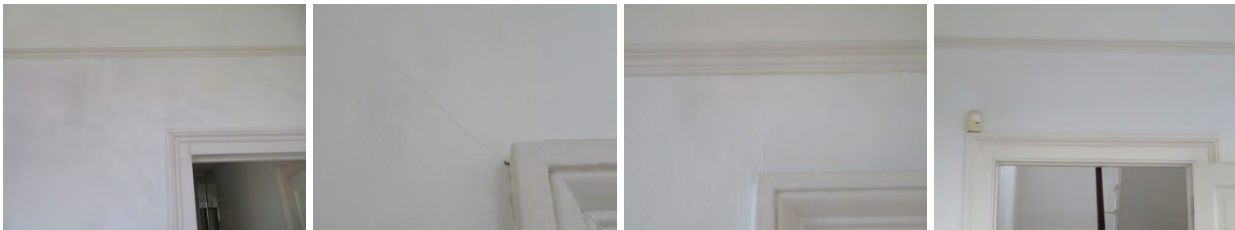
Cracking and movement above door openings in internal partitions is, to some extent, to be anticipated and we recorded some slight evidence of this, as shown below. A number of partitions are of masonry construction whilst some timber studwork is also apparent.

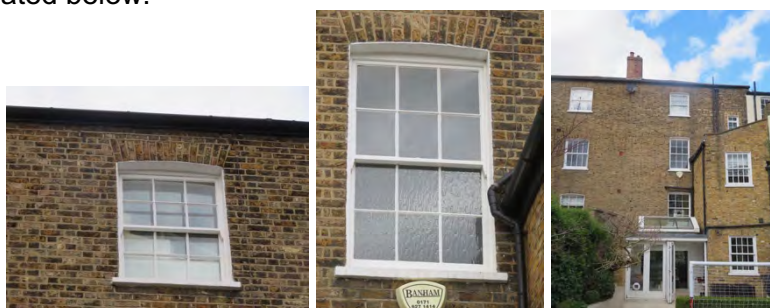
The windows remain in fair condition considering their age and nature; however, there is some evidence of deterioration to window cills which perhaps suggests poor decoration in recent times as well as also basic making good of rotten timber cills, as shown by reference to the following photograph. Overhauling, maintenance and decoration of the single glazed double hung sash windows will improve their overall condition.

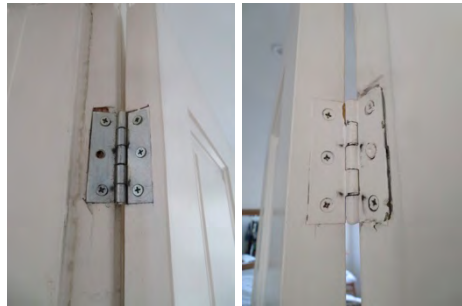
The doors remain in fair condition; however, the quality of hinges is generally basic and missing screws also compromise matters in this regard, as illustrated by reference to the following photograph. Improvements to the ironmongery and furniture to the doors is recommended but beyond this significant remedial works are considered unlikely.
