BUILDING SURVEY REPORT

Indoor Market at xxxx

On Behalf Of

ADM
2019

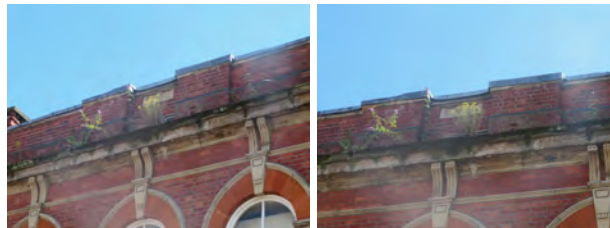
The pointing to the parapet is weathered and the original coping stones appear to have been dressed in lead, as illustrated by reference to the following photographs. The leadwork does not adequately discharge rainwater clear of the brickwork and more importantly the parapet beneath resulting in saturation. In our opinion replacement of the lead capping's and the coping stones and the introduction of new stone copings with appropriate drips, throatings and falls is recommended to prevent continued saturation of the cornice. Repointing to the brickwork to the parapet is necessary to prevent plant and buddleia growth in particular from developing, which is evident.

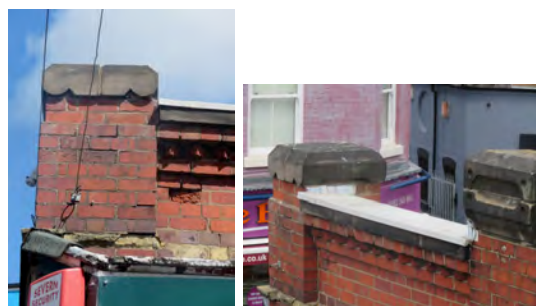
To the front of the hairdressing unit to the corner of the site there is a retained brick parapet, which is largely square in nature and circa 21 inches in thickness, as illustrated by reference to the following photographs. It is clear that the parapet is misaligned and potentially unstable and cracking is evident in the brickwork to the parapet wall to the rear of it, as illustrated above.

In the short term it appears unlikely that the masonry will become live and fall from position, however this potentially could occur and in this regard therefore restraint strapping, or demolition and reconstruction of the section of masonry to the main parapet corner is strongly recommended. Works of this nature should be undertaken in the near term.

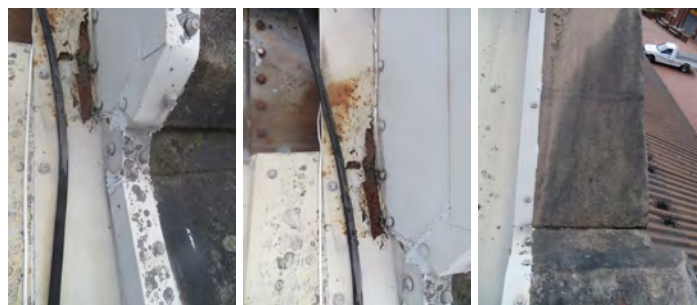
The abutments internally between the parapets and the weatherings to the main roofs of the hall are poorly formed with pre-stress powder coated aluminium capping details. The quality of the details as illustrated is poor and flat sections are corroded, as these do not adequately discharge rainwater clear of the capping's, as illustrated below. In the short term significant remedial works are not anticipated, but in due course replacement is required. The design is also poor as it could channel water behind the flashing detail as indicated by the latter photograph.

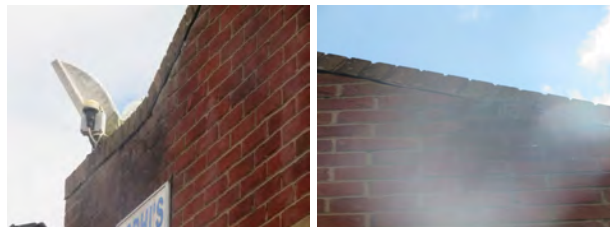
The design of the parapets is however poor and the brick on edge detail is not adequately weathered and is allowing saturation to occur during periods of heavy rainfall. To the external face it is clear that saturation of the brickwork to the flank wall occurs, due to the poor capping detail as illustrated by reference to the following photographs.

This is allowing buddleia growth to occur in some areas and the mortar pointing is becoming loose and recessed as a consequence. Further deterioration is inevitable if appropriate capping's and repairs to the parapet walls are not required. In due course such deterioration could result in the instability and undermining of the parapet.

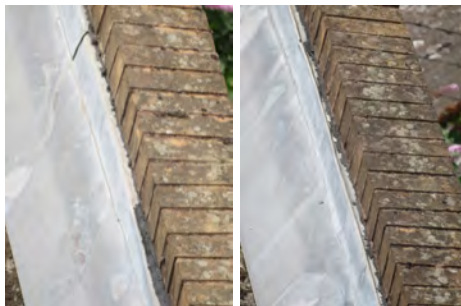
Lead flashing details have been installed; however the quality of workmanship is poor and the pointing at the junction of the flashings and the capping is deteriorated as illustrated below.

In our opinion the introduction of lead cappings dressed over the brickwork and finished with a welted drip down onto the lead flashings or clear of the building to its extremities is strongly recommended. Works of this nature should be undertaken in relatively near term.

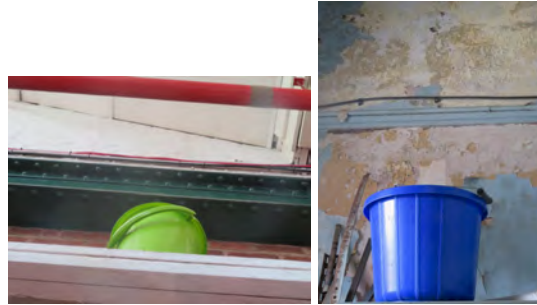
In various areas during the course of our survey we recorded the use of buckets to collect ongoing water penetration through leaks to roofs, as illustrated below. Clearly this is unacceptable on any long term basis and significant works to improve the condition of roofs and prevent water penetration is essential, in our view.

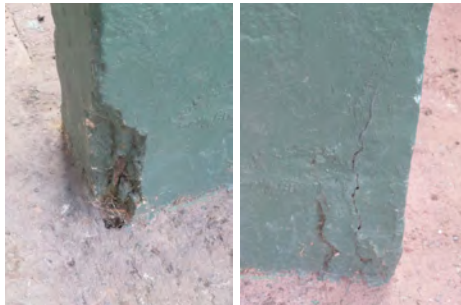
We did however record some evidence of spalling reinforcement within the exposed sections of the portal framework, as illustrated below. This is entirely in keeping with structures of this type, age and nature and suggests that the original precast construction progress was not of the highest order. Steelwork which is located close to the surface of the concrete is not adequately protected

against oxygen and water exposure, which when these both occur allows carbonation to develop. Carbonation is effectively the production of rust scale due to a chemical reaction and over time the scale, which increases in size and forces the face of the concrete from the background. The extent of the spalled concrete visible at the time of our survey is relatively minimal, however it must be considered that the visual extent of this is only the tip of the iceberg. Far greater deterioration to the steel reinforcement is to be anticipated. Further repairs in this regard are therefore necessary, although not extensively so.

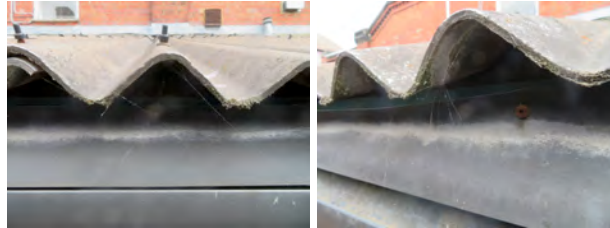
Deterioration to the extremity of the asbestos sheets however was evident below. In our opinion removal of the asbestos cement weathering's are recommended. The works should be undertaken in a controlled manner by licenced contractors and the asbestos material disposed of to a licenced tip. Works of this nature are not of the most urgent form but, in our opinion, it would be good management and appropriate to remove all asbestos components and asbestos cement sheeting from the site.

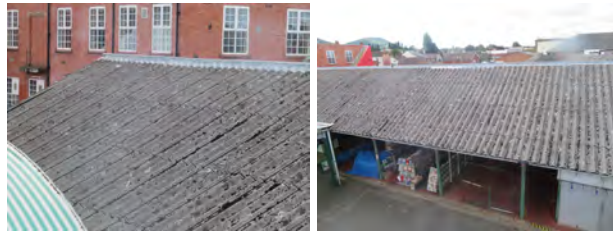
Similar but larger profiled Big 6 sheet asbestos cement weathering's have been utilised on the open covered market area to the rear right hand corner of the site, as illustrated overleaf.

The roof generally remains in fair condition, however again the asbestos cement sheeting is aged and beginning to deteriorate. Moss growth and other debris is building up on the surface, as illustrated by reference to the following photograph.

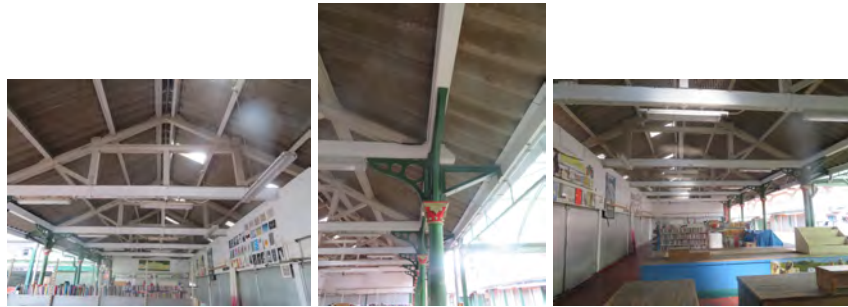
The roof structure to this building is supported by means of a timber trussed system, which in turn transposes loads down onto metal columns as illustrated below.

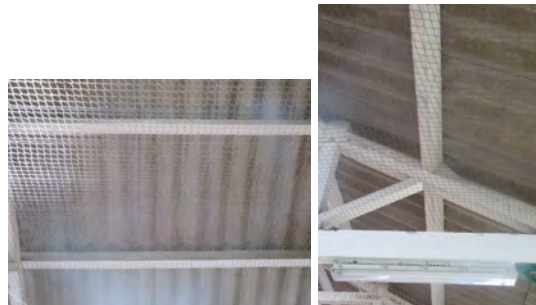
Timber purlins allow the sheets to be bolted to the main timber trusses in a fairly standard manner, as illustrated by reference to the following photographs.

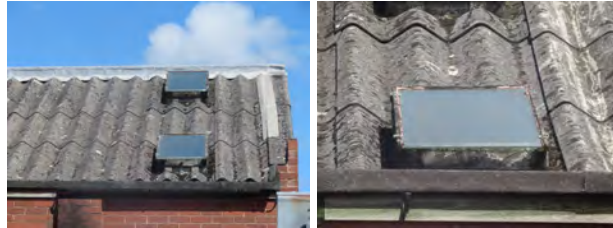
To the rear of the roof various raised roof lights exist within the asbestos cement, as illustrated below. The roof lights remain in fair order however the metal framework is corroding and the weathering details at the junction of these and the asbestos cement sheet is poor, which can result in water penetration internally. Complete renewal of the rooflights and weathering's will be required in the near term.

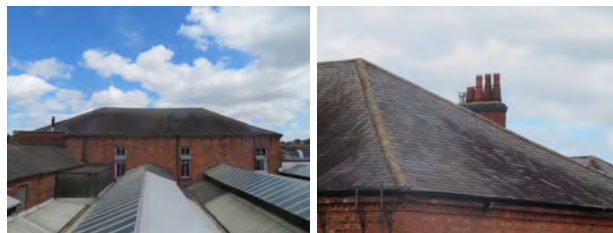
Externally the roof holds fair alignment and the hips and ridge are generally adequately aligned, as illustrated below.

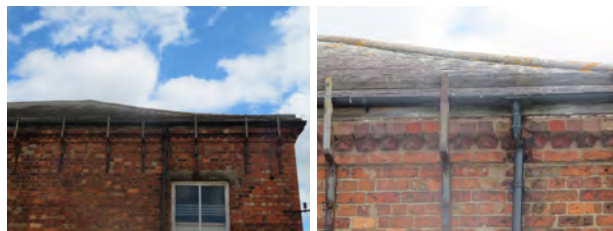
Some slight curvature to the hips to the rear of the building in particular where evident, as illustrated by reference to the following photographs.

Large roofs of this type are prone to spreading of the rafters due to a lack of tie within the roof. We were unable to gain sight of the roof structure and therefore cannot confirm our suspicions in this regard. The extent of deflection to the hip is not overly significant and does not, in our opinion, undermine the overall structural integrity of the roof timbers. Further investigation and assessment of the timber roof structure is imperative and should be implemented immediately.

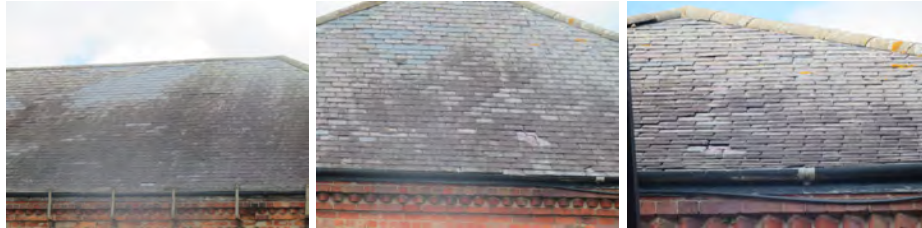
The roof appears to be covered by slates and it is clear that these have been patched on many occasions as illustrated below. Concrete type ridge and hip tiles appear to have been utilised to weather these sections of the building and again these are a little aged. Repointing of the ridge tiles is necessary.

There are a number of slipped slates which suggests that the nails which retain the slates in position are beginning to fail and the roof is nail sick as a consequence. We recorded no particular evidence to indicate significant overhauling of the roof coverings within the recent past, which exacerbates deterioration which was evident at the time of our inspection.

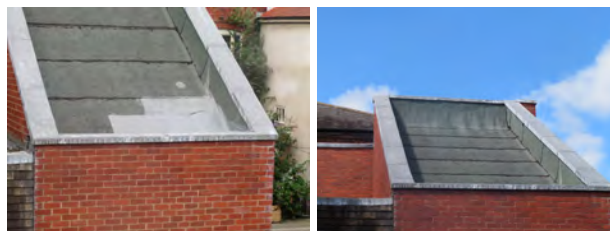
To the rear of the main xxxx building a sloping pitch roof is evident and has been weathered by a high performance felt application, as illustrated below.

We were unable to gain sight of the structure but have no reason to believe that this remains in anything other than a stable condition. It is clear, however, that water penetration has occurred previously, and crude liquid applied coatings, such as Acrypol, have been utilised in an attempt to prevent water ingress. We were unable to gain access to the accommodation beneath this area and cannot confirm if such works have been successful. In our opinion this is considered unlikely. Stripping and recovering of the roof are therefore to be anticipated and works of this nature should be undertaken in the near term. As part of this work it is likely that replacement of the roof deck will be required, given water penetration. In our opinion rot is anticipated to have developed within the timber roof structure requiring repairs.

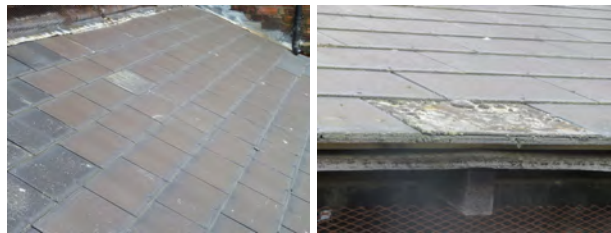
A similar lower mono-pitched slate roof has been formed, which appears to utilise more modern manmade slates. The roof is generally in poor condition however with patched and broken sections evident by reference to the following photographs. Again the slates may well contain asbestos and testing is recommended. In the near term repairs will extend the life expectancy of this roof section, however the detailing of the slating is such that this is approaching the end of its useful life.

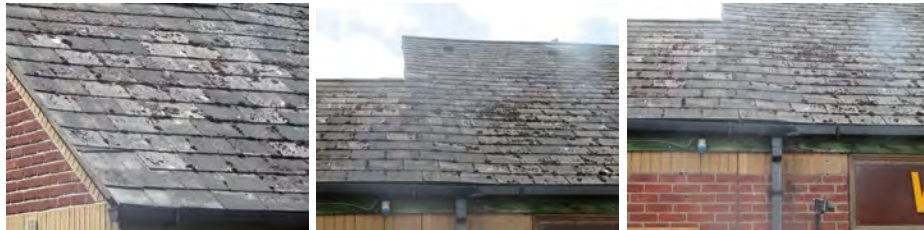
Once again the roof is weathered by means of manmade slates which exhibit evidence of deterioration, discolouration and moss growth as shown by reference to the following photographs. In our opinion the deterioration in the colouration of the slates is the first indication that these are perhaps approaching the end of their useful life. It is possible that a further ten years exists with the life expectancy of these components, but replacement must be anticipated within this time frame. It is possible also that the slates contain asbestos and testing of these so that this can be determined is recommended.

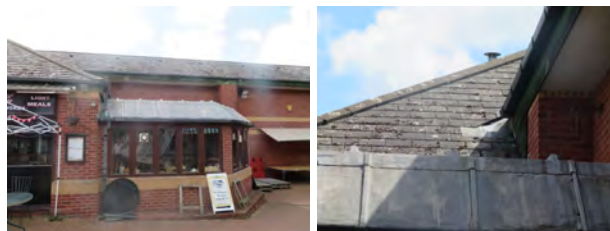
To the far end of the café a pitched and flat combined roof detail is weathered in leadwork, as illustrated below. The roof generally appears to remain stable and in good order and the leadwork remains in apparently good condition and it is unlikely, in our opinion, therefore that significant replacement of the roof covering is to be anticipated within the near term.

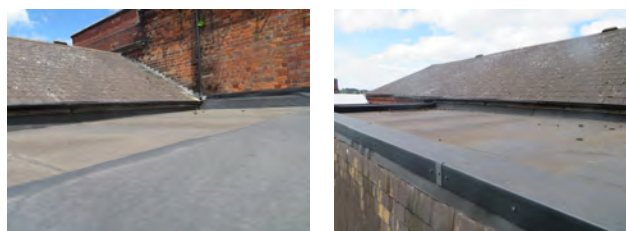
To the front of the building a timber structured flat roof was recovered and is weathered with a single ply type membrane, as illustrated below.

The roof deck, we believe, is of timber construction and generally holds good alignment with little evidence of any undue movement or deflection and we are satisfied that it remains structurally stable. The detailing of the roof covering is however poor, albeit we are satisfied that the material remains watertight at this time.

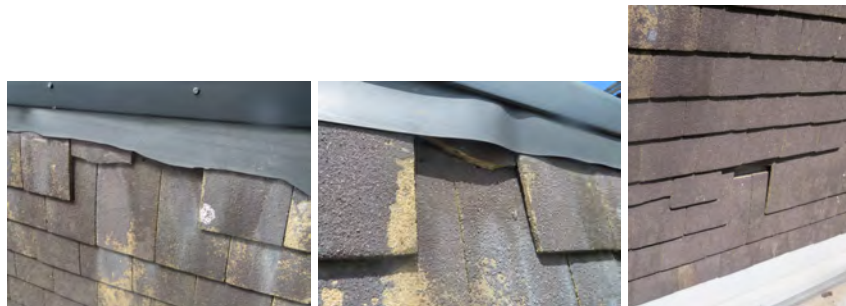
The single ply membrane is lapped crudely over the tiles, a number of which are also broken, as illustrated by reference to the following photographs. Repairs to the tile hanging are necessary in the near term and replacement of the single ply membrane is to be anticipated and ideally works of this nature should be carried out within the next five years or so.

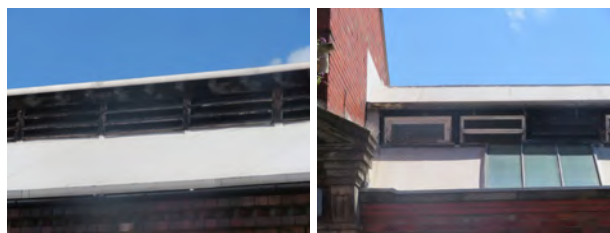
A similar single ply membrane has been utilised to weather a section of the roof towards the front of the main indoor market building, as illustrated by reference to the following photographs.

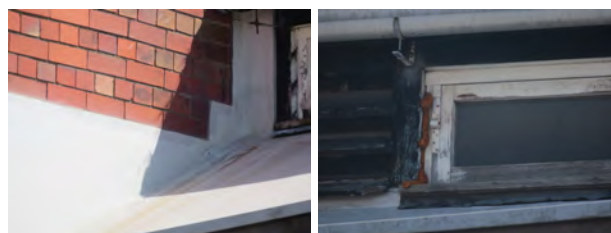
The quality of workmanship is generally poor in our view with detailing at abutments of brickwork and timber clad sections poorly applied and liquid coating sections added, as illustrated below.

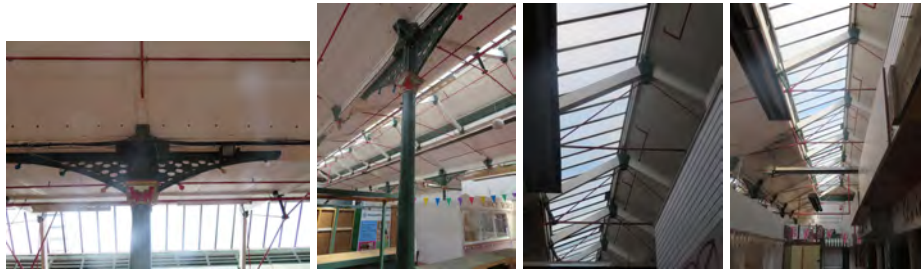
The main areas of the covered market are structured in a similar manner with timber purlins and trusses braced with a lattice of metal ties, which transpose load onto supporting columns as illustrated below.

In general the roof structure appeared to hold good alignment with little evidence of any undue movement or deflection and we are satisfied that it remains structurally stable. Clearly the roof is of an aged design and constructed predominantly during the Victorian period.

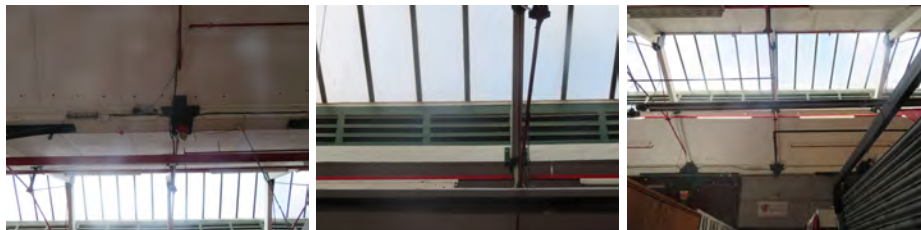
Within the building ventilation and north lights have been incorporated as part of the original design to provide natural light into the unit, as illustrated by reference to the following photographs.

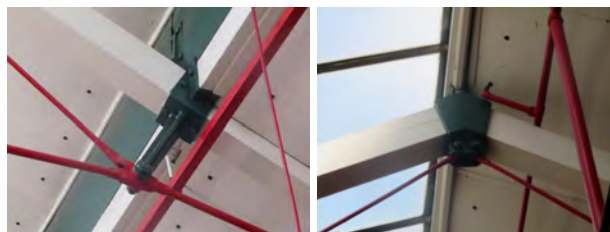
It is possible that some deterioration and fatigue in the steel ties and mechanisms is developing, albeit we recorded no evidence of it. Similarly the spiked jointing of timbers utilising metal plates, as illustrated below, could also be at a stage whereby they are in need of repair and upgrading, although again we recorded no evidence of it.

Our inclination is that the main roof structure remains in good order and certainly without evidence to the contrary we cannot recommend significant replacement. It is likely also that the structure and design may well be listed. Further intrusive investigation, testing of the component strength of the metal framework and ties is recommended to ensure that these remain in serviceable order, as we believe to be the case.

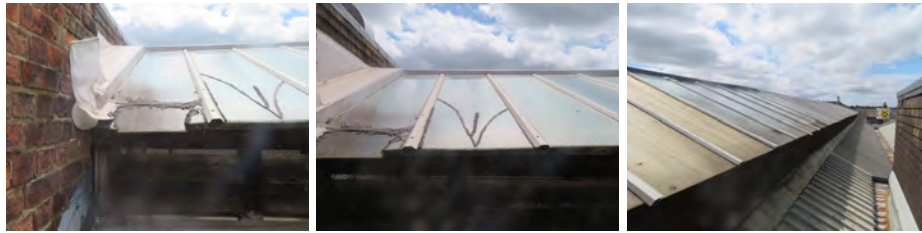
Over time sections of the glazed north lights have been infilled and others have been crudely repaired with perspex sections, a number of which are broken and in poor condition as illustrated below.

The glazing incorporates many sections of different wired glass, as well as the perspex components. In our opinion replacement of all perspex with new Georgian wired sections is strongly recommended. A number of cracked and broken panes were also identified and these should also be replaced.

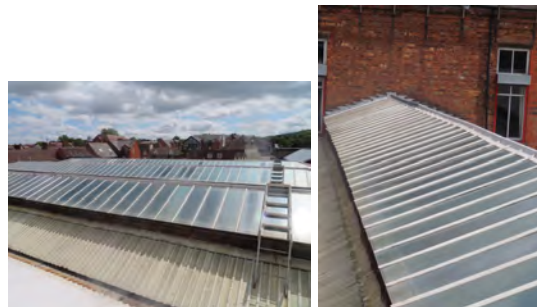
The main north lights are evident across various roofs, as illustrated by reference to the following photographs.

The north lights are timber framed and generally remain in fair condition, however more recently plastisol coated cappings have been introduced to weather timber sections of the roof lights, which may well be rotten beneath the cappings, although these could not be inspected and therefore we cannot confirm our suspicions in this regard.

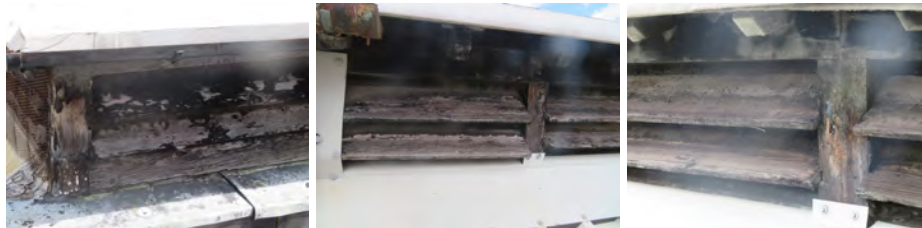
The timber framework to the north lights appears to remain in fair condition and we are satisfied that it remains structurally stable. It is apparent however that the timber vents, which run to the extremities of the raised north light sections and the associated rear area of the roof, are badly weathered and aged and have not been decorated for many years as illustrated below.

Extensive repairs to the rotten and deteriorated timbers are to be anticipated, although the level of degradation is limited, it would appear, based on the lack of maintenance historically. Extensive overhauling of the timber structures and the framework to the north lights must therefore be anticipated over time and if decorations are not applied in the near term further deterioration is such that extensive replacement of rotten timbered sections may well be anticipated. Failure may also lead to spread of dry rot to the main North light structure although we recorded no evidence of it at the time of our inspection. Such development is inevitable in our view if water ingress is not alleviated.

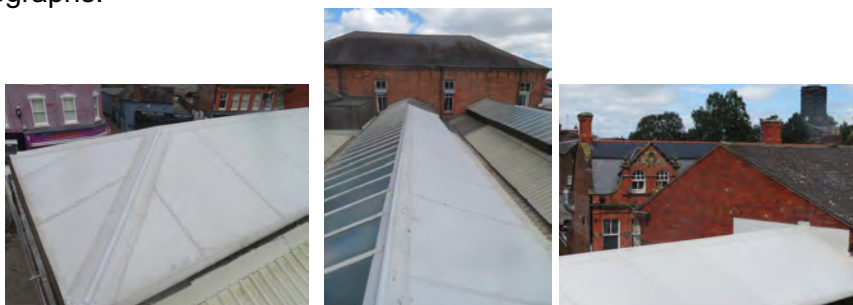
To the hipped ends and the southern faces of the north lights timber linings have been introduced and weathered with a single ply membrane, such as Sarnafill, as illustrated by reference to the following photographs.

The Sarnafil, or similar single ply membranes, appear to remain in fair condition considering their age and nature and we are satisfied that these are currently watertight. Recovery of these roof sections is not anticipated in the near term.

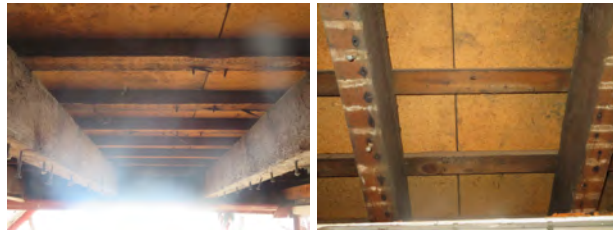
Sight of the roof structure internally beneath these areas was obtained in isolated areas where the fireboard linings had failed, presumably due to historic water penetration prior to recovering, as illustrated by reference to the following photographs.

It is likely, based on the previous photographs, that the roofs were slated prior to the application of the Sarnafil. The original battens are retained, and the deck is now provided by means of chipboard. In our opinion this is unacceptably poor, although the chipboard decking remains in fair condition. General good codes of practice would suggest the use of weather bonded ply to form a deck rather than chipboard, which can degrade if it becomes damp. We recorded no evidence of dampness and deterioration and we are satisfied that the deck remains serviceable, albeit much of this was concealed from view and could not be inspected in detail.

In our view the single ply membranes to the southern elevations of the north lights remain watertight and life expectancy of a reasonable amount is retained, albeit that in due course recovering is to be anticipated. In conjunction with recovering the incorporation of a modern weather bonded ply deck to replace the existing chipboard is strongly recommended.

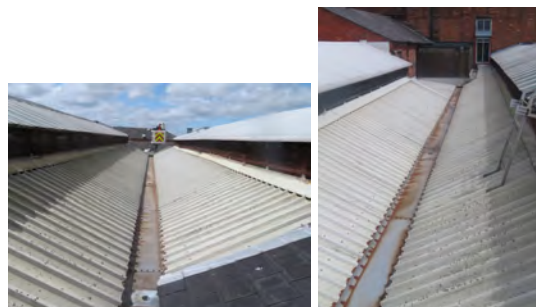
Between the various north lights of the main roofs further timber sections exist which span in towards a central valley gutter, as illustrated by reference to the following photographs. There are several pitches and valley gutter details of this form over the main covered market area. The roof structure appears to be well aligned, although the timberwork was concealed from view and could not be inspected in detail.

The slopes are weathered by means of pressed aluminium sheeting, which is not, in our opinion, suitable for small pitched sections of this nature with various intersections to adjacent components.

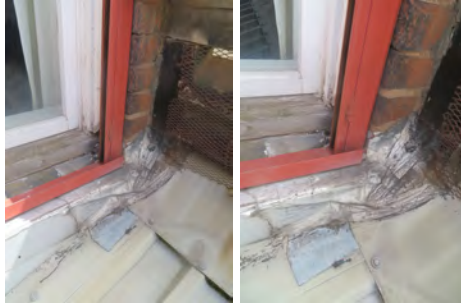
The formation of flashings and upstand details to various abutments is poor and corroded sections and many flashband weatherings have been introduced, as a consequence, to alleviate water penetration at junctions and abutments as illustrated below. Continued leaks of this form are to be anticipated.

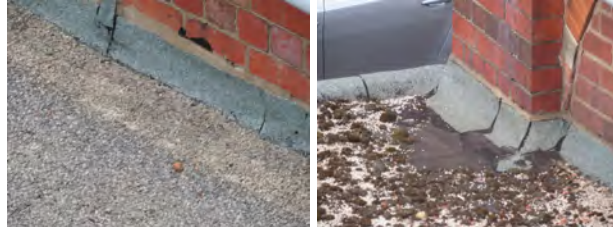
The detailing at the junction of the roof and adjacent walls are of poor formation, as illustrated below, which much increases the risk of water penetration and consequential rot to timbers within the foreseeable future. Stripping and recovering of the roof must be anticipated and in conjunction with this work it is likely that replacement of the deck is necessary.

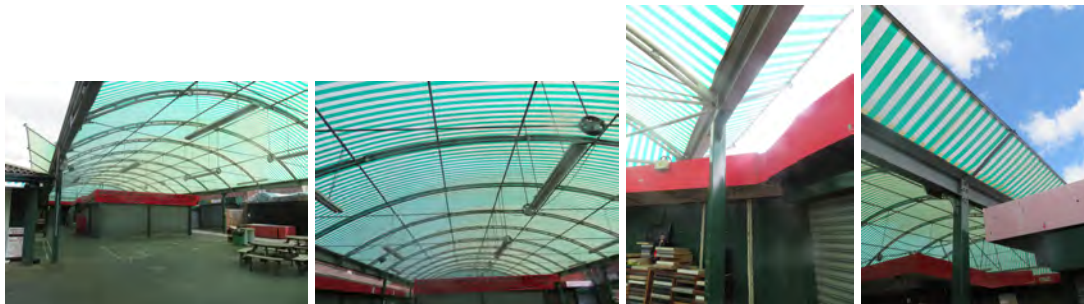
The canopy weathering is supported by means of a modern metal space frame type structure, which consists of lightweight columns and roof frame sections as illustrated below. The structure and framework of the building is designed simply to support the roof and generally appears adequate and capable of doing so. Some deterioration to the coated finishes of the framed sections of the building were evident, however the roof covering and its structure generally appears to remain in serviceable condition at this time.

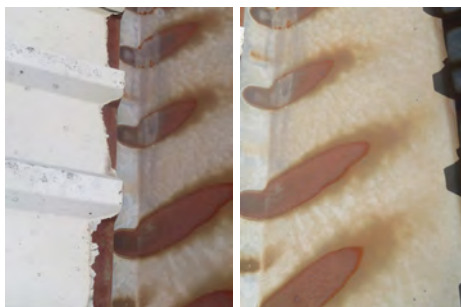
Staining to the galvanised sections is occurring following corrosion to the sheeting adjacent to it, as illustrated by reference to the following photographs. This clearly can foreshorten the life expectancy of the galvanised sections, however in general these appear to remain serviceable and in watertight order at present.

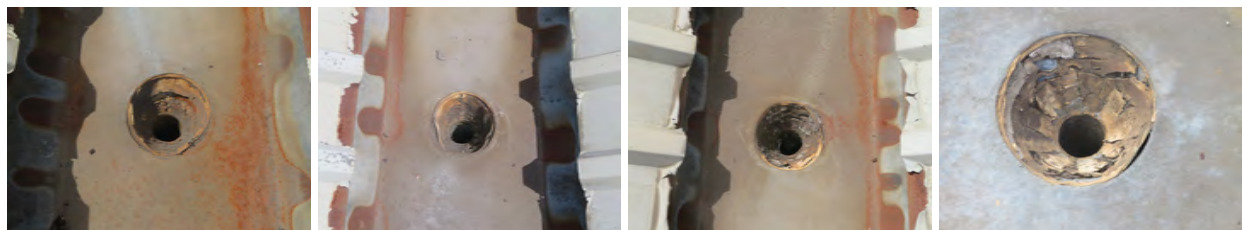
Numerous mastic applications appear to have been undertaken to outlets previously, presumably to render these watertight, as illustrated below. Such works are unlikely to be of benefit.

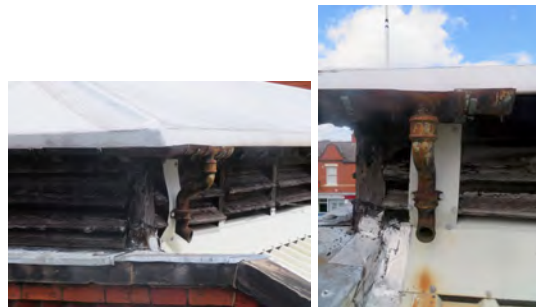
Rainwater from the north lights is collected to its hipped ends by means of cast iron gutters and downpipes, which are extremely aged and generally in poor condition as illustrated below. Cleaning, overhauling and redecoration in the near term together with realignment and sealing of leaking joints will extend the life expectancy of these sections, however in reality they must be considered as approaching the end of their useful life and replacement is warranted near term.

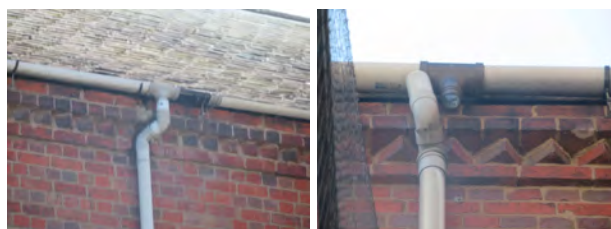
The guttering and plastic downpipes to the rear and left hand flank elevation of the main xxxx building are particularly poor, with broken sections evident and unconnected spigots and outlets to downpipes evident by reference to the following photographs.

In our opinion replacement of all plastic rainwater gutters and downpipes is recommended. Ideally suitably sized powder coated aluminium box gutters should be reinstated with similar downpipes. Alternatively, Heritage style uPVC components could be utilised if approval is granted for the use of this material.

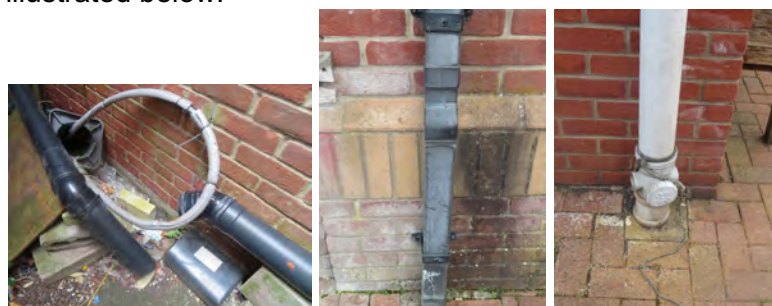
Once the underground drainage has been jet washed cleaned a full CCTV survey of the underground drainage installation should be undertaken so that the nature, condition and extent of the underground drainage installation can be established. Repairs to the underground drainage installation are in many instances to be anticipated, in our view, particularly given the absence of apparent maintenance and the fairly haphazard means of discharging rainwater into outlets, which were recorded as illustrated below.

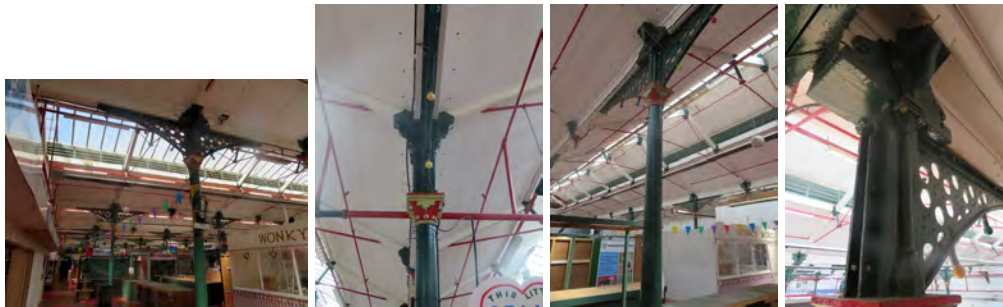
The columns are generally illustrated by reference to the following photographs and these appear to hold good alignment with little evidence of any undue movement or deflection and on this basis therefore we are satisfied that the main structural columns are stable.

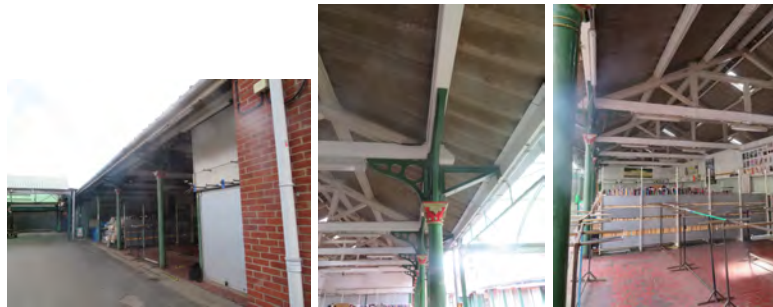
Similarly the metal columns which support the main structure within the partially covered warehouse, as illustrated below, also remain stable and in good condition, although corrosion at lower levels was evident and in this regard some decoration of exposed metal surfaces should be carried out.

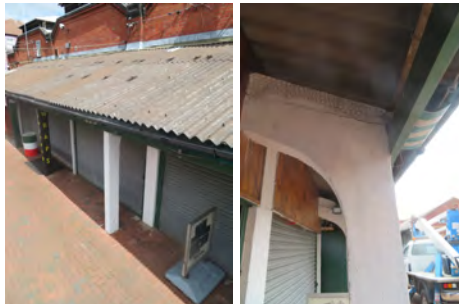
The lean-to sections to the right hand side of the main covered market are formed by means of precast concrete columns and portal frames, as illustrated below. In general these reinforced concrete structures held good alignment with little evidence of any undue movement or deflection and we are satisfied that they remain structurally stable. We reported previously some evidence of minor spalling concrete which is indicative of corrosion of the steel reinforcement, however the extent of this is minimal and in our opinion following minor remedial works significant further works are unlikely.

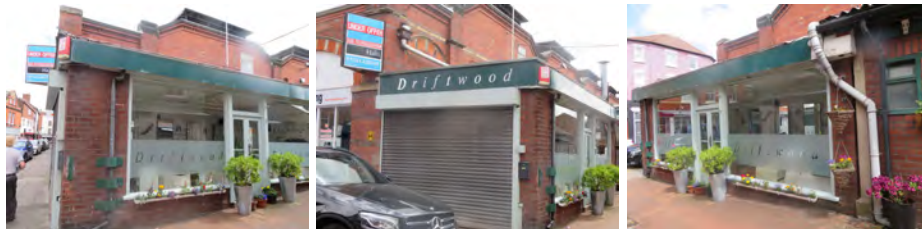
The single storey building to the front right hand corner of the site is constructed predominantly of load bearing brickwork and presumably a steel beam concealed by the fascia which spans the various openings to the hairdressing unit, as illustrated below.

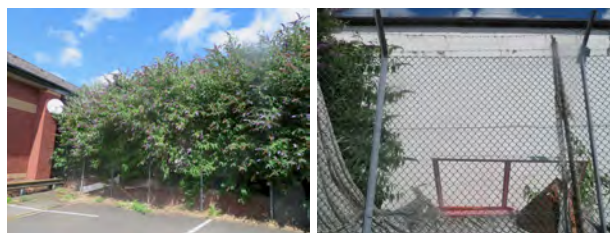
Sight of much of the rear elevation was precluded due to overgrowth and stored debris to the rear area and rendered and painted sections of masonry as illustrated below.

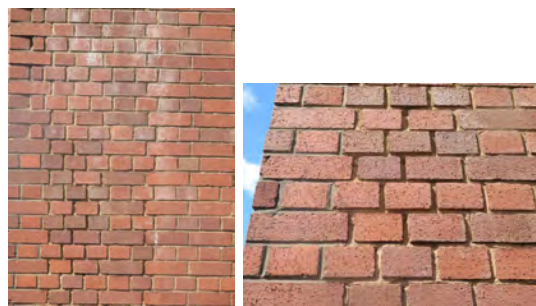
We have advised previously of saturation and damage to the brickwork caused by leaking gutters and also poor parapet capping details and further deterioration in this respect is to be anticipated. Sections of loose and recessed mortar pointing were also recorded in various areas, as illustrated below. Repointing of sections of the brickwork in this area are to be anticipated, although in general we are satisfied that the brickwork walls remain structurally stable and in good order.

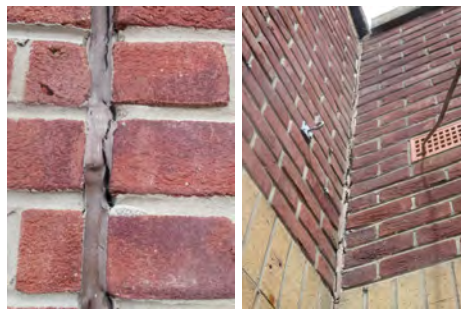
The design and construction of the building appears appropriate and expansion joints have been formed in the masonry to accommodate thermal expansion in the brickwork, as illustrated below. It is apparent that the mastic seal has failed and replacement of this is recommended, however in general the brickwork appears to be well designed.

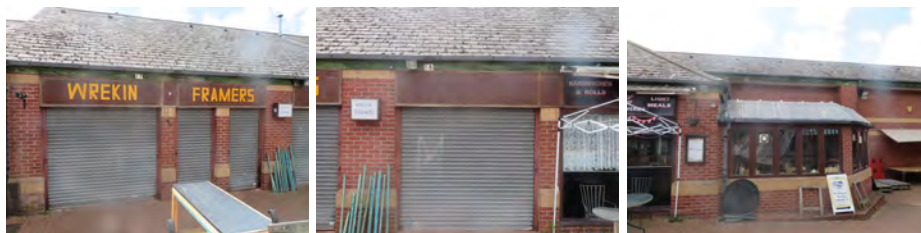
The brickwork to the café building, as illustrated below, has large openings and it is possible that a steel frame exists within it, although we cannot confirm our suspicions in this respect. The openings in all locations were well aligned and we are generally satisfied that the building remains structurally stable. We must advise that we had no access internally to the building and therefore cannot confirm matters in this regard, other than it appears to be appropriately formed and was generally adequately constructed.

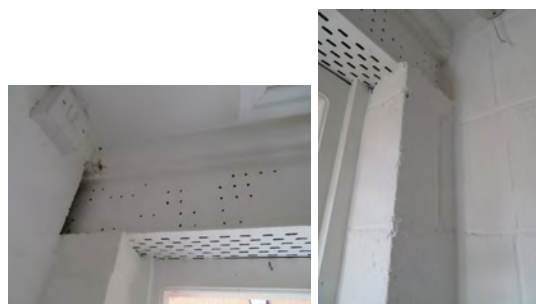
Within the toilet areas blockwork was identified which forms the inner skin of the cavity walls and Catnic lintels were also noted, as illustrated below, suggesting that the building is of relatively modern form and adequately constructed. A damp proof course exists but again we were unable to gain access internally and cannot confirm that this remains functional, as we believe to be the case.

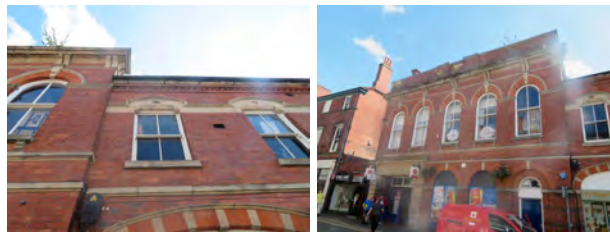
Similar arch openings span windows at first floor level to the xxxx building, as illustrated by reference to the following photographs.

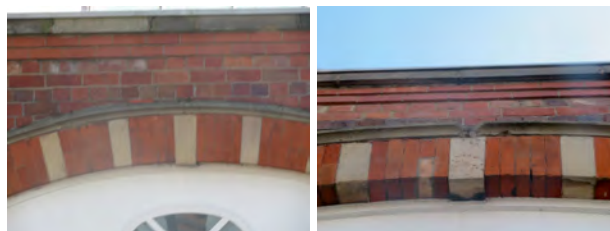
In general all openings within the brickwork to the front façade held good alignment with little evidence of any undue movement or deflection and we are satisfied on this basis therefore that they remain structurally stable. Some slight movement and minor deflection to the central keystone was identified to an occasional brick arch, as illustrated below. This is perhaps indicative of minor movement and failure of the arch, but in general the brickwork walls to the front elevation held good alignment with little evidence of any undue movement or deflection.

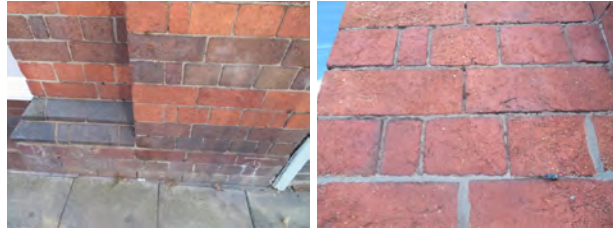
The solid brickwork utilises oversized imperial bricks which are a little unusual in size and bond with the brick bond recorded by reference to the following photographs. The walls in many instances are at least 13½ inches and more likely 18 inches in thickness and clearly the building was of substantial construction when first built.

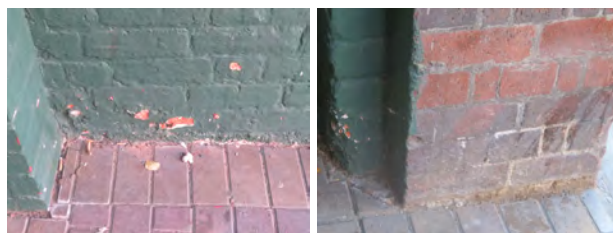
Dampness has caused deterioration and spalling of brickwork at lower levels, as illustrated by reference to the following photographs, although it is of relatively limited extent.

We recorded no evidence of a damp proof course to the external walls of the building; however it is possible that a slate damp proof course may have existed originally. Internally within the main covered market area we recorded evidence of rising dampness causing spalling of brickwork at low levels, suggesting that the damp proof course has failed if it existed.

The injection of a new chemical damp proof course is strongly recommended to supplement any existing slate DPC. Rising dampness much increases the risk of rot and other deterioration to timber structures which become saturated as a consequence. Given that the main ground floor slab is of solid formation the risk of the development of rot is much reduced, although it cannot be ruled out given some staircases and other components are close to saturated masonry at ground floor level.

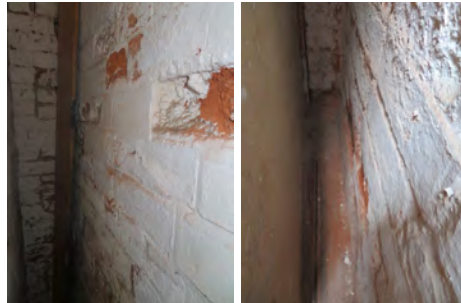
The extent of rising dampness was difficult to determine internally as many of the external walls were concealed by individual units internally, however where the brickwork could be assessed it is clearly spalling and damp, as illustrated below.

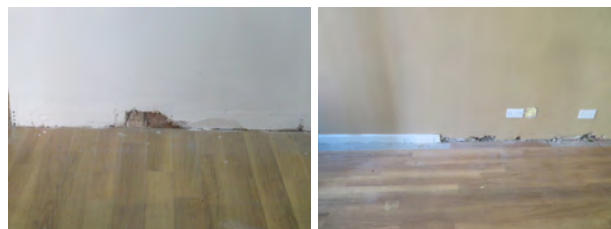
It is likely that similar rising dampness affects much of the xxxx building, however we had no access to much of this section of the property and therefore cannot confirm our suspicions in this regard. Where access was obtained internally to the xxxx dry lined walls prevented random moisture meter readings being taken. Such linings may well have been introduced to conceal dampness, which in our view is likely to exist. Damage to the plasterboard linings to the walls was recorded around the extremities, which is possible indicative of dampness, as illustrated below.

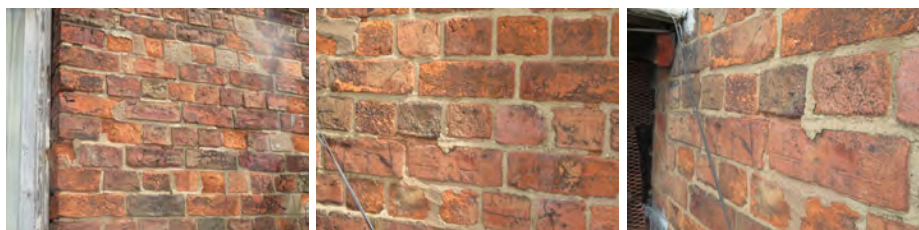
The brickwork has been poorly maintained and there is evidence of loose and recessed mortar pointing and spalling or crumbling brick surfaces evident in many areas, as illustrated below.

Extensive repointing and repairs to spalled brickwork are therefore necessary and strongly recommended.

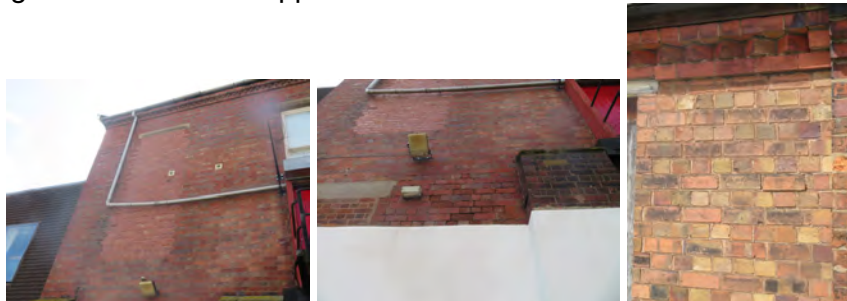
Clearly many alterations have been undertaken to the property over time and a number of window openings have been crudely infilled and new masonry constructed as illustrated below. The works are not of the highest standard but appears to be in order.

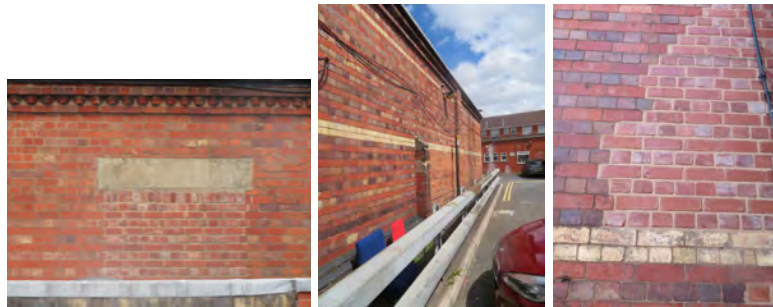
The right hand flank and rear walls of the market and similar sections to the rear were evident, albeit much of the market building is concealed by the adjacent dwellings. The brickwork is again of dense masonry construction and generally holds good alignment with little evidence of any undue movement or deflection and we are satisfied that it remains structurally stable. We have advised of the misalignment of the gable to the rear, which should be further investigated and repaired. The brickwork however, whilst dirty and aged, remains generally in good order although evidence of a number of alterations and rebuilt sections were recorded as illustrated below.

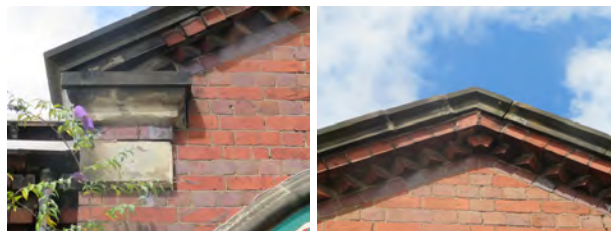
The stonework which forms part of the architectural embellishment to the buildings is serviceable but dirty in many areas and we have advised that the stonework and the parapet details are not ideal.

In our opinion it would be possible and perhaps appropriate to jet wash clean the main exposed brickwork elevations to enhance and restore the original colour. If works were undertaken as part of a general renovation of the elevations of the building it would much enhance the overall appearance, albeit in our view complete repointing of the external elevations of the building and restoration of stone sections would be necessary as a consequence.

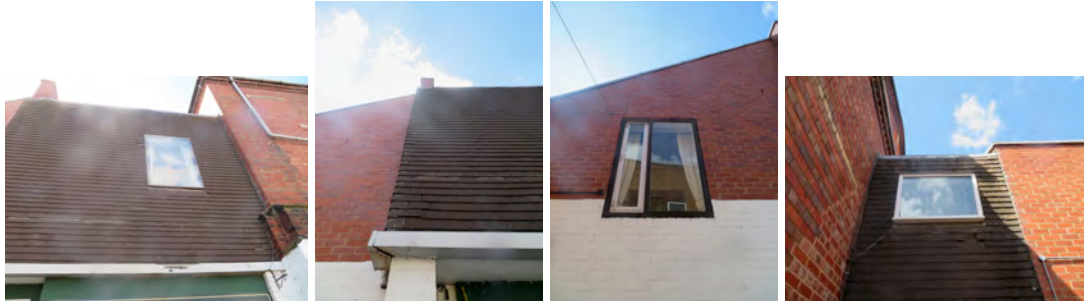
Various more modern alterations and additions have been raised to the rear of the main xxxx building, which have utilised cavity brick and block walls and also tile hung sections on exposed blockwork walls, as illustrated generally by reference to the following photographs. The buildings and extensions generally hold good alignment with little evidence of any undue movement or deflection and we are satisfied that they remain structurally stable.

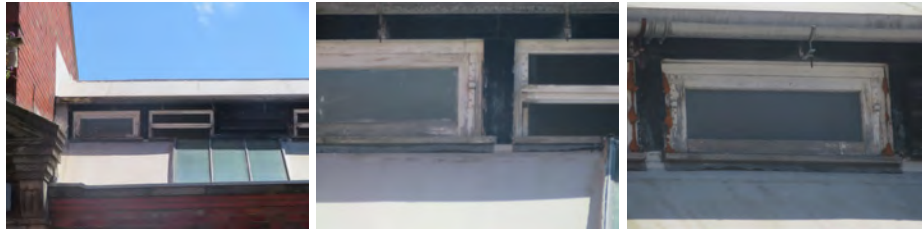
It was not possible to inspect this area of the property closely, however it is clear externally that the timber cladding is in poor rotten condition and expanding foam has been utilised around window openings to repair these components, as illustrated below.

The rainwater goods and gutters above the timberwork are choked with debris which is causing these to overflow, which further compounds the risk of rot and deterioration to these sections. Dampness and deterioration was evident internally and replacement of the timber cladding externally must be anticipated as part of further renovation and refurbishment works.

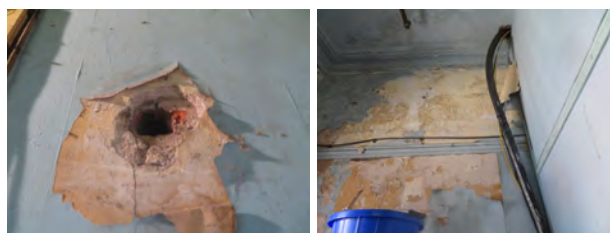
Arches are created internally in these areas and in some locations these could be inspected. Cracking and movement were evident internally which indicates, in our opinion, water penetration and some minor movement as illustrated below. The movement appears to be of recent origin and further investigation of the arch should be carried out immediately and perhaps temporary support introduced. Repairs are to be anticipated.

Water ingress has caused damage to these areas of the building and much restoration and reformation of plasterwork is necessary to return the building to a good sound condition.

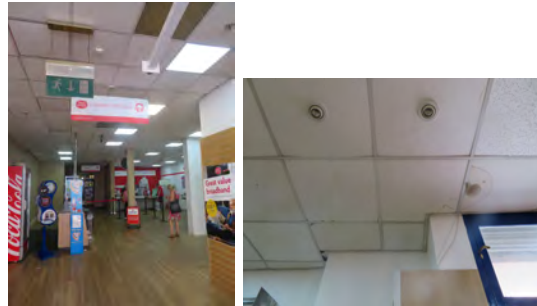
We were unable to gain sight of the ceilings within the main xxxx building, beyond the ground floor public areas, which were finished by means of suspended ceilings which are generally aged and of fairly basic quality and formation, as illustrated below. Evidence of water damaged sections was recorded.

We cannot confirm therefore that suitable fire separation is provided above the ceilings between the upper parts of the building. We had no access to the upper parts and therefore cannot confirm our suspicions in this regard. It is likely that the fire separation between the ground and first floors of the main xxxx building is inadequate and upgrading, given an opportunity or as part of the further works to renovate the building, should be contemplated and undertaken to ensure a minimum ½ hour fire resistance by recognised 15mm fireline board linings is provided.

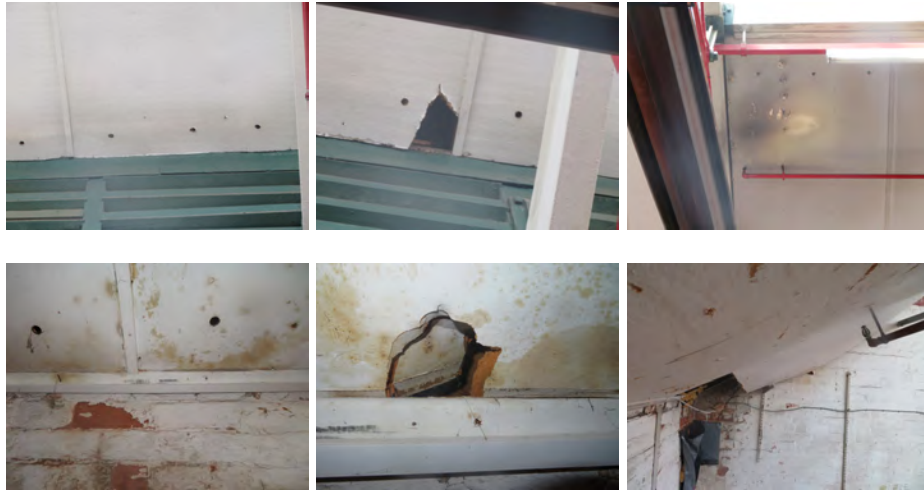
It is likely that significant leaks from the roof has caused damage in this regard. Staining and other deterioration indicative of water penetration has caused further damage to these fibreboard linings, which do not survive well following water penetration.

Clearly ongoing water penetration from roof leaks will cause further damage and deterioration to these fibreboard linings and there is evidence of this occurring as illustrated below. In due course replacement of these linings may well be required to upgrade the overall condition of the market area.

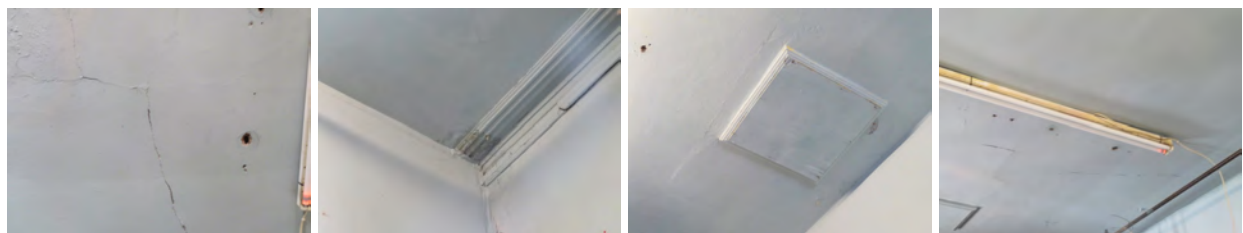
These are generally in poor condition with cracked, blown, water damaged and repaired sections evident by reference to the following photographs. Replacement of all lath and plastered ceilings is to be anticipated as part of the further renovation and refurbishment work.

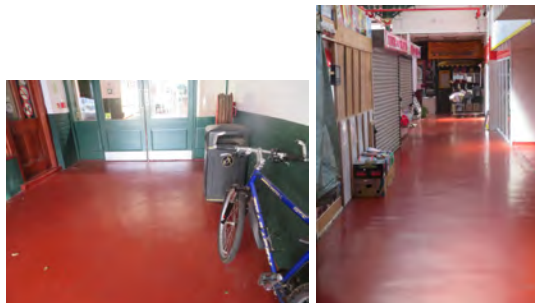
Entrance to the market is obtained in a number of areas with a concrete slab evident with a coated finish applied, it would appear, on a bitumastic membrane. The floor to the main covered market is uneven as a consequence.

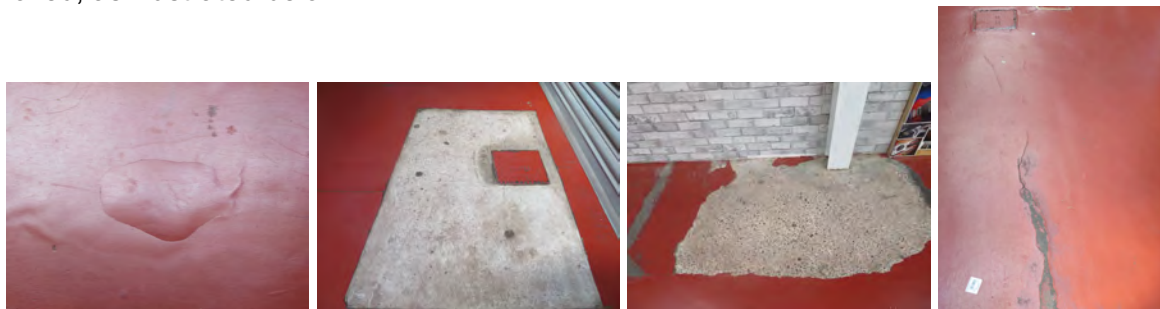
The coating in some instances is also beginning to deteriorate and in other areas it has been removed, as illustrated below.

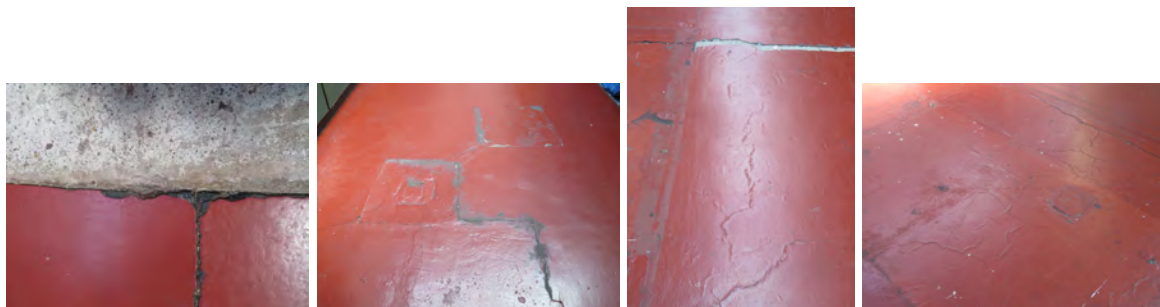
There appears to be a thin bitumastic covering on top of the concrete, as illustrated by reference to the following photographs. Further investigation as to the nature of the floor construction in this regard is required. It is possible that the floor paint which has been applied over the bitumastic coating is beginning to degrade. This treatment is not suitable for a bitumastic sub-base.

At present the floor remains serviceable, however the coating is likely to become slippery when it is wet, and the overall condition of the floor is deteriorated. Excavation of the bitumastic base may well be required and the use perhaps of a non-slip resin finish would be of significant benefit.
