BUILDING SURVEY REPORT

Indoor Market at xxxx

On Behalf Of

ADM
2019

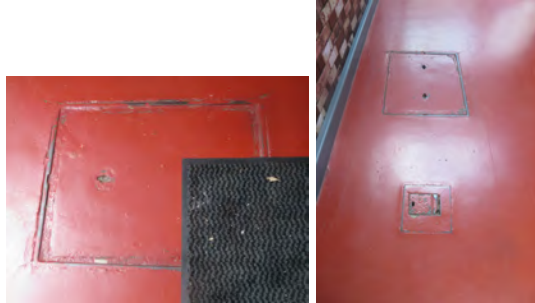
Many inspection chambers are located within the floor slabs which provide difficult detailing, however unsuitable chambers and lids have been utilised as illustrated below. This hinders the maintenance and lifting of these chambers and the incorporation of double sealed units internally is strongly recommended.

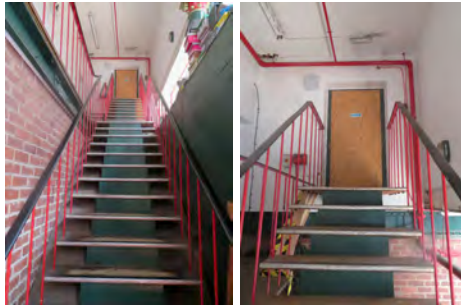
Access to the mezzanine is provided by a modern timber staircase with metal handrails, as illustrated below. The staircase appears to hold good alignment with little evidence of any undue movement or deflection and we are satisfied therefore that it remains structurally stable.

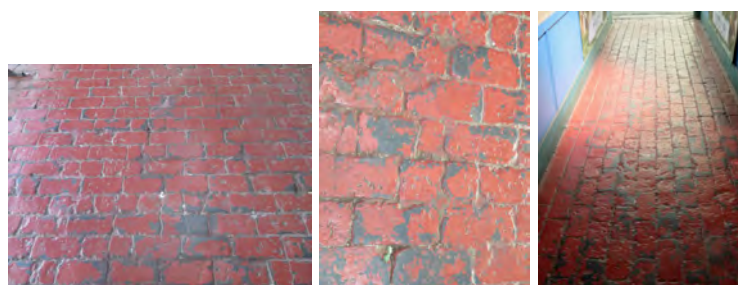
Pointing of the brick joints is a little deteriorated and repointing would be beneficial. Deterioration to the surface is also likely and the painted application may become slippery when wet.

Consideration should be given to introducing a new floor covering as part of the refurbishment of the property. The application of painted floor finishes is not recommended given dampness which is likely to occur, which will cause these surfaces to fail more readily particularly as is evidenced by reference to the previous photographs. The application of such floor paints on bitumastic sub-bases can also result in failure, which we believe occurs at this time.

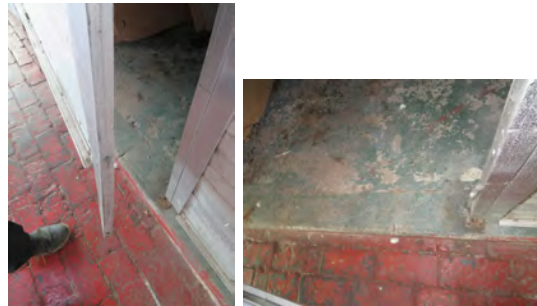
In a similar manner to the main covered market raised floor slabs have been formed within a number of the perimeter units, as illustrated below. Again this can hinder alterations to the unit in due course. It may be considered prudent as part of renovation and refurbishment of the market to introduce a new concrete slab and excavate the existing pavings, although in our view whilst this would be beneficial there is no immediate need to carry out these works.

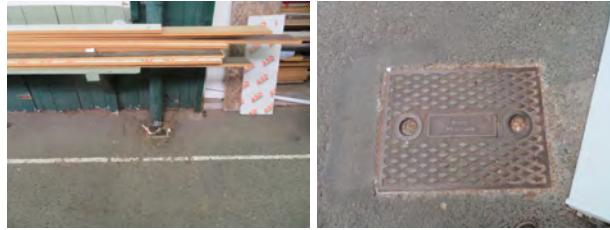
Misaligned and uneven surfaces also exist around drainage gullies and inspection chambers, as illustrated below.

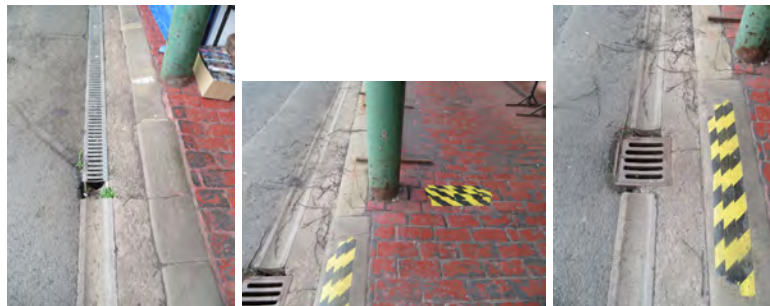
Again the inspection chambers are not ideal for the open market area sand should be replaced with a more appropriate form. Drainage gullies set within the area close to the semi covered market are in poor condition and slot drains would benefit from reformation and repair, as illustrated below.

Uneven surfaces to the walkways potentially risk fall and some markings have been introduced to indicate potential hazards, although in our view this is unacceptable. As a minimum extensive overhauling and relaying of the flooring sections will be required to return these to a safe condition. A full co-ordinated programme of improvements to floors, junctions and intersections with drainage and the like is strongly recommended in the main market areas.

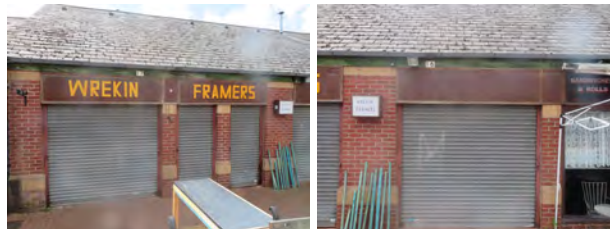
Many other roller shutter doors exist and provide security to various units and other areas of the site, as illustrated by reference to the following photographs.

Many of the shutters are in poor condition and replacement of these is to be anticipated within the foreseeable future. We are unaware if the responsibility for replacement of the shutters to individual stores rests with the store holder, or whether the freeholder has responsibility in this regard.

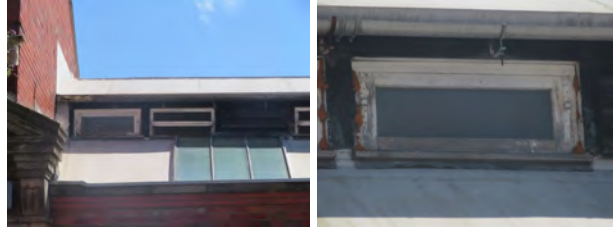
The windows to the main market building are limited given its nature, however to the front office areas upper sections of timber windows were identified and illustrated below. The windows are aged and generally in poor condition and replacement of these is recommended as part of the refurbishment of this section of the property.

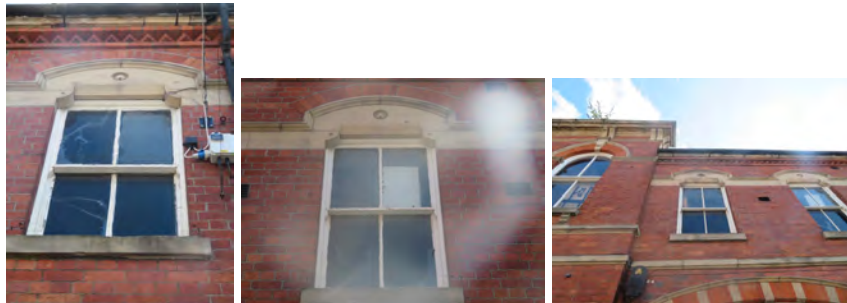
To the main xxxx building double hung timber sash units have been formed to this and the adjacent section, as illustrated below.

The windows remain in fair condition but are generally aged and single glazed and as such prone to condensation. A lack of decoration is resulting in decoration to the timber framework. Larger windows of this type exist to the rear of the building, as illustrated below.

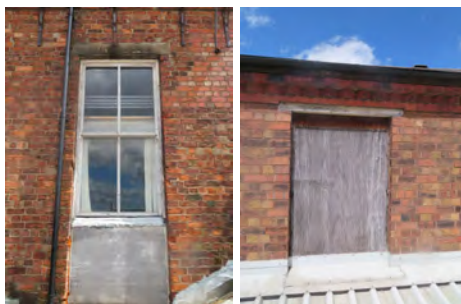
To the flank elevation where it overlooks the main warehouse building the windows are generally in aged poor condition and windows have been partially boarded over, as illustrated by reference to the following photographs. Replacement of a number of windows is therefore to be anticipated as part of the further renovation and refurbishment of the property.

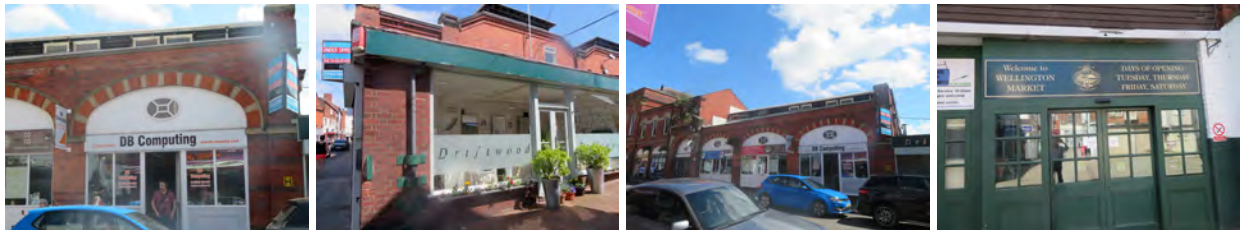
There are a number of shop fronts in various locations, as illustrated by reference to the following photographs. The responsibility for repair, maintenance and decoration of this is likely to vary between occupants and the freeholder and as such your solicitor should clarify matters so that your potential future obligations are fully understood. At present the shop fronts and windows remain in fair condition.

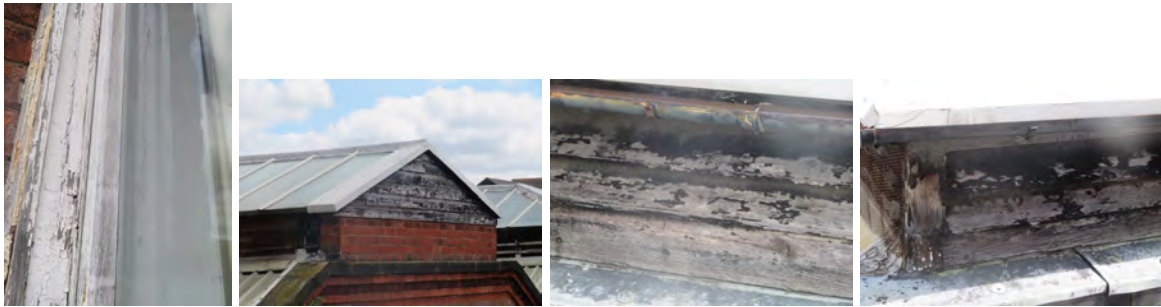
Externally it is clear that little or no decoration has been carried out to the property for a number of years and as such many timber and ferrous components are deteriorated due to a lack of decoration. Painting of external masonry has also been limited. Exposed timber surfaces and deteriorated paint finishes are evident in many areas and illustrated by reference to the following photographs.

In our opinion complete redecoration of all normally and previously painted surfaces must be contemplated and undertaken within the next 12 months. Failure to apply decoration to timber and ferrous components in particular much increases the risk of rot and corrosion and foreshortens the life expectancy of individual components. Deterioration has occurred due to a lack of regular redecoration and is now necessitating repair and maintenance to many of these such structures.

External redecoration must be considered as cyclical in nature and should be carried out every three to five years or so to conserve the integrity of timber and ferrous components.

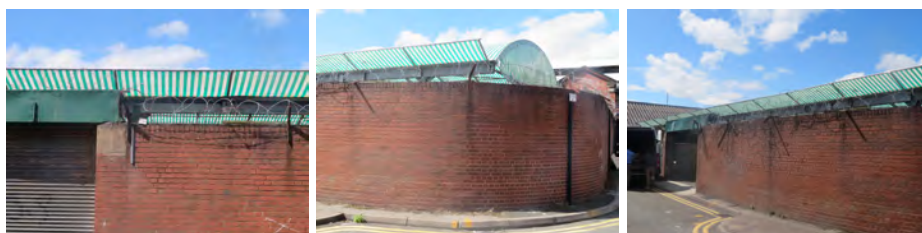
To the rear of the open market area high brick boundary walls have been formed, as illustrated below. The walls generally remain in fair condition considering their age and nature and they are of more modern origin than the original construction date of the property. Impact damage and loose and recessed mortar pointing was evident and improvements as part of normal maintenance will be required.

The upper sections of the wall are not properly weathered which is resulting in staining and failure of the mortar pointing to the brick joints and thus improved maintenance is recommended. The incorporation of new appropriate cappings or weatherings to the top sections of the wall is strongly recommended to prevent deterioration occurring over time.

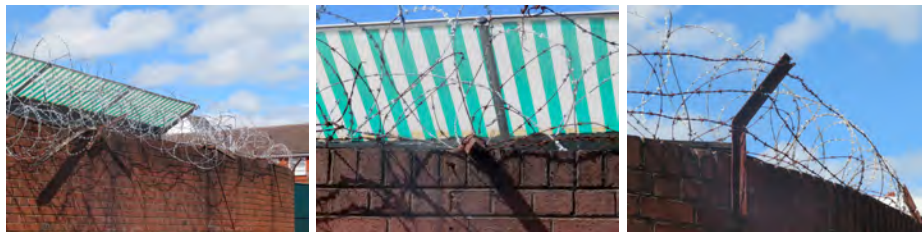
Security has clearly been an issue to the rear of the site and much barbed wire and razor wire has been attached to the top of the walls, as illustrated below. The mountings for the wire are generally in poor condition and it is questionable if the wire complies with current Health and Safety Regulations. Replacement of the wire with modern security installations is strongly recommended.

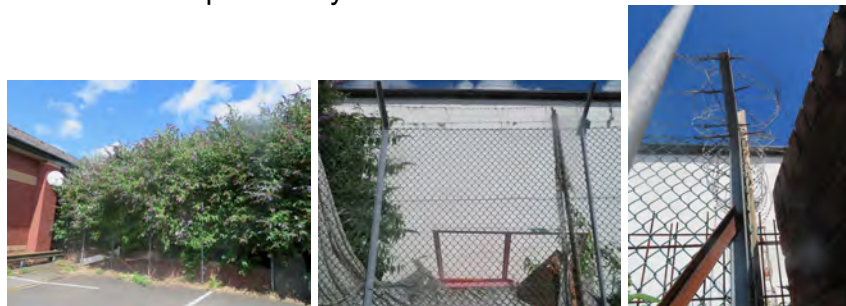
To the rear of the older partially covered market a metal and chain link fence is retained, as illustrated below. We are unaware if this forms part of the site boundary and the demise of the property, although convention would perhaps indicate that this is in the ownership of the adjacent car park, which we believe is operated by the xxxx.

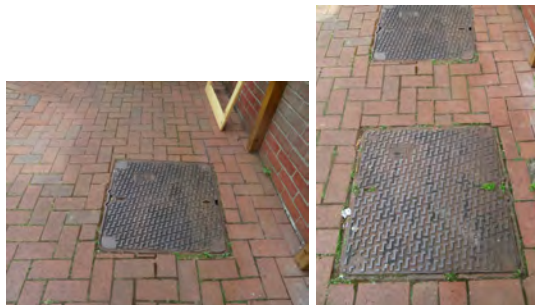
Some deterioration to gullies was recorded and unevenness, particularly around these and inspection chambers, was identified as illustrated below. Replacement of the chamber covers with recessed lids which would accommodate the incorporation of new brick paviours is strongly recommended, to enhance the overall appearance of the property and also to replace aged damaged covers, which are generally corroded and difficult to lift.

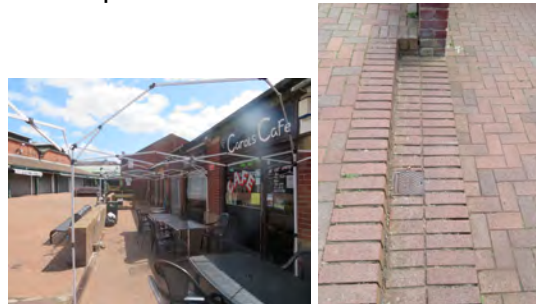
Steps exist between various changes of levels on the site and, as illustrated by reference to the following photographs, it is unlikely that these comply with current Disability Discrimination Act legislation. There are no handrails to assist ascending and descending the steps and also the nosings should be of different colour to help partially sighted individuals. Improvements in this regard should therefore be contemplated.

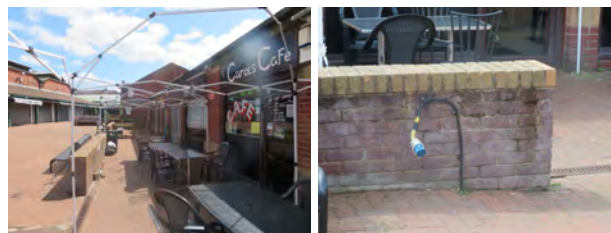
A number of walls exist within the open area, particularly where level changes occur, as illustrated below. The walls are deteriorated, and the brick capping does not adequately protect the brickwork beneath from dampness, causing staining and discolouration as well as loose and recessed pointing to develop as illustrated in the photograph above. Improvements in this regard are also necessary as part of normal maintenance of an open area of this nature.

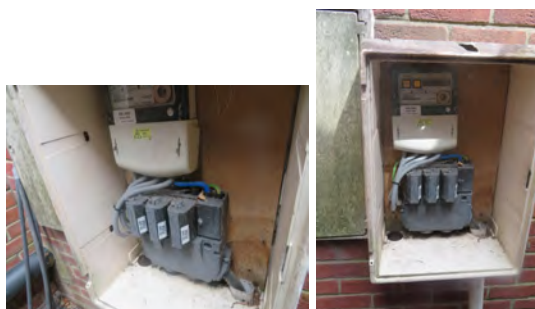
A separate 3 phase electrical mains head appears to have been introduced to the new café building to the right hand side of the main courtyard and this is housed in an electrical box externally and is evident by reference to the following photographs.

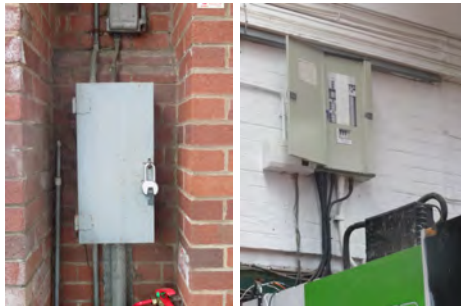
Various sub-mains are thought to provide lighting and power to other partially covered areas and some electrical equipment was identified, as illustrated by reference to the following photographs.

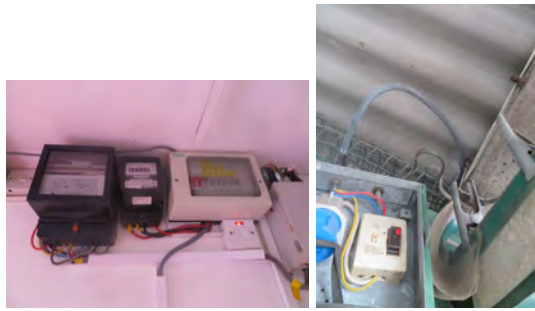
In some areas isolated fuseboards were identified serving individual units, as illustrated by reference to the following photographs. In overall terms the electrical infrastructure is believed to be serviceable but far from being compliant with current standards and significant upgrading and improvement is to be expected.

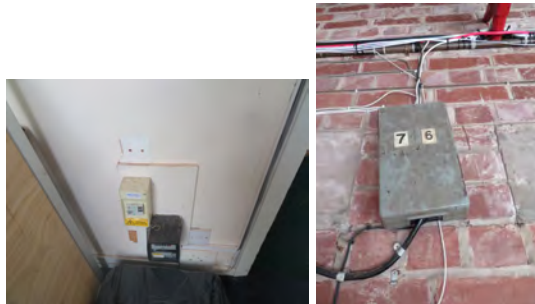
It is clear that many installations are aged, as illustrated below.

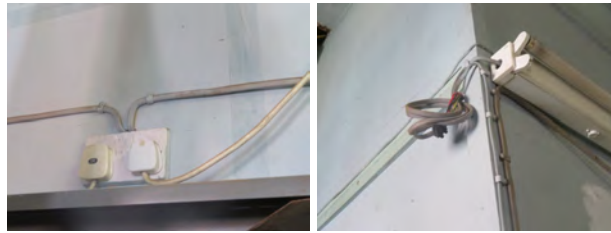
Electrical alterations, which have been undertaken, and the wiring generally is of poor formation and is unlikely to be compliant with current Regulations as illustrated below.

In our opinion significant upgrading of the fire precautions and the electrical provisions within the building in entirety are to be anticipated. It is possible that complete rewiring of the infrastructure and supplies serving individual units throughout much of the estate will be required. As a matter of urgency appropriate tests and inspection certificates in regard to the electrical installations should be provided and deficiencies, which are potentially dangerous, rectified to return the electrical infrastructure into a good serviceable condition.

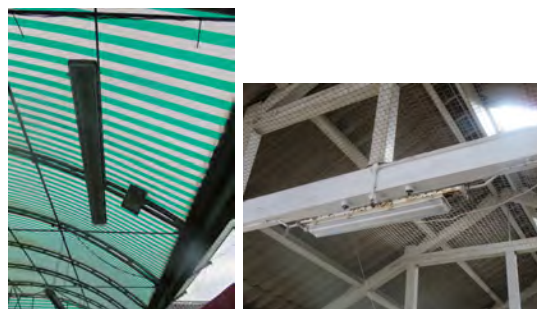
The lighting which is provided within the partially covered market areas is basic and consists of fluorescent striplight fittings, evident beneath the main canopy and within the older partially covered market area by reference to the following photographs.

In all instances the lighting is fairly antiquated in nature and many sections are believed to be inoperative. The energy efficiency of fluorescent lighting system is poor, in our opinion, and a concerted upgrade of the lighting provisions within all market areas is strongly recommended and the introduction of LED fittings would improve the overall energy efficiency of the use of the building.

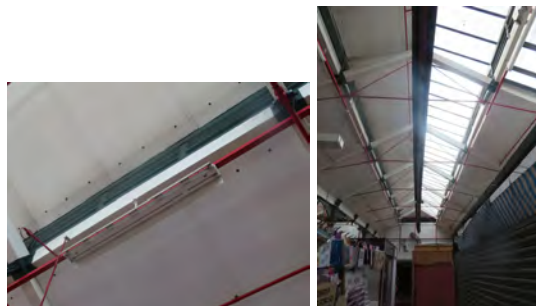
Lighting within the main covered market is again provided by relatively basic fluorescent lighting systems as illustrated below.

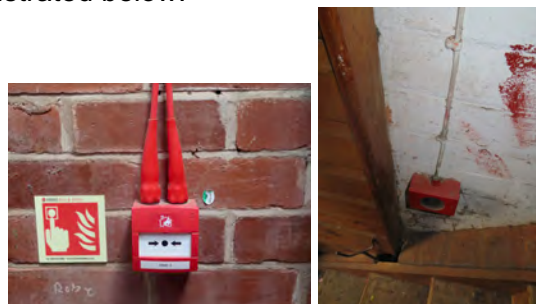
A basic fire alarm system is thought to exist within the covered market area; however its overall condition is antiquated, it would appear, with aged wiring and break glass units recorded close to door entrance points as illustrated below.

The main fire panel could not be found during the course of our survey and it is likely that this is within locked cupboards and rooms. Some newer sections are incorporated suggesting some works have been undertaken recently however further works are still to be anticipated.

In our opinion significant improvements to the fire alarm systems, emergency lighting and provisions within the building is necessary and specialist advice on requirements in this regard is necessary and should be undertaken as soon as possible. Linking of the alarm system of the main covered area to other areas of the site is also strongly recommended.

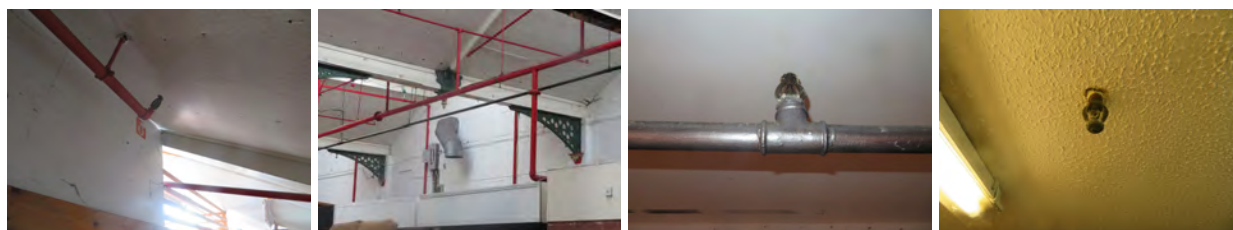
Individual sprinkler heads were located throughout the main covered market area; however the sprinkler system does not extend to other partially covered or external areas. Much pipework to the sprinkler system is run at high level within the open areas, as illustrated below. Individual sprinkler heads appear to remain serviceable, although we cannot confirm our suspicions in this regard.

The nature of the covered market is, in our opinion, such that a fully operational sprinkler system is likely to be required to provide suitable fire precautions and means of escape within the building. Testing, maintenance and perhaps renewal of the sprinkler system in entirety may well be required and specialist advice with regards to the condition and operational ability of the existing system should be sought.

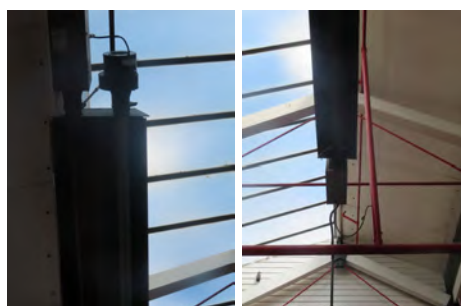
Space heating to the unit appears to be provided by means of ceiling mounted gas type space heaters as illustrated below. The space heaters are generally aged, inefficient and it is our opinion that many are likely to be inoperable. The condition of the remaining serviceable units is of concern and these could potentially be dangerous. Replacement of the space heating is to be anticipated, as in our view it is approaching the end of its useful life.

The energy efficiency of the space heating is generally poor given the limited levels of thermal insulation within the building, particularly with the ventilation of upper roof areas. Careful consideration with regards to whether heating is provided within the covered market area is recommended and it may be more cost effective to remove heating from the building, although this would be subject to the demands of the occupants and customers visiting the market. The existing systems are however at a stage where renewal is to be anticipated.

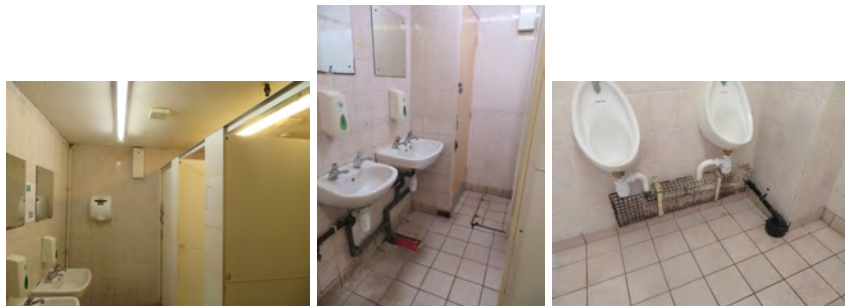
The toilets within the indoor market area are basic at best and generally a little antiquated and in need of significant modernisation, as illustrated below.

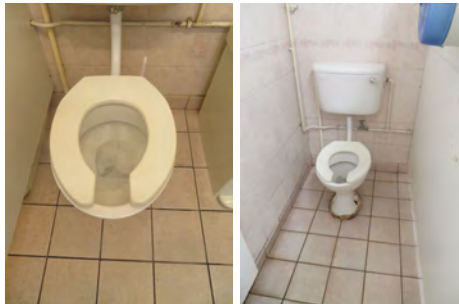
The toilets within the covered market area were however free flowing at the time of our survey, as illustrated below.

In our opinion replacement of all above ground drainage pipework to the plumbing and sanitary facilities will be required in conjunction with the refurbishment of it.

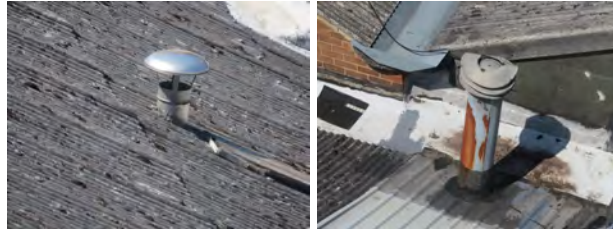
The property has no traditionally constructed chimney stacks. There are however a number of vents which penetrate through roof coverings of various forms, as illustrated generally by reference to the following photographs.

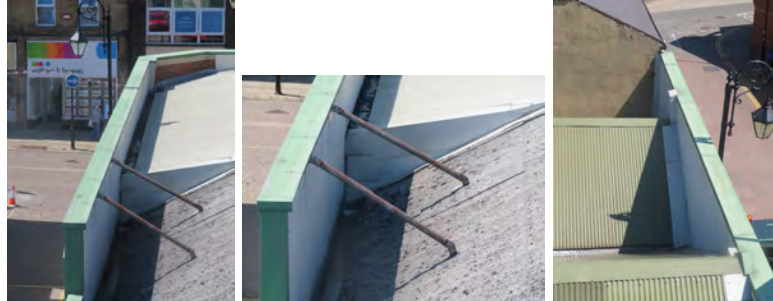
To the xxxx Street elevation parapet walls have been raised above roof level, as illustrated below, as part of the cladding of the flank elevation.

The parapet walls are believed to be formed by means of a steel framed structure and additional bracing has been provided to the higher sections as illustrated previously. We cannot confirm our suspicions in view of the cladding, and it is possible that slender masonry structured walls exist. In general the parapet walls of this formation hold good alignment with little evidence of any undue movement or deflection and are considered structurally stable. Significant remedial works in terms of maintenance of the structure is considered unlikely and the bracing which is evident will clearly assist in this regard. If masonry is found to exist behind the cladding demolition and restructuring may well be required.

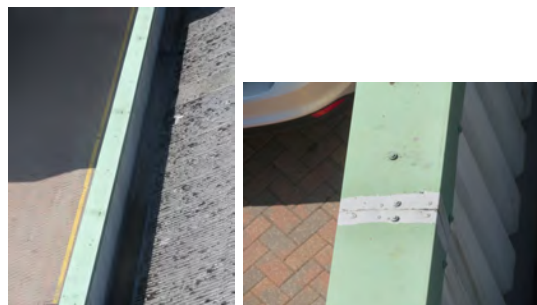
The capping's to the parapets is beginning to deteriorate and liquid applied waterproof coatings have been introduced, as illustrated below. This suggests that water penetration has occurred at these joints, which is often a fault in capping's of this type.

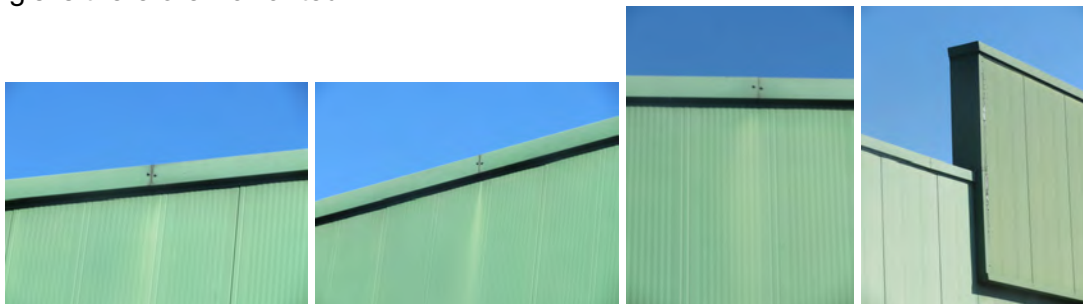
Externally to the elevations there is clear evidence of staining to the cladding panels, as a consequence of water penetration through these joints as illustrated below. Replacement of the capping's is therefore warranted.

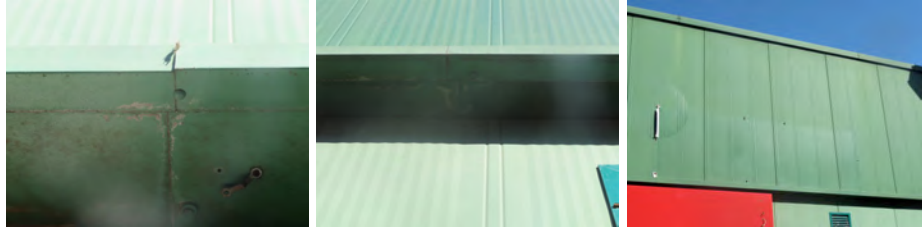
The claddings externally to the elevations and the parapets are clearly aged and the colour is deteriorating, and water penetration has occurred to the soffits as a consequence of leaks to the roof and parapet capping's, as illustrated below. Replacement of the external claddings, whilst not essential, is strongly recommended.

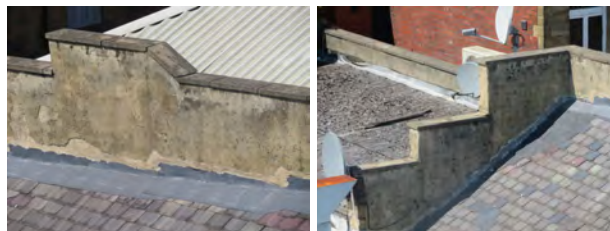
The solid 9 inch brick walls appear to have been rendered and it is clear that the render and the concrete copings which weather the top sections of the parapets are in poor order, as illustrated below.

Failure of the cappings to adequately weather the parapets is resulting in much staining and also the development of cracked and blown render which is evident above. Replacement of the coping stones is required and in conjunction with this re-rendering of the parapets may well be required and indeed is recommended as part of the overall renovation and refurbishment of the property. If repairs are not undertaken in the near term continued deterioration to the masonry may undermine their structural integrity.

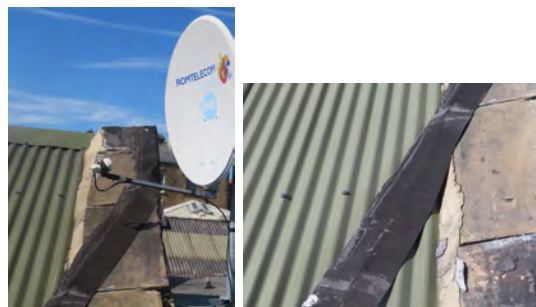
The weathering of the parapets and the junction of the roofs and the parapet sections has been inappropriately formed and is clearly in poor condition, as illustrated below.

The parapet is misaligned and leans inwardly and the stone copings are clearly facilitating water ingress and some crude repairs have been carried out previously, although in our view these are unlikely to be effective.

We anticipate that demolition and reconstruction of misaligned sections of parapets of this nature will be required as part of the gradual renovation and refurbishment of the roof areas of the building. Short term repairs may prevent water ingress occurring in this location, although we cannot confirm our suspicions in this regard.

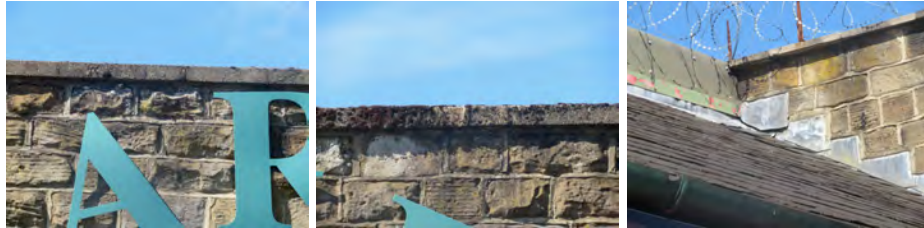
The coping stones which weather the parapets in this area are poorly formed with no adequate drip or weathering and as such saturation is occurring to the stonework, as illustrated below. This appears not to be causing any significant deterioration at this time, however spalling of the stonework and failure of the pointing is likely to result as a consequence. Repairs are therefore warranted and should be undertaken in the relatively near term to prevent further deterioration.

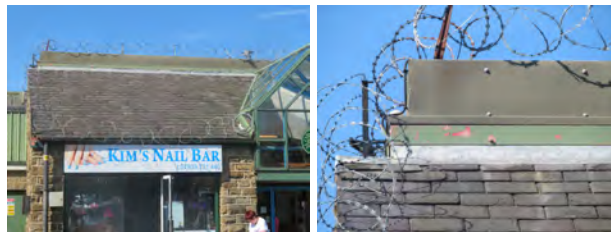
To the roof above xxxx Nail Bar, close to the main entrance to the market, a masonry parapet appears to have been weathered with Plastisol coated cappings, as illustrated below.

The parapet wall appears to hold good alignment with little evidence of any undue movement or deflection and we are satisfied therefore that it remains structurally stable. Capping and cladding of masonry parapets of this type is not ideal, but it appears to have been successful and of adequate functionality at this time and significant remedial works are not required, although replacement of the cappings in conjunction with works to the roofs and parapets generally will be required.

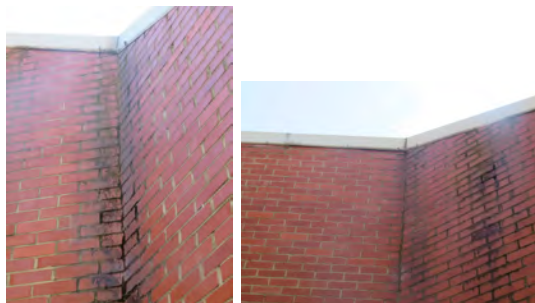
Similar capping details to parapets appear to have been poorly formed and in conjunction with defects to the rainwater goods saturation and rainwater run-off is causing damage to the brickwork, which is water stained and exhibiting loose and recessed mortar pointing, as illustrated by reference to the following photographs. Improvements to the capping detail are essential. Saturation of the brickwork results in water penetration and failure of the pointing and much increased maintenance costs.

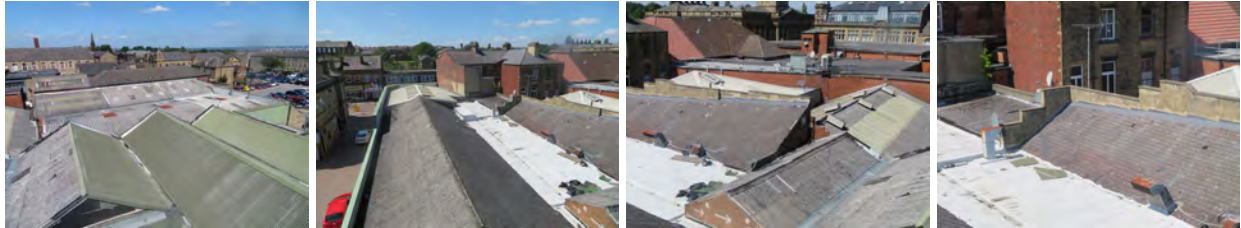
The main covered market area has numerous intersecting roof pitches to various sections, as illustrated generally by reference to the following photographs. The slopes, pitches and structural formation of the roofs vary dependent on location.

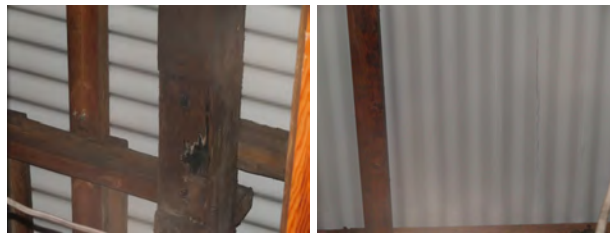
Sections of the xxxx Street elevation appear to be formed by means of timber rafters, perhaps with intermediate support provided by a steel frame. Sight of the rafters was generally difficult to obtain, as ceilings and internal claddings prevented a detailed sight of these. The height of access panels was in excess of our surveyor's ladders and these areas could not be safely accessed at the time of our survey, however timber purlins and framework beneath the cladding panels are evident by reference to the following photographs.

The timber structure where visible generally held good alignment with little evidence of any undue movement or deflection and we are satisfied therefore that it remains structurally stable. Externally the pitched sections, as illustrated by reference to the following photograph, generally held good alignment with little evidence of any undue movement or deflection and we are satisfied therefore that they remain structurally stable.

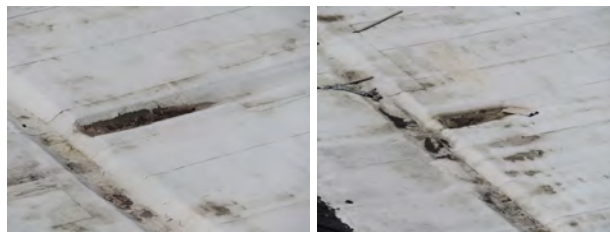
We recorded distinct depressions within the waterproof coverings, as illustrated by reference to the following photographs. Such depressions often illustrate the development of rot within the roof deck and structure beneath and in our view this is occurring. Given the overall condition of the roofs and in view of obvious water penetration, the development of wet and dry rot is inevitable in our view and is occurring. Significant restructuring of timber sections and the roof deck perhaps in entirety to the flat roof area is inevitable, in our opinion. If works are not undertaken, the extent of the wet and dry rot infestations are likely to increase in extent, thereby much increasing the cost of remedial works.

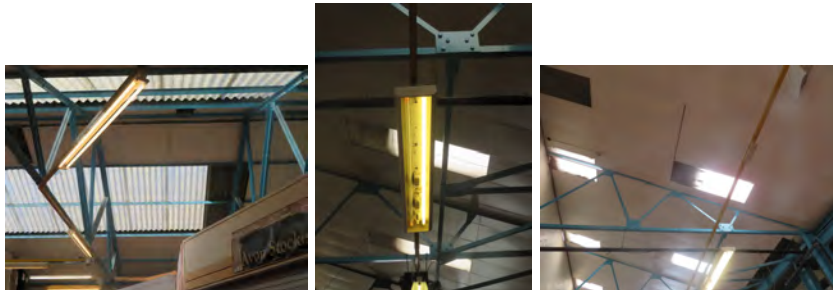
The majority of the indoor market roof is weathered by means of pitched roof structures of varying forms consisting of lattice trussed metal framework, as illustrated by reference to the following photographs.

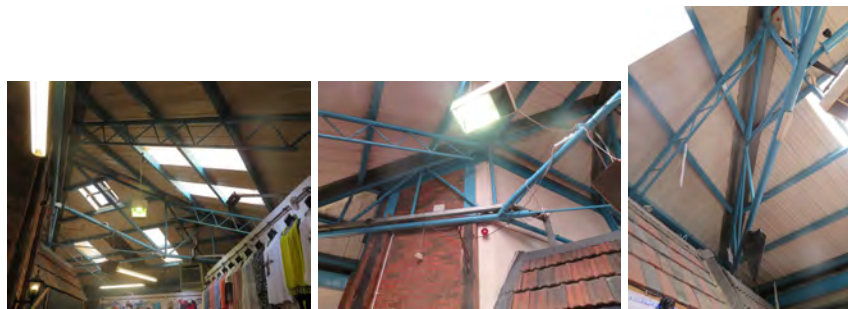
More modern space frame type roof structures exist where a section of open area has presumably been in-filled historically, as illustrated by reference to the following photographs.

Significant restructuring of these metal framed roofs is considered unlikely, however it may be considered prudent, in conjunction with renovation and refurbishment of the main indoor market, to appoint specialist engineers to further assess the steel framework to the roof area.

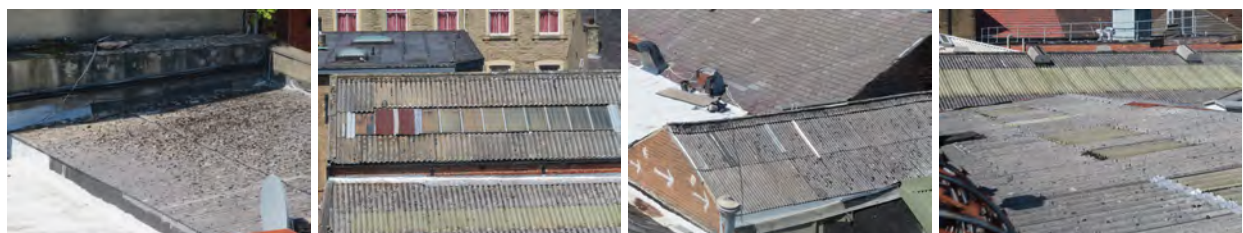
The roof coverings to these various sections consist of many different materials, however the roofs are generally weathered by means of asbestos cement sheeting, as illustrated by reference to the following photographs. The use of this material is not ideal for shallow roof pitches and can result in water penetration at junctions and laps of individual sheets.

The asbestos cement sheeting is, in our opinion, approaching the end of its useful life and the detail and formation of the sheeting is poor although some sections are of more recent origin and remain in better condition as a consequence as illustrated below.

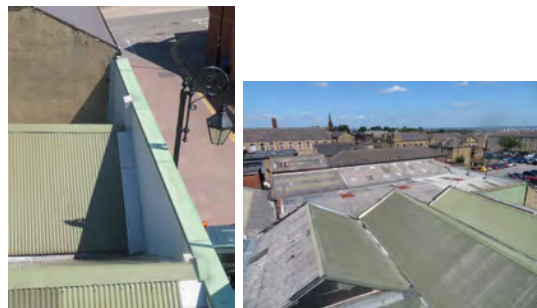
Plastisol coated roof sheeting has been introduced, possibly replacing sections of asbestos cement historically. Cladding of these roofs perhaps was undertaken in conjunction with the works to the xxxx Street elevations, as the green coloured sheeting appears to be of similar age and form as illustrated below. Other roof sections have also been weathered with plastisol coated sheeting.

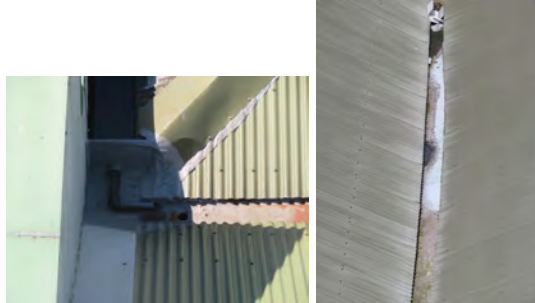
The design and detailing of many of the intersecting roofs is poor and the use of ridged sheeting is a little inflexible in this regard and can result in water penetration, particularly at junctions of parapets and intersecting roof pitches where valley gutters have been formed, as illustrated below.

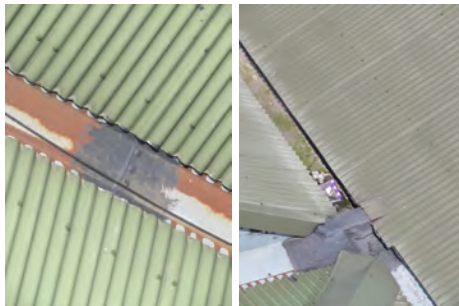
It is clear that the overall condition of the valley gutters and indeed their design is poor and Acrypol coatings have been applied in many locations as illustrated previously and by reference to the following photographs. Corrosion to the metal lined valley gutters is also becoming apparent externally in particular.

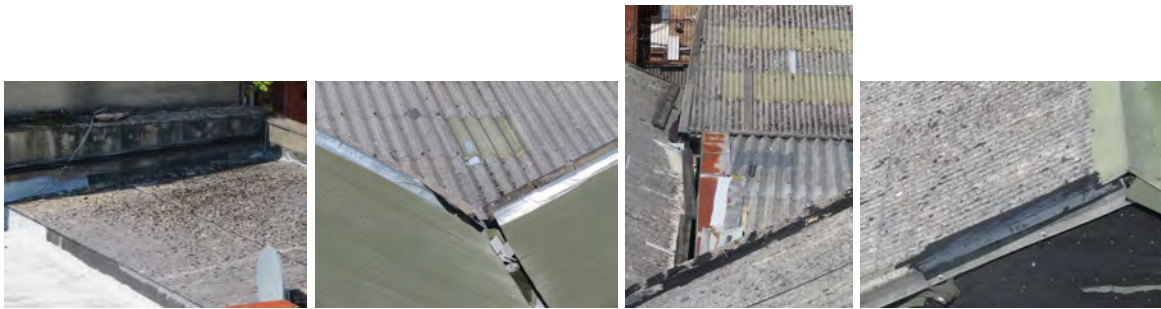
Extremities and detailing at intersections of roofs are also poorly formed and many temporary repairs have been carried out, as illustrated by reference to the following photographs.

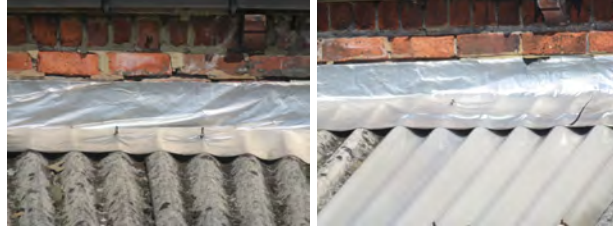
In many areas flashband has been utilised to create new flashing details at the junctions of asbestos cement sheeting and brickwork, as illustrated by reference to the following photographs. The flashband material is not adequately pointed and water ingress could occur in these locations. Replacement of all flashing details in conjunction with recovering of the roofs is strongly recommended.

Many of the flashing details at junctions of abutments and intersecting roof pitches are poorly formed and we have highlighted water ingress and repairs which have been undertaken in these areas. Replacement of all flashing details is necessary, in our opinion, and works of this nature should be undertaken in the relatively near term.

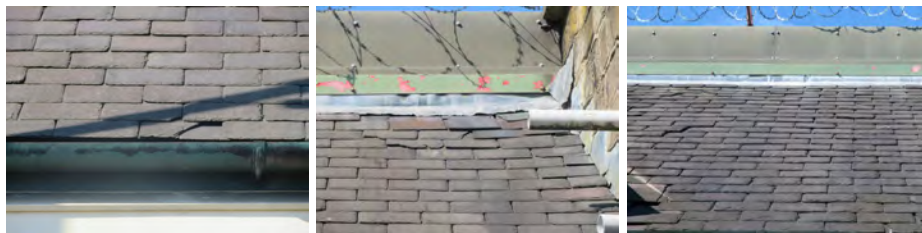
The slated roof pitch to the main entrance generally remains in fair condition, however broken and disturbed slates were recorded, as illustrated below. Overhauling of the roof in this area is required and should be undertaken in the near term.

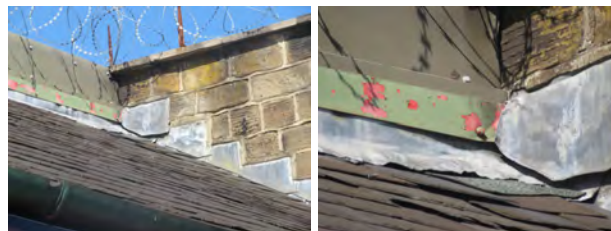
The lead flashing details at the abutments of the stonework and the clad rear parapet are poorly formed and could result in water penetration, as illustrated by reference to the following photographs.

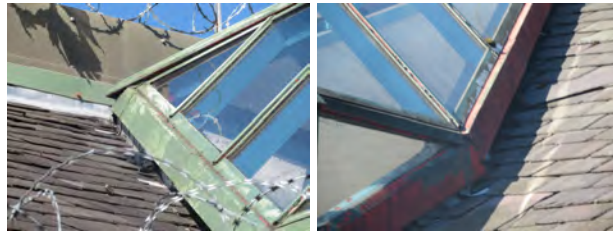
The detailing and weathering of the abutments is extremely poor and the powder coated aluminium sections are weathered, as illustrated by reference to the following photographs.

We are of the opinion that the lantern remains serviceable and structurally stable, however it is at the end of its useful life, in our view, and replacement is recommended and should be undertaken in the near term. Continued water penetration will occur whilst it is retained in position.

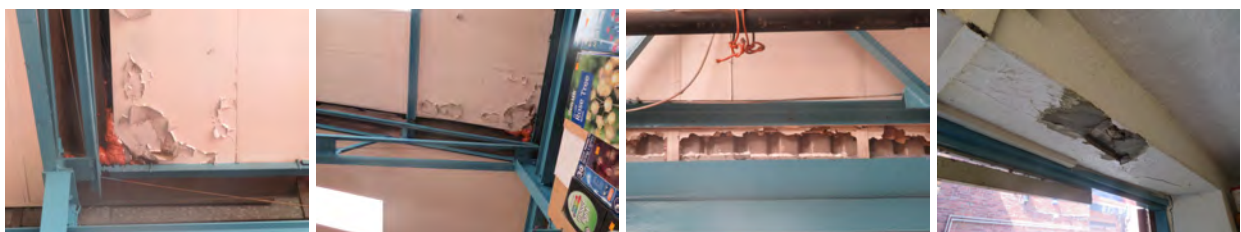
Sections of saturated ceiling linings and walls were identified which provide further evidence of ongoing water penetration, as illustrated below.

Continued water ingress is inevitable until such time as extensive, if not complete, replacement of the roofs over the main market area are undertaken.

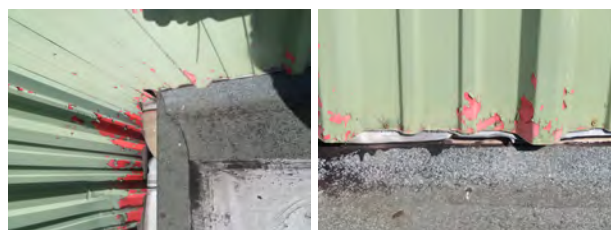
Weathering details at junctions of claddings are poorly formed with bitumastic flashings dressed beneath the cladding pieces, as illustrated below. Water penetration is likely to occur in these locations during periods of heavy rainfall.

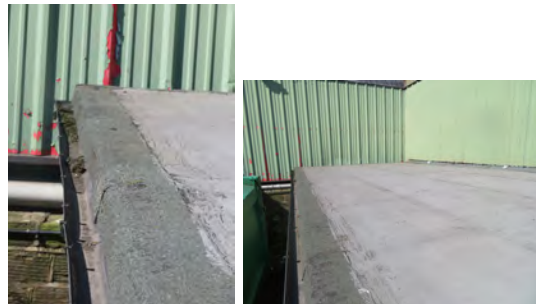
The gutters are aged and a little choked with debris, as illustrated by reference to the following photographs, however in general they remain serviceable at this time. Replacement of the uPVC guttering must be anticipated within the relatively near term.

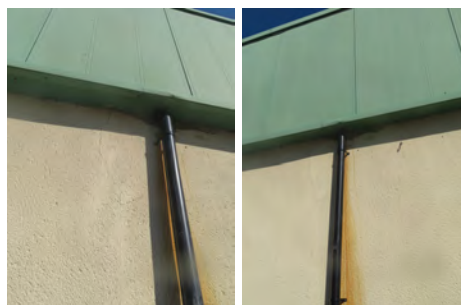
There is clear evidence of leaks and deterioration from a number of these downpipes, as illustrated below.

Reconfiguration of the rainwater downpipes and discharge in this area is recommended. The downpipes remain serviceable, although clearly leaks have occurred and some replacement and remedial works are recommended.

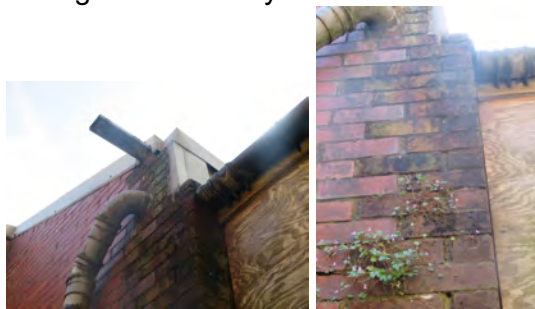
The rainwater goods to the rear and close to the tunnel entrance are clearly defective and blocked and result in overspilling and saturation of the brickwork during periods of rainfall, as illustrated below. Replacement of these sections of guttering and downpipe are required, and much reconfiguration of the roof drainage is necessary.

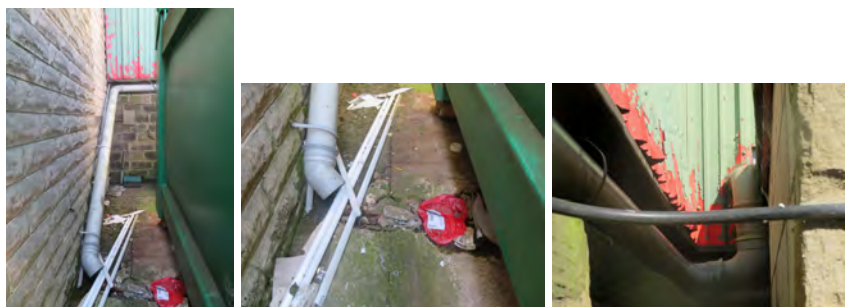
Alterations have been undertaken to the main drainage from the roof and pipework has been run from existing sections to discharge crudely onto hardstandings to the rear of the building, as illustrated below.

This suggests that either additional drainage has been provided or that the underground drainage system which originally would have collected rainwater from these pipes has failed, or is blocked, and cannot be repaired.

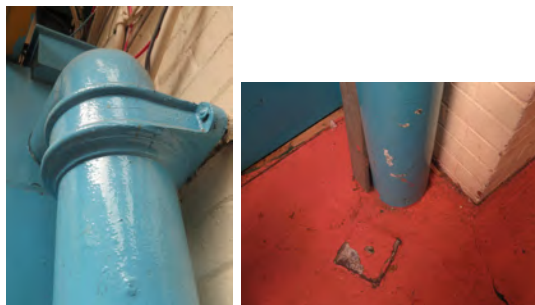
Some cast iron downpipes were also retained and run internally within the building discharging directly into a back inlet gulley as illustrated below.

In our opinion extensive overhauling of the gutters and downpipes are necessary. Careful assessment of anticipated loads during periods of heavy rainfall should be made and improvement in the volume that can be handled by the rainwater goods must be considered to prevent flooding. Given the extent of flash floods, and the likelihood of an increasing frequency of such heavy rainfall events, regular flooding of the building may well occur during severe rainfall events. This clearly hinders the operation and trading from within the unit and creates potentially dangerous conditions internally if floods become slippery when wet.

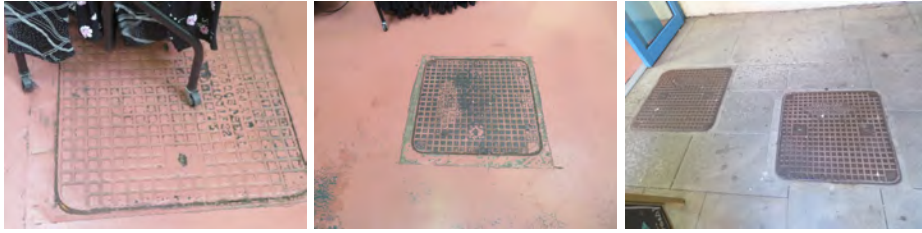
Inspection chambers are located within the floor areas of the market in many locations, as illustrated below.

We were unable to lift the inspection chambers during the course of our survey and therefore cannot confirm the nature and condition of the underground drainage installation. We anticipate, however, that some defects are likely to exist. Overhauling and cleaning of the underground drainage installation is therefore recommended and works of this nature should be undertaken in the near term.

A specialist contractor should also carry out a full CCTV survey of the underground drainage installation in conjunction with cleaning so its condition, nature and extent can be established. Improvements and repairs to the underground drainage installation must be anticipated.

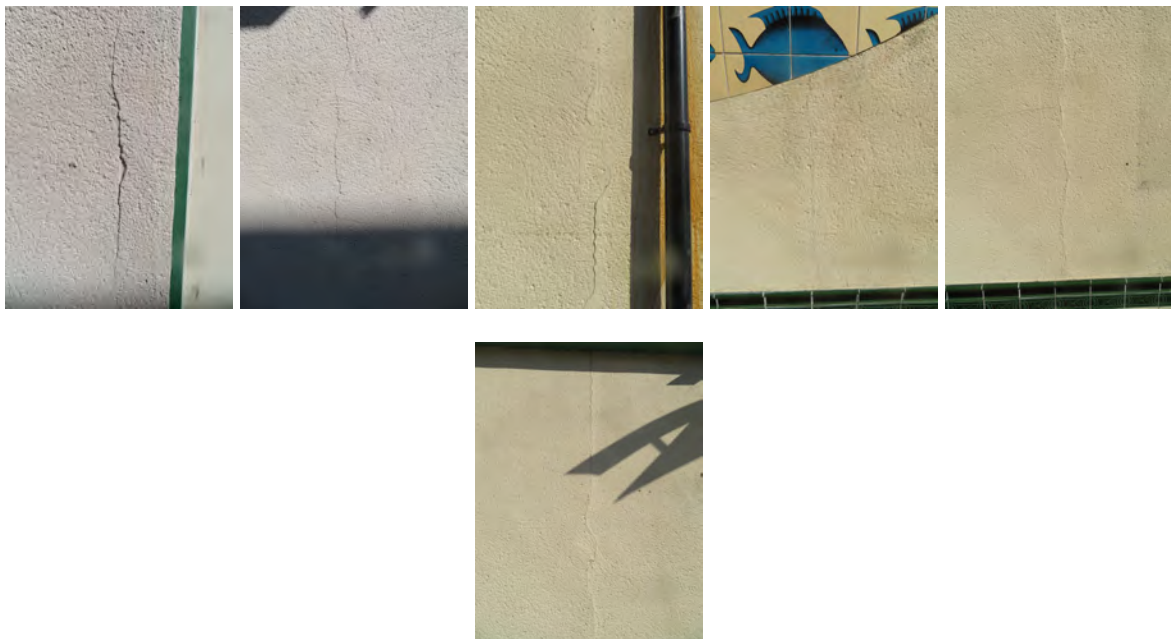
Vertical fractures were identified in many locations to the rendered block sections to the flank elevation, as illustrated below.

These photographs are in keeping with a lightweight concrete block structure which has subsequently been rendered and are indicative of thermal expansion. If the render is repaired and made good further cracking is inevitable. It appears therefore that no expansion joints have been constructed in the blockwork, which is not ideal given its expanse and length. The wall will be prone therefore to movement of this nature. In conjunction with re-rendering the incorporation of render expansion joints utilising stop beads may be considered prudent and would be a manner in which the movement could be adequately controlled. Horizontal cracking and defects to the render was also recorded, as illustrated by reference to the following photographs.

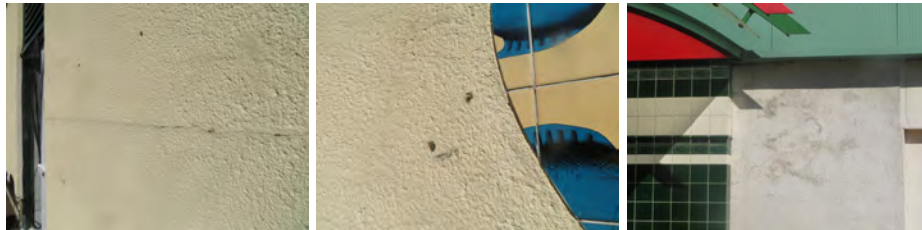
The latter photograph illustrates saturation and dampness due to leaks, which is causing a deterioration to the render surface. Repairs and perhaps complete re-rendering of the flank elevation must be anticipated within the foreseeable future. Clearly continued saturation due to defects in the roof will exacerbate matters in this regard.

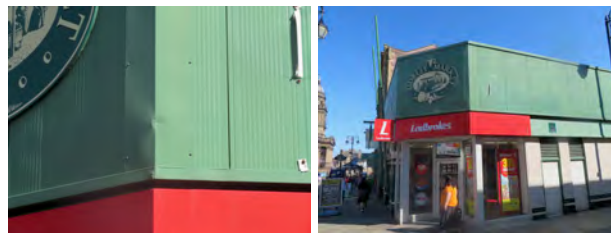
The cladding at upper sections is Plastisol coated and aged and we have reported previously of water ingress. We also recorded impact damaged sections to the corner and must also advise that the cladding is faded and deteriorating generally, as illustrated below.

Replacement of the cladding systems may well be required in due course, although despite their age and minor damage it is our view that these remain serviceable at this time.

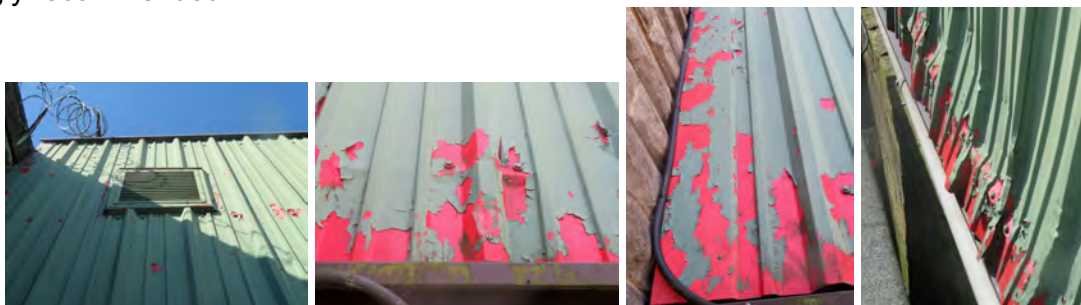
The cladding to the rear area close to the car park or external stores area is badly impact damaged and the decorative coating has failed, as illustrated below. Replacement of this cladding is strongly recommended.
