BUILDING SURVEY REPORT

Indoor Market at xxxx

On Behalf Of

ADM
2019

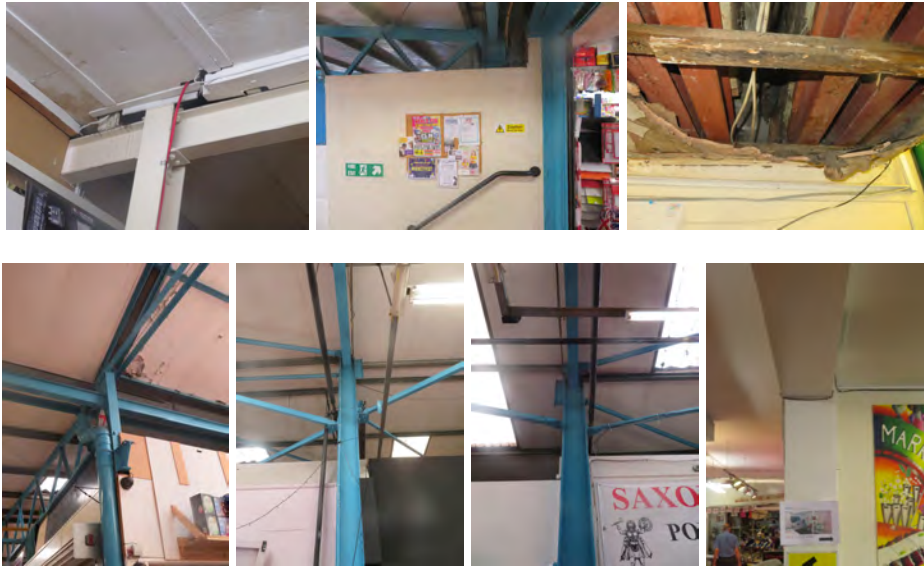
The main load bearing structure of the building is presumed to be provided by the columns, although these were generally concealed from view by internal fittings and linings and as such could not be inspected in detail. Loadbearing masonry walls also transpose roof loads to the foundations of the site. Internally within the open areas of the main market further columns form part of the structure of the building and transpose load from the roof trusses down to the foundations, as illustrated below.

In our view significant remedial works to the structural frame of the building is considered unlikely, however it may be necessary to carry out isolated repairs and replace corroded sections of columns particularly where these are concealed below ground level.

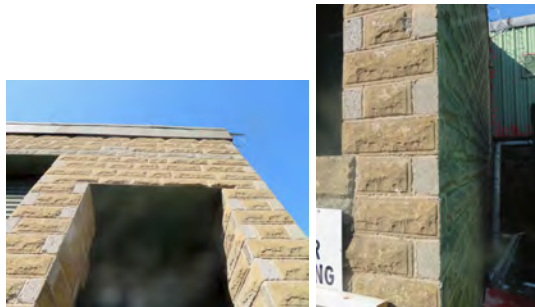
We had no access to this area at the time of our survey. A similar toilet block has also been formed and both are constructed by means of stone, possibly with block linings internally. The stonework, as illustrated below, generally held good alignment with little evidence of any undue movement or deflection and we are satisfied that it remains structurally stable.

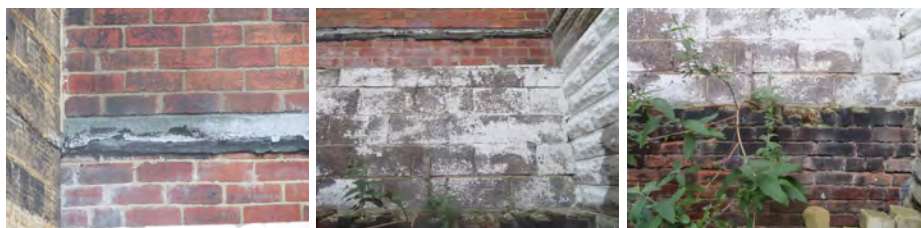
Within the manager's car park area sections of brickwork are exposed where a small building has been demolished previously. The works have not been carried out to a good standard and saturation and plant growth is occurring within the brickwork as a consequence, as illustrated below. Improvements to the condition of the brickwork in this area are necessary to prevent further deterioration.

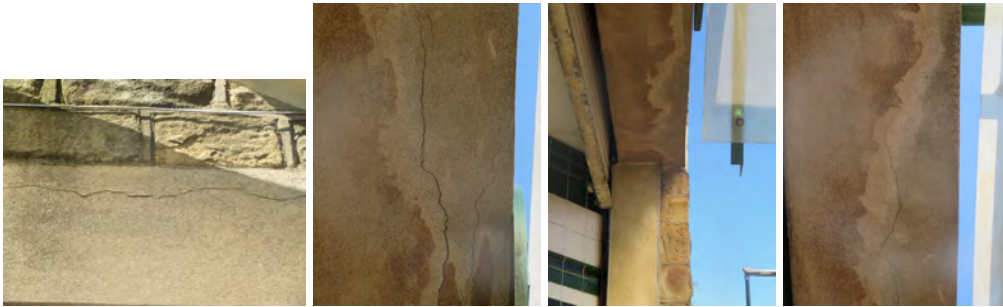
To the main entrance we presume a steel frame exists, however we recorded cracking within the concrete cladding of this, as illustrated below. In our opinion this indicates possible corrosion of the steel framework, which is expanding as a consequence. Exposure of the steel structure to ascertain its condition is strongly recommended and works of this nature should be undertaken in the near term. It is possible that replacement of the steel beam and framework may well be required, and it is clear by reference to the previous photograph that saturation has occurred, which much increases the risk of corrosion to the steelwork.

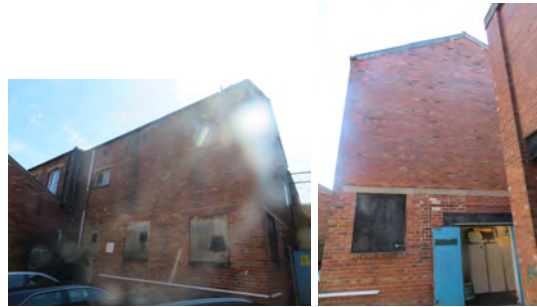
To the right hand side of the unit an older brick building appears to form part of the internal market area, as illustrated by reference to the following photographs.

The overall condition of the brickwork is poor, although in general we are happy that the building holds good alignment with little evidence of any undue movement or deflection and we are satisfied therefore that it remains structurally stable.

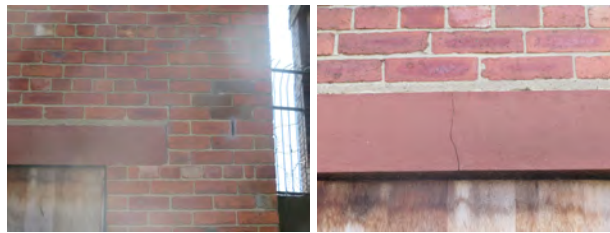
Minor cracking was evident within concrete lintels and at bearings of walls, as illustrated below, however this is of relatively limited extent and is of no significant concern in our opinion.

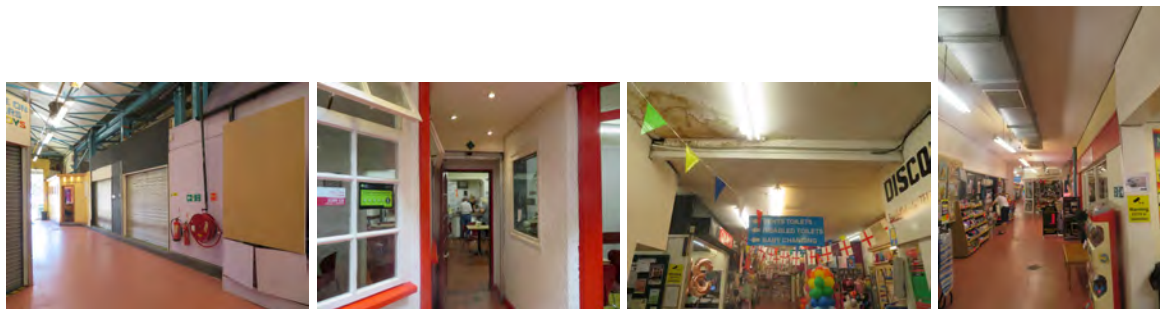
The indoor market units are constructed in a haphazard fashion of various materials, many of which are combustible in our view as illustrated by reference to the following photographs.

In our opinion as part of an upgrade and refurbishment of the trading areas it may be considered prudent to demolish the existing structures and build modern concrete block units of a regular form for occupation by individual retailers. Clearly the position with regards the existing units has evolved over a long period. A number of the units appear to be in largely redundant unused condition, which are generally neglected as illustrated below. Again, improvements in this regard are strongly recommended.

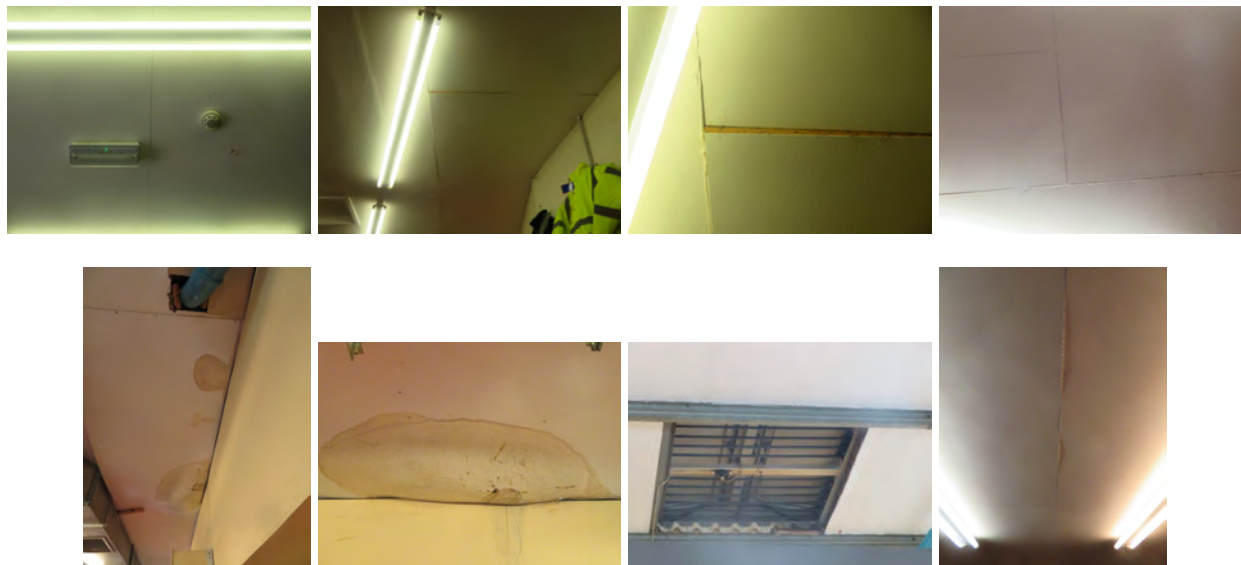
Beneath the main flat roof areas of the building lowered ceilings have been formed and it appears that plasterboard and other timber boarded materials have been utilised to form ceilings. The quality of workmanship is generally poor and these ceilings exhibit evidence of dampness and cracking at board joints, indicative of the poor quality of the ceiling construction as illustrated below. Water damage is also very evident in the latter photographs. Replacement of these ceilings is strongly recommended and works of this nature should be undertaken in conjunction with the overall renovation of the property and following recovering of the roofs.

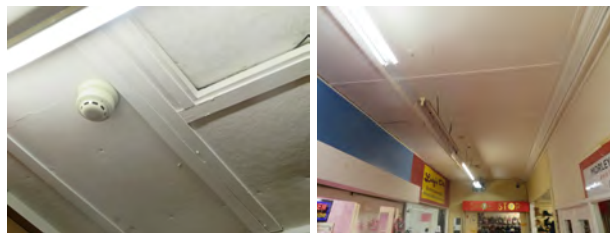
Other ceilings perhaps consist of fibreboard or plasterboard sections with timber battens being recorded, although it is possible that asbestos cement may also exist in this area as illustrated below.

Replacement of the majority of ceilings and linings within the building are required to improve its overall integrity, particularly following removal of asbestos cement sections. Many of the ceilings appear not to provide suitable fire resistance and concerns with regards to the fire precautions and means of escape within the unit must be expressed. A full fire safety audit may well look to improve the fire precautions and means of escape and necessitate the incorporation of less flammable material to ceilings, walls and the construction of the various units within the main market area. Improvements to emergency lighting and smoke detection systems are to be anticipated. The incorporation of a sprinkler system within the building is also strongly recommended.

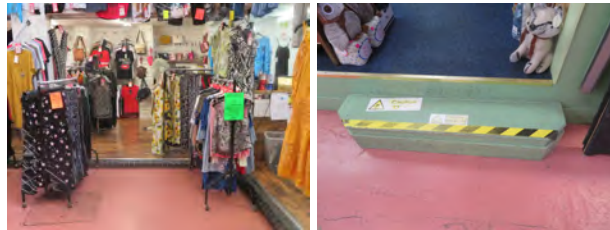
Individual stall holders have also created steps to provide access between the units and the formation of new slabs, possibly on top of the existing concrete floor of the building, as illustrated by reference to the following photographs.

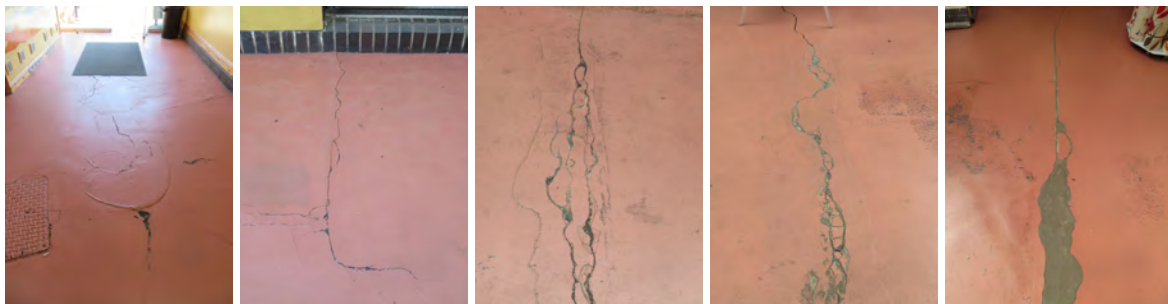
The concrete floor slabs hold fair alignment but the surface and overall construction of these is poor and many cracked, blown and uneven sections of flooring was evident, as illustrated below.

The overall conditions of the floor slabs are poor, in our opinion, and extensive remedial works and the introduction of new non-slip coverings are strongly recommended to return these to a sound, level, safe condition. Complete restructuring of floor slabs throughout the indoor market may well be required.

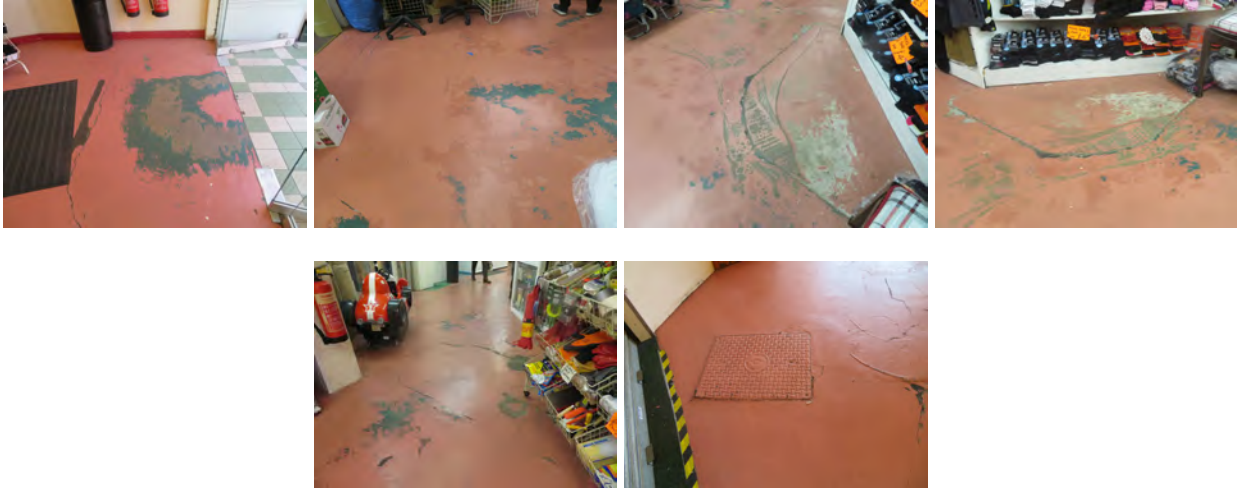
The floor appears to be covered with a bitumastic based material, possibly to prevent rising and penetrating dampness.

Such materials, however, cannot be guaranteed to be successful and there is evidence of wear to the finish in heavily trafficked areas in particular, as illustrated by reference to the following photographs.

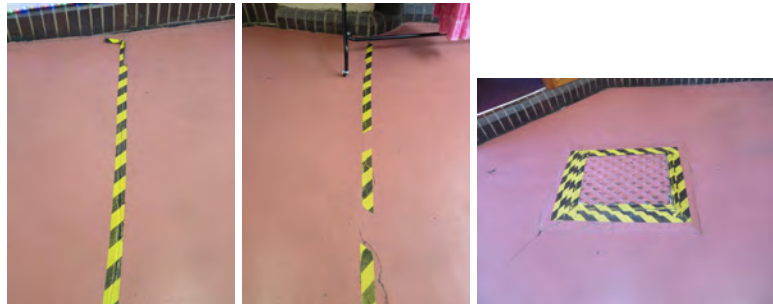
Within the floor cracking and uneven surfaces are identified by warning tapes, as are raised ironworks to inspection chambers forming part of the drainage system, which are also located in the floors as illustrated below. In our opinion whilst the warning tape is of benefit this does not indemnify the owner against claims if somebody were to trip or fall.

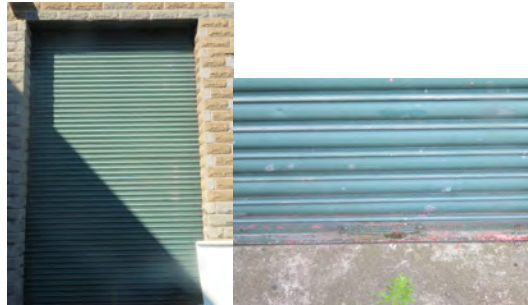
A roller shutter door provides access to the separate stores area, as illustrated by reference to the following photographs. The door is aged and impact damaged, but we believe remains serviceable. Replacement of the roller shutter door may well be required in due course.

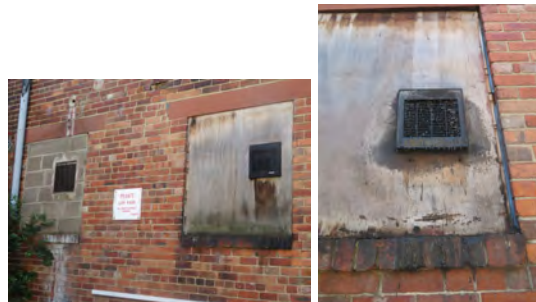
Towards the rear areas of the building, particularly where these are not generally visible to users of the market, various windows have been infilled with blockwork and timber boarding as illustrated below.

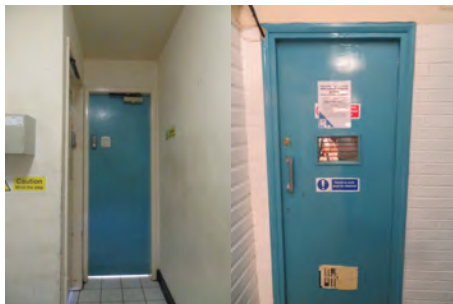
Doors to toilet accommodation are also of basic formation, although they remain serviceable as illustrated below. Improvements in this regard and replacement of lightweight doors is strongly recommended.

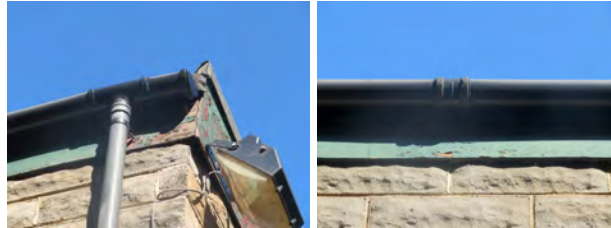
Timber fascias to buildings were also undecorated and deteriorated as a consequence, as illustrated below. External timber and ferrous components require regular redecoration and it is clear that windows to toilet blocks have not been painted more recently.

In our opinion complete external redecoration of the property is strongly recommended and works of this nature are necessary to conserve the integrity of timber and ferrous components. Decorations appear to have been applied infrequently and as a consequence structures are failing and rot has developed as a consequence. Replacement of claddings and the use of pre-finished components to fascias, soffits and other areas would reduce the cost of decorations, which are necessary on a regular basis. In our opinion external redecoration should be carried out every three to five years to conserve the integrity of timber, ferrous and other previously painted components.

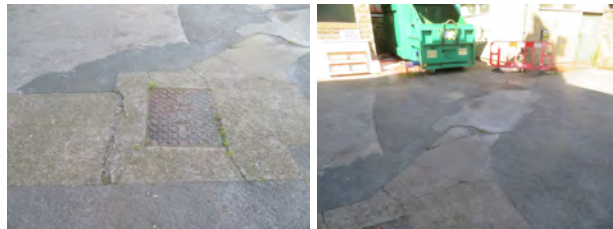
To the main manager's car park area the surface is beginning to deteriorate, with patched concrete and tarmac sections evident by reference to the following photographs. This area is accessed by other buildings and easements and rights for access should be fully established.

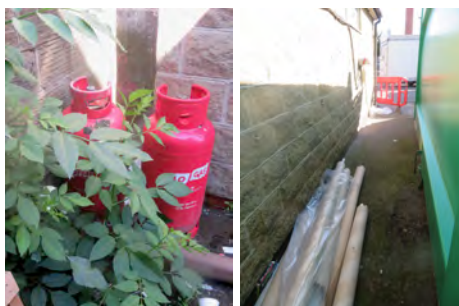
Damage has also been caused to the finish for the excavation of drainage to the rear of the compactor. Storage of waste and debris in the area, which is potentially hazardous, also detracts from the overall condition of the area of the property as illustrated below.

In our opinion complete resurfacing of the area is to be anticipated. Inspection chambers within it are generally corroded and in poor condition and replacement of these is also strongly recommended.

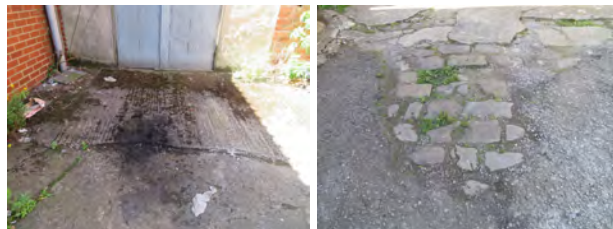
To the rear area, which we believe form parts of the demise, tarmac and concrete surfaces are deteriorating which expose old cobbled sections beneath, as illustrated by reference to the following photographs. Complete reformation and resurfacing of these areas are strongly recommended and should be undertaken in the near term.

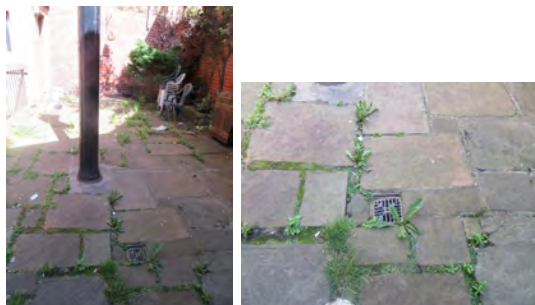
Paving is generally overgrown with weed growth evident, as illustrated by reference to the following photographs.

In our opinion the area could be much enhanced and potentially used as a courtyard for the consumption of food and beverages from stalls, however improvements to the area are required to facilitate this.

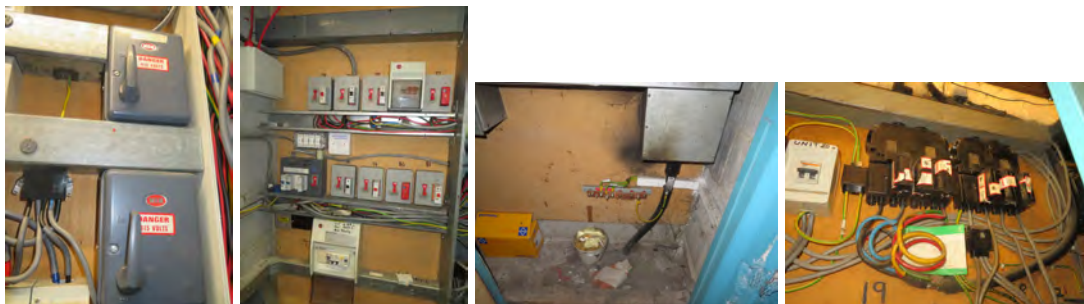
Access was provided to two electrical mains intake areas, which illustrate aged switch gear as illustrated below.

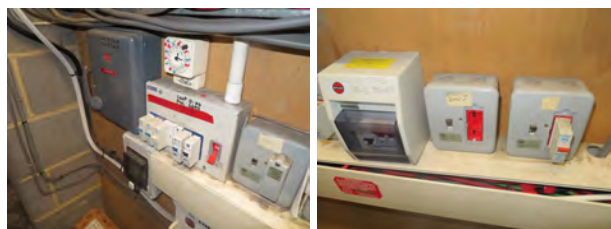
Upgrading of fuses and switch gear has been carried out but generally to a basic standard, as illustrated by reference to the following photographs.

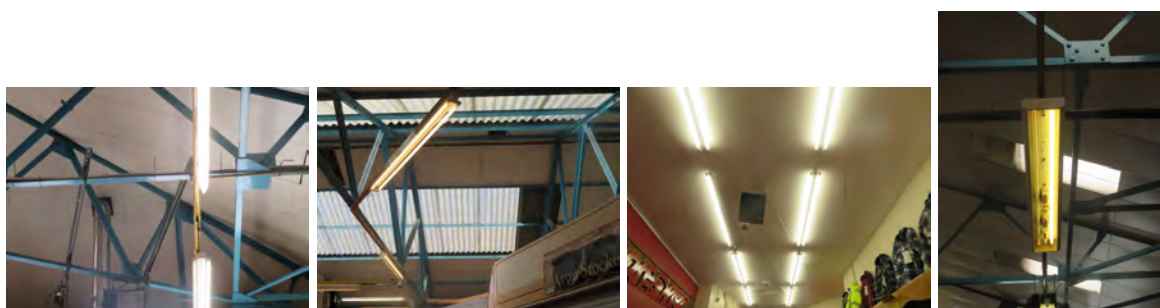
Lighting within the main walkway areas is provided by haphazard fluorescent fittings, many of which are aged and antiquated as illustrated by reference to the following photographs.

Many of the light tubes were inoperative and in our opinion significant upgrading is strongly recommended. This would offer the opportunity of introducing modern LED fittings. A coordinated programme of upgrading of the lighting would be of benefit in our opinion.

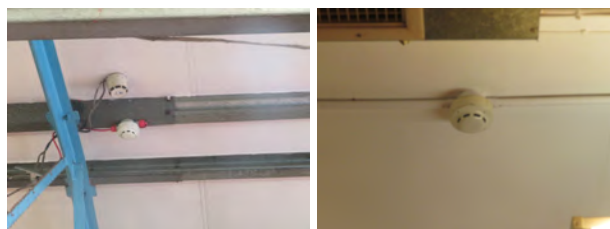
It is clear that some older systems are retained, which are possibly redundant with new and old detectors evident by reference to the following photographs.

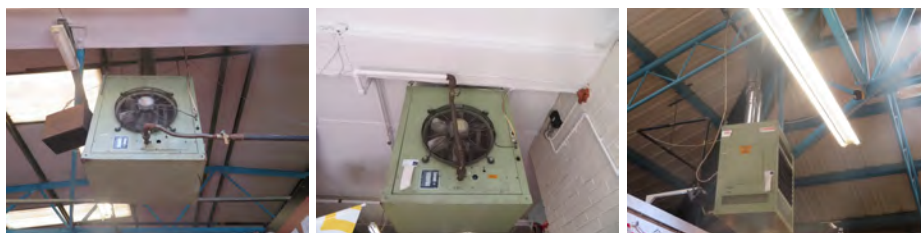
Heating is provided by a number of space heaters generally located close to entrance doors, as illustrated by reference to the following photographs.

The units appear antiquated and some damage and deterioration to the casing was evident. We cannot confirm if the units are operational and servicing of these as a minimum is required. In our view it is likely that replacement of the heaters may well be necessary.

The efficiency and benefit of the heaters is limited, in our view, given the absence of any thermal insulation within the building and much improvement is therefore to be anticipated.

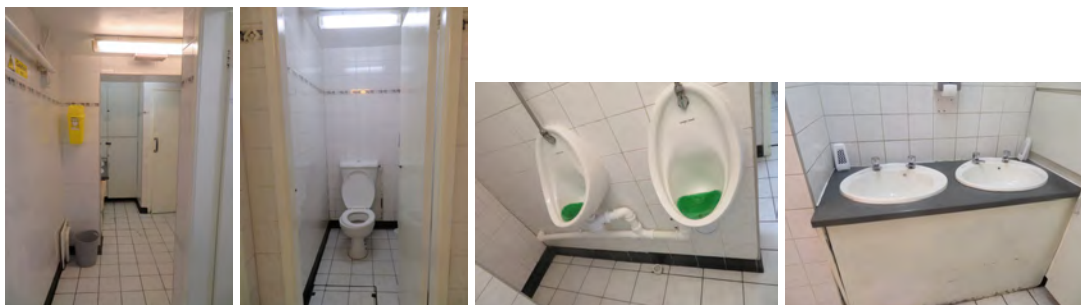
The indoor market has basic toilet facilities for use of the general public. Access was not possible to the ladies toilet at the time of our survey as these were generally in use. The gents toilet is illustrated generally by reference to the following photographs.

The toilets provide basic facilities and remain serviceable, although much updating and refurbishment is recommended.

At present there is no disabled toilet facility within the unit, which is in contravention of current Regulations, and the provision of such disabled toilet accommodation is therefore strongly recommended. Complete reconfiguration and reformation of the toilet facilities for use by the public is strongly recommended and works of this nature should be undertaken in the near term to enhance the amenity of the area.

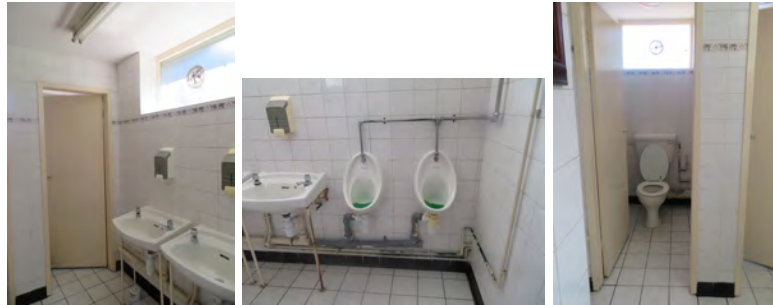
Store holder toilets are provided in the extension close to the manager's car park. Once again the facilities are serviceable but generally these are basic in nature and would benefit from a complete refurbishment, as illustrated by reference to the following photographs.

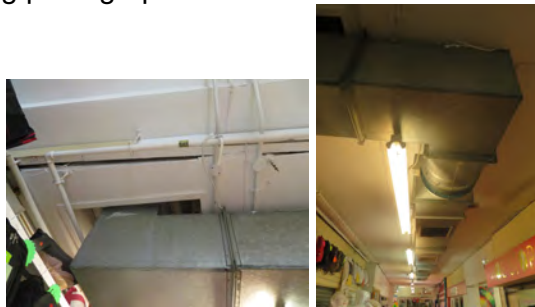
Sections of the building have mechanical ventilation suspended beneath the ceiling, as illustrated by reference to the following photographs.

We cannot confirm if the system is operational, although we anticipate as a minimum that much maintenance will be required. Servicing of the mechanical ventilation system should be carried out by a specialist contractor and assessment of its necessity and adequacy undertaken. It is likely, in our opinion, that complete replacement of this is required.

We believe that the installation was necessary due to the limited ventilation within the lower section ceiling of the market close to xxxx Street.
