BUILDING CONDITION SURVEY REPORT

XXXX

ADM
June 2019

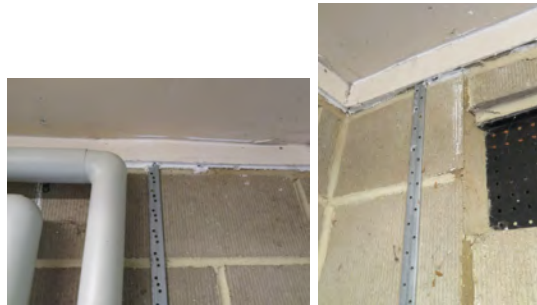
We anticipate that the roof structure is a complex arrangement of timber trusses, possibly with steel supports, however we cannot confirm our suspicions in this regard. Based on our external inspection and the evidence available to us at this time, we are of the opinion that the roof remains structurally stable. Within the plant room galvanised holding down straps are evident, which secure the wall plates to the walls, in accordance with good codes of practice as illustrated below.

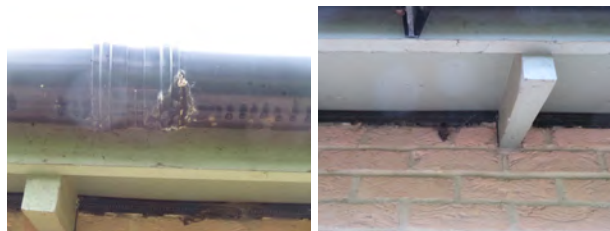
To the eaves and extremities of the property ventilation appears to be provided between the soffits and to the underside of the exposed rafters where a mesh inset guard has been incorporated to the ventilation slot, as illustrated by reference to the following photographs. We recorded no evidence of condensation within the roof void, however we could not inspect this and therefore we cannot confirm our suspicions in this regard. The apparently undamaged polyethene vapour barrier will also assist.

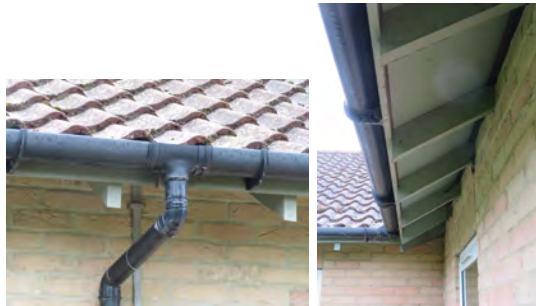
Rainwater from the main pitch roofs are discharged to uPVC guttering attached to the timber fascias to the roof generally, as illustrated below.

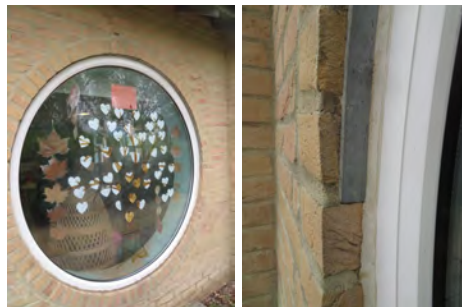
The window openings, in all instances, generally remain well aligned and to the curved window a flat strap provided support to the curved arch at upper sections, as illustrated below.

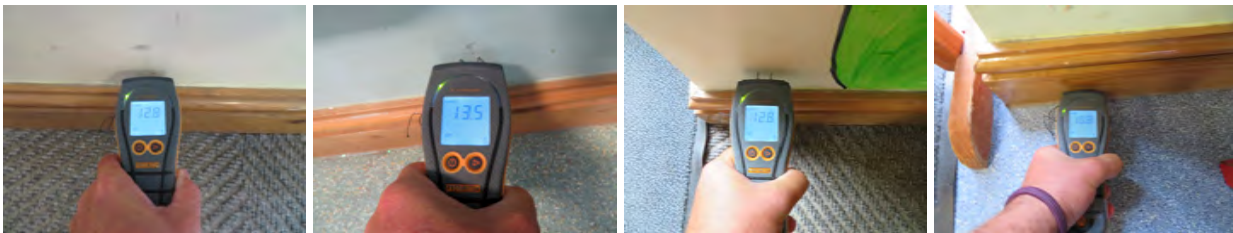
Random moisture meter readings were taken internally during the course of our survey and in all instances the moisture content within wall plaster and skirting was well within normally anticipated parameters, as illustrated below. We are satisfied therefore that the damp proof course remains in good order and significant remedial works are not anticipated in this regard in the foreseeable future.

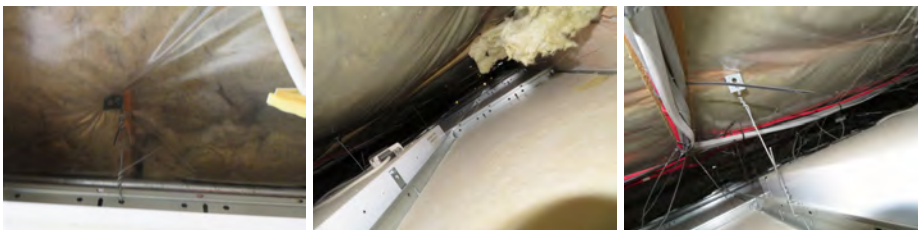
The ceilings throughout the internal areas of the property are formed by suspended metal grids incorporating fibrous tiles. The grids are suspended generally from the frame above, as illustrated below.

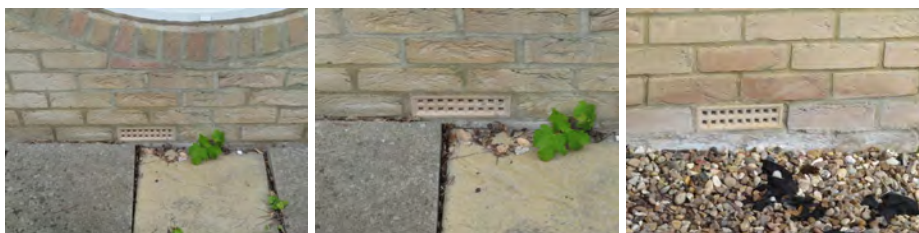
Sub-floor ventilation is provided to the floors in various areas with air bricks being recorded, as illustrated below. The number of air bricks are perhaps limited and improvement in this regard could be undertaken, although this is not essential in our view.

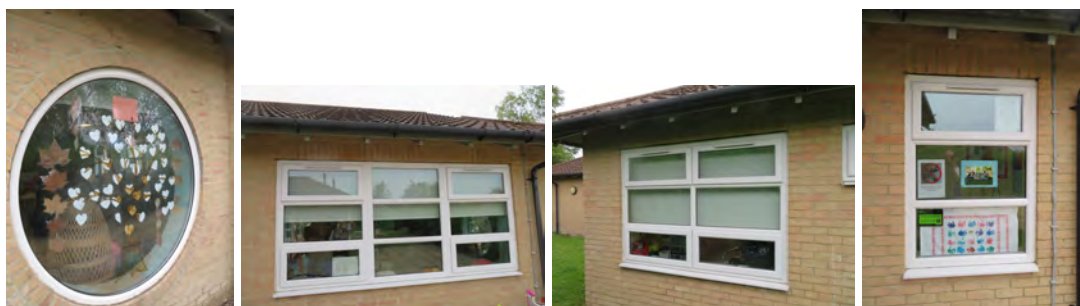
The windows to the property appear to be the original double glazed uPVC components with round and more normal rectangular windows recorded and illustrated below.

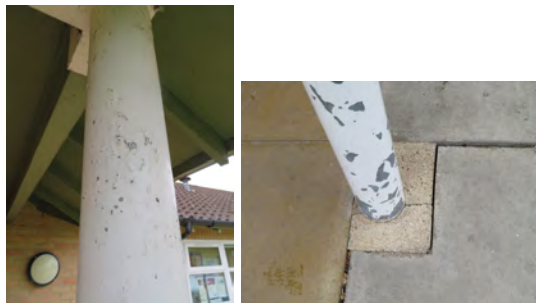
Externally the décor to the building is limited to exposed timber soffits and timber doors and frames. Redecoration appears to have been applied relatively frequently, however the metal post supporting part of the cantilevered roof structure to the front of the building would benefit from redecoration, although it is galvanised and structural deterioration due to a lack of decoration is unlikely.

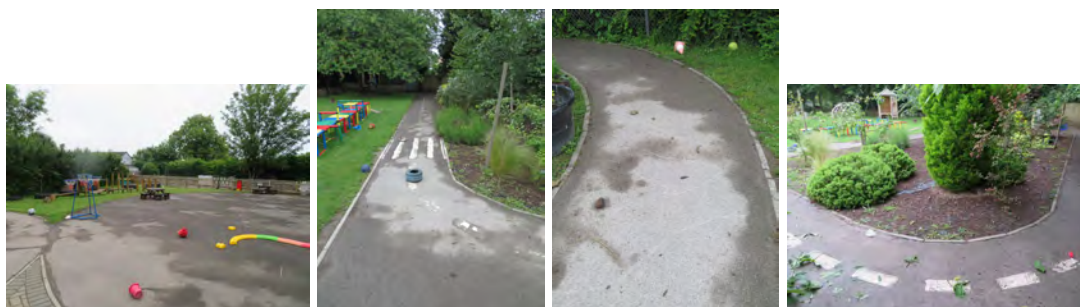
To the main area tarmac paths and playground facilities are provided, as illustrated below.

In general these remain in fair condition, but resurfacing may well be anticipated in due course.

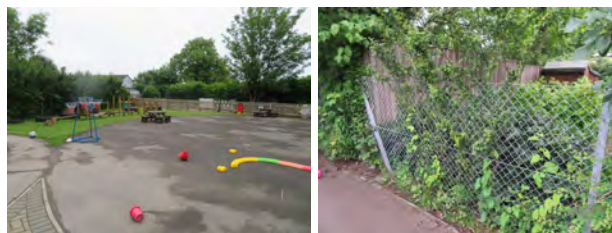
The boundary fences to the parameter vary but generally consist of fairly basic wire fencing with metal posts, as illustrated below.

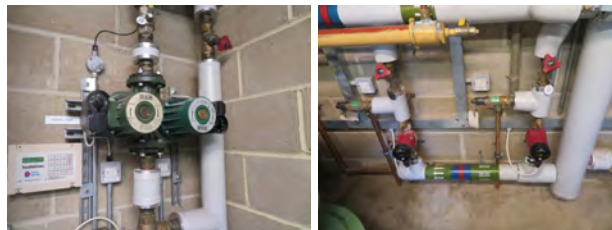
Hot water is distributed generally via copper pipework which is pumped to the various plumbing and sanitary facilities. The pumps within the plant room generally appear to be of good modern order and remain generally in good condition, as illustrated below.

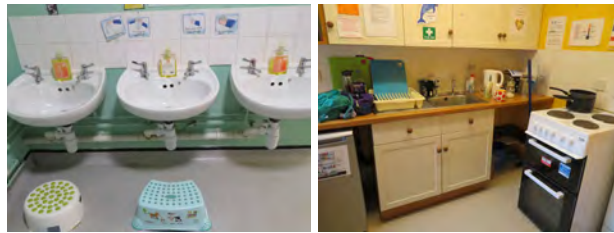
The sanitary facilities to the building are relatively limited and consist of childrens’ toilets and occasional kitchen facilities, as well as a disabled facility as illustrated below. Regular repair and maintenance are required, but beyond this significant remedial works are considered unlikely.

The disabled toilet facility was generally serviceable although the main light was inoperative. Improvements to the disabled toilet must be anticipated in due course.
