BUILDING SURVEY REPORT

XXXX

ADM
January 2020

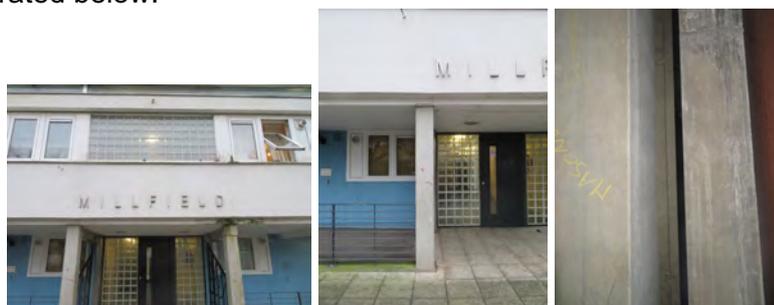
The frame to the building appears to consist of square columns and load bearing concrete wall structures, as illustrated below.

We cannot confirm our suspicions; however, it would appear that the frame is hollow and pre-cast in nature. It is possible that the framework consists of hollow steel sections encased in concrete; however, we cannot confirm our suspicions in this regard.

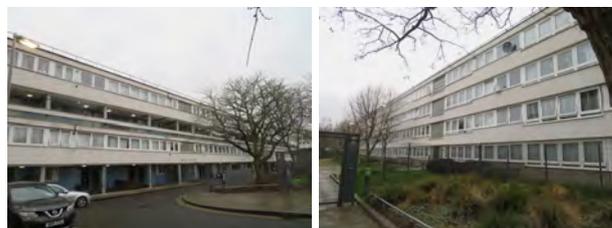
The majority of the building to the front elevation and the rear elevation, as illustrated below, has however had new insulation introduced, which has been rendered to a finish with a pre-formed waterproof resin render application, as illustrated below.

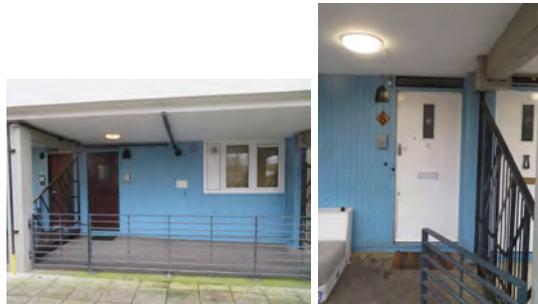
To the front of the building, at ground floor level and to Flat 8 in particular, timber cladding weathers presumably a non-load bearing infill, which may well be of timber construction, as shown by reference to the following photographs. We cannot confirm the extent of thermal insulation and the construction of the cladding and intrusive investigation is recommended in this regard. It is possible that only limited security is provided by the cladding.

Within the construction we recorded evidence of expanding metal lathing which has been utilised presumably to enhance the security of the cladding. Improvements in this regard and the addition of thermal insulation is strongly recommended and must be anticipated.

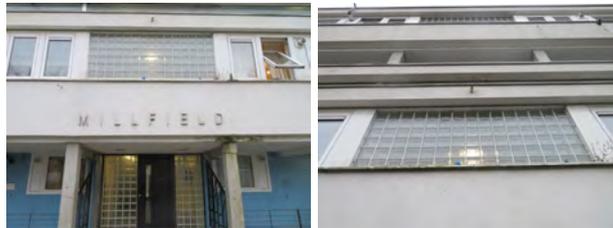
To the common areas of the buildings, previously exposed communal staircases have been infilled, it would appear, with glass blocks, as illustrated below.

The glass blocks generally remain in fair condition commensurate with their age and nature. The insulation provided by the glass blocks is limited; however, there is no necessity for significant insulation levels to be provided to the common areas, which are generally unheated. The glass blocks remain in fair condition and some repointing may be required over time but, beyond this, significant remedial works are considered unlikely.

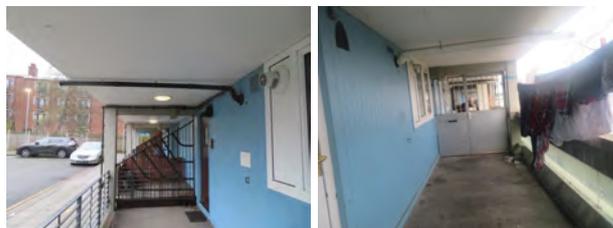
At both ground and first floor level, an external ceiling has been formed to create the walkway at first floor level and a covered area leading to the entrance or individual ground floor flat doors, as illustrated below.

In both instances the ceiling appears to have been formed by a weather resistant boarding secured to the underside of the concrete floor slab above by means of timber battens, illustrated previously and again by reference to the following photographs. In no areas that could be exposed did we identify any thermal insulation.

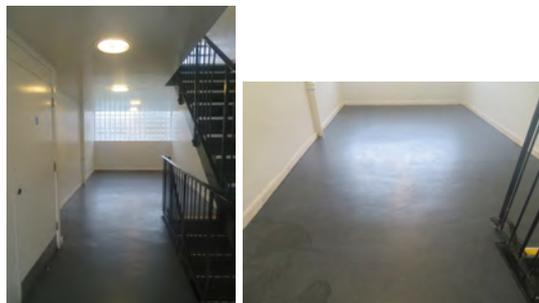
Within the common areas and staircases the floors are of solid construction and finished by means of vinyl flooring, which is a little uneven in appearance but in other regards remains in good condition.

The floors generally hold good alignment with little evidence of any undue movement or deflection, as do the associated external walkways, and on this basis therefore we are satisfied that they remain structurally stable.

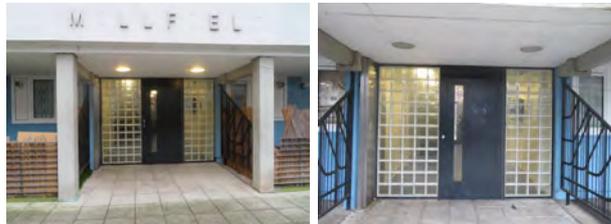
Access to the common parts is secured by a strongdoor set within glass block screens, as illustrated by reference to the following photographs. The door is secured by means of electronic entry phone systems which appear to be in serviceable order at this time, although regular maintenance and perhaps renewal or replacement may well be warranted within the foreseeable future. Similar doors are also provided to the rear of the building and again these remain in good condition.

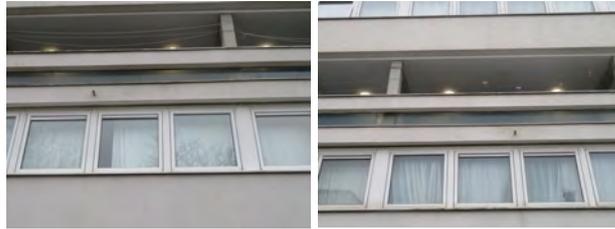
The windows to the block appear to be a double glazed uPVC installation, as shown by reference to the following photograph.

Externally, the windows remain in fair condition considering their age and nature and the pre-finished elements of the windows remain serviceable.

The quality of the original installation was not of the highest order and the energy efficiency of the sealed units is limited and far from compliant with current standards.

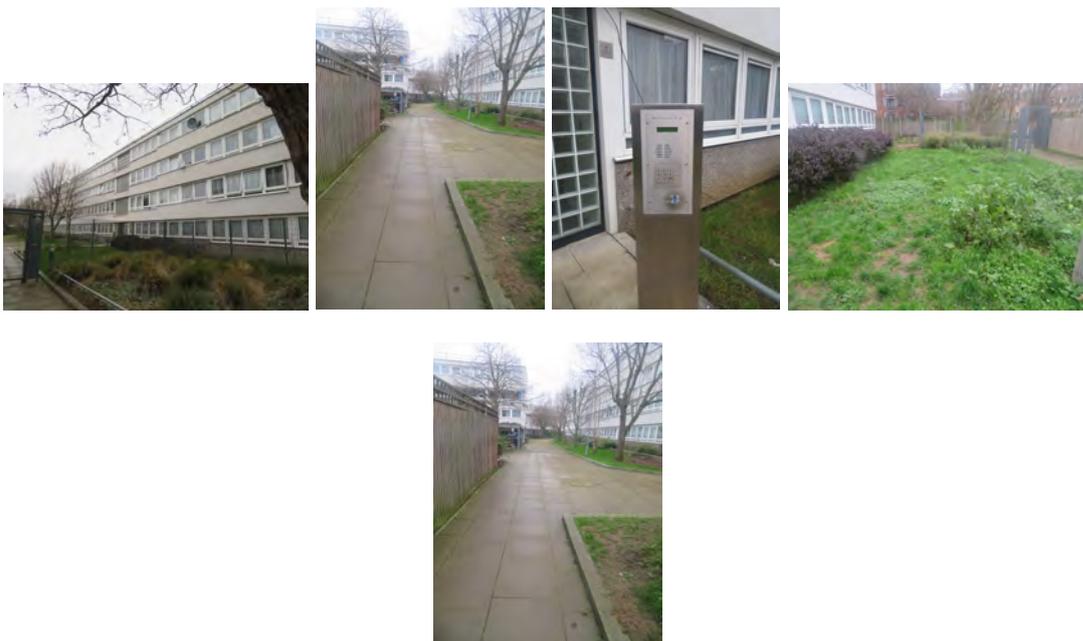
To the rear, security is provided to open areas, which again consist of gardens, paving's and landscaped sections, as illustrated below. Security installations exist to the rear of the block.

The hard standings generally remain in good condition, although the lawn and garden surfaces would benefit significantly from improved cultivation over time.

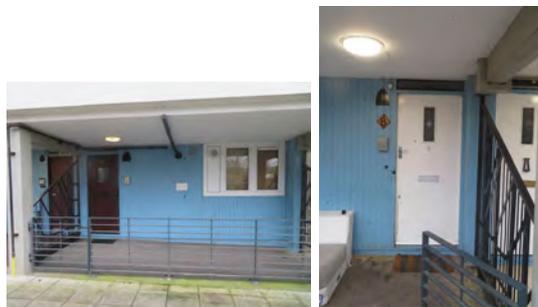
Boundary railings have been utilised to sub-divide sections of the ground floor to provide covered external areas for certain ground floor lessees, as illustrated below. These generally remain in good condition and significant remedial works are considered unlikely in the near term.

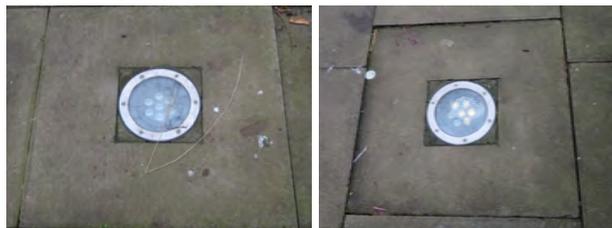
New lighting has been installed externally to the estate and the area generally with modern LED fittings being recorded. Some lighting set within the floor was also evident, which generally remained in good condition, although some sections were in working order whereas others appear not to be in adequate operation. Regular repair and maintenance of external lighting, garden areas, boundary fences and the like will be required from time to time, with expenditure recovered generally through the service charge provisions of the lease.

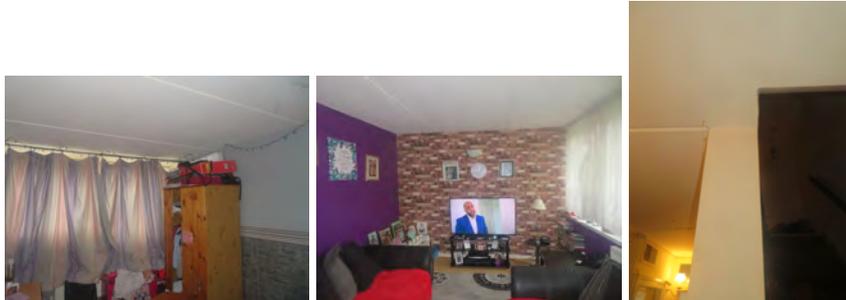
As detailed previously, the majority of ceilings within the flat are exposed undersides of the concrete floor slabs above, which have subsequently been artex finished, as illustrated below.

The ceilings generally hold good alignment with little evidence of any undue movement or deflection and, on this basis therefore, we are satisfied that they remain structurally stable. The Artex may well contain traces of asbestos and testing of this should be undertaken so that its condition can be established. Details of any asbestos content within the flat should be recorded on a register so that risks can be analysed by tradesmen and occupants of the building to minimise any potential health issues by disturbance of asbestos materials.

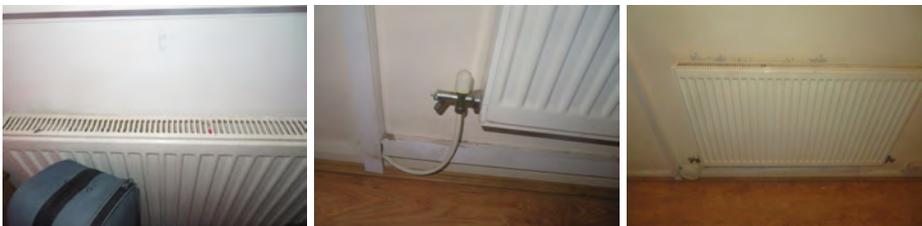
Hot water to the central heating system is distributed via pipework run to various radiators located within the flat and illustrated by reference to the following photographs. The system uses small bore pipework and remain serviceable however repairs are to be anticipated within the relative near term.

We recorded no particular evidence of defects or leaks to the central heating system, which we anticipate operates adequately. Servicing and overhauling of the system are, however, essential and, in our view, the heat output from a number of the radiators is potentially lower than considered desirable given potential heat loss from the property.

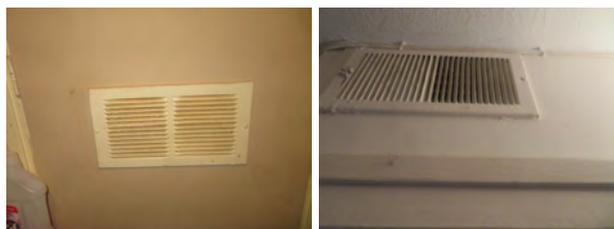
It appears that an old blown air heating system is retained and within the kitchen and other areas we recorded grilles which are indicative of such systems, as illustrated below.

The cupboard containing the old equipment was locked shut and could not be inspected; however, we anticipate that the boiler is retained and its removal could create additional storage space within the flat.

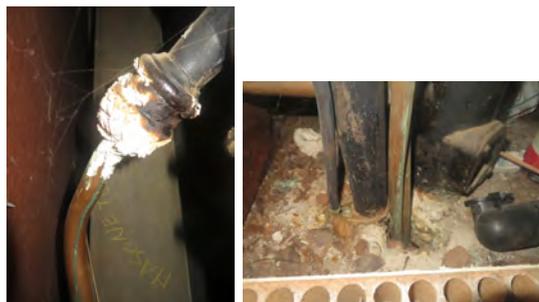
Drainage from the plumbing and sanitary facilities generally runs via uPVC pipework. The pipework is a combination of more recent and older sections and, we believe, runs to the main communal soil stack, although this is concealed within duct work. The soil stack is generally of cast iron formation, we believe, in keeping with buildings of this age and nature. There is evidence of leaks from sections of the drainage pipework, which have been persistent and longstanding, as illustrated below. Repairs and replacement of aged cast iron and copper pipework are to be anticipated as part of further renovation and refurbishment of the property.

There is evidence that certain of the sanitary facilities regularly become blocked and it is likely that the drainage installation serving the flat is in poor order and similar issues may exist generally throughout the block.
