# BUILDING SURVEY REPORT

**XXXX**

## xxxx – Building Survey

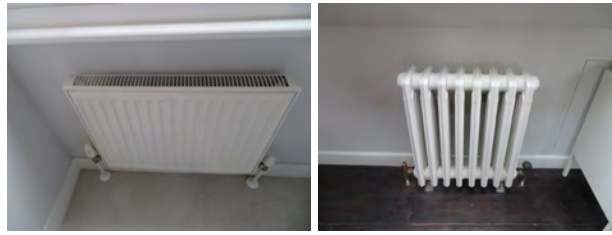
Where visible the radiators are of relatively modern form and some designer column type radiators were evident within the loft conversion area, as illustrated below.

The heat output of radiators generally is anticipated to be inadequate given potential heat loss and the existence of radiators covers. Cold conditions may then develop during winter months. Improvement to the central heating system is recommended and the introduction of modern thermostatic control valves may be considered prudent.

Testing and overhauling of the central heating system are strongly recommended to ensure that it continues to function adequately. The system is of relatively modern origin and complete replacement is considered unlikely.

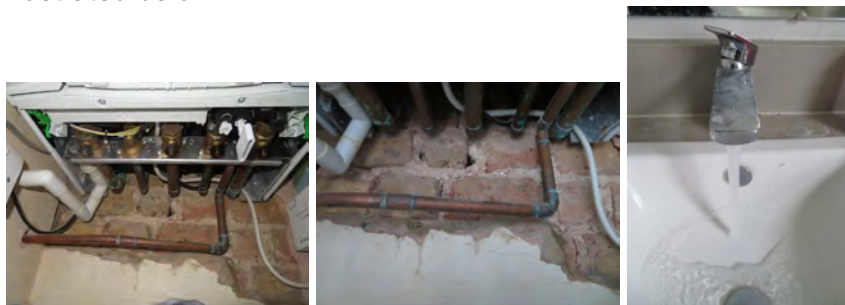
Hot water is produced by the boiler and distributed on demand to the various sanitary facilities located throughout the property. At the time of our survey hot water was available to the various plumbing and sanitary facilities under adequate pressure and we are satisfied that the hot water distribution infrastructure remains serviceable. The majority of the pipework was concealed from view and could not be inspected in detail. Close to the boiler relatively modern copper pipework was evident, as illustrated below.

We recorded no evidence of leaks to pipework at the time of our survey and significant remedial works are not anticipated in the near term. Regular maintenance and inspection of the pipework will be necessary and from time to time some remedial works may well be necessary.

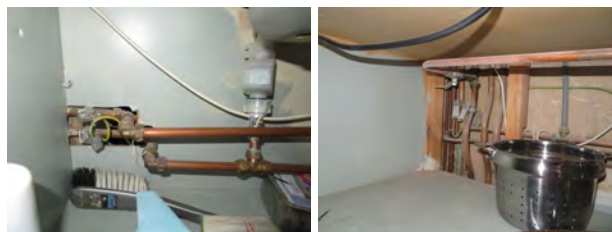
The majority of the copper pipework was concealed from view and could not be inspected in detail, but where visible this remained in fair condition with copper pipework evident behind sink units, as illustrated below. Some plastic sections of pipework were also identified.

In general we are satisfied that the cold water supply and distribution pipework remains in serviceable condition. We recorded no particular evidence of leaks or other major defects. Replacement of hot and cold pipework however may well be necessary in conjunction with replacement of the kitchen and refurbishment of the bathrooms over time.

We recorded no evidence of an in-line descaler serving the cold water supply to the property. Given the hard water nature of London limescale build-up may well cause damage to the boiler and sanitary facilities and foreshorten their life expectancy. The introduction of an in-line descaler on the cold water supply serving the boiler is considered essential in this regard and it may be prudent also to incorporate or replumb sections of the property to incorporate a water softener, particularly to the non-potable supplies.

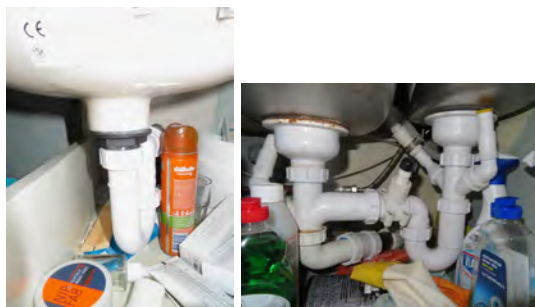
Drainage from the various plumbing and sanitary facilities is generally run via uPVC pipework with bottle traps evident beneath sinks and wash hand basins, as illustrated below.

The pipework is not of the highest order but remains serviceable at this time. The various toilets were tested and were generally free flowing, as illustrated below.
