## SAMPLE BUILDING SURVEY REPORT

## 1.00 INSTRUCTIONS.

## 2.00 INSPECTION.

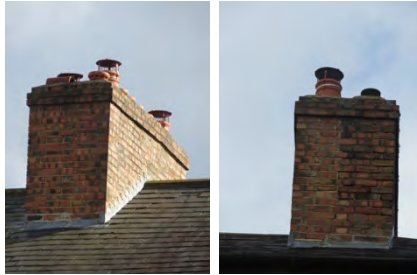
The property has a main chimney stack located to the right hand side and shared with the neighbouring property. Accordingly, we must advise that the chimney stack is a party structure and therefore if works of an extensive nature are instigated party wall procedures must be followed, as set down by the Party Wall etc. Act 1996. The chimney stack, as illustrated below, generally holds good alignment with little evidence of any undue movement or deflection and on this basis therefore we are satisfied that it remains structurally stable.

The overall condition of the chimney stack is fair, however there is evidence of deterioration and loose and recessed mortar pointing in various areas as illustrated below.

Repointing of the stack is required and in addition the flaunching or weathering to the top section of the stack appears deteriorated and this has resulted to the failure of the pointing, as illustrated below. Reflaunching of the stack is therefore to be anticipated and required in the relatively near term.

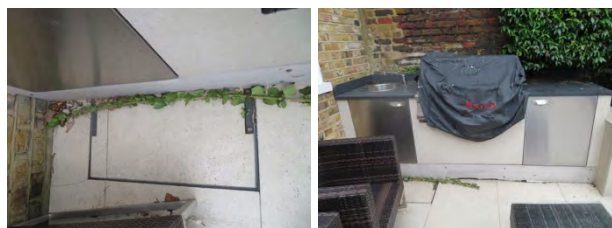
The downpipes run to discharge directly into the underground drainage installation to the rear garden; however, much of this was concealed from view. An inspection chamber exists in this location; however it has been partially built over by a cooking area and the cover could not therefore be lifted, as shown by reference to the following photographs.

We recorded no evidence to indicate that the drainage remains in anything other than serviceable condition; however, we cannot confirm our suspicions in this regard.

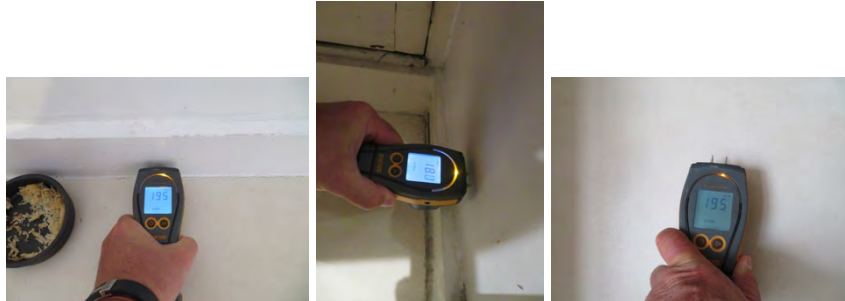
Within the original parts of the property we anticipate that a slate damp proof course may have been formed; however, this was concealed by rendered applications and therefore we cannot confirm our suspicions in this respect. Rising dampness within buildings of this type, age and nature can frequently occur at lower ground floor level. Moisture meter readings were taken generally throughout the property which did reveal some slightly raised moisture content in isolated areas, as shown by reference to the following photographs.

We recorded no visual evidence of rising dampness or failure of the damp proof course; however, minor readings of this type perhaps indicate the early deterioration of the damp proof course or perhaps the beginning of failure of older specialist tanking and damp proofing works. It is likely that the lower ground floor area has been tanked previously; however, copies of any guarantees should be obtained in respect of works carried out in this way.

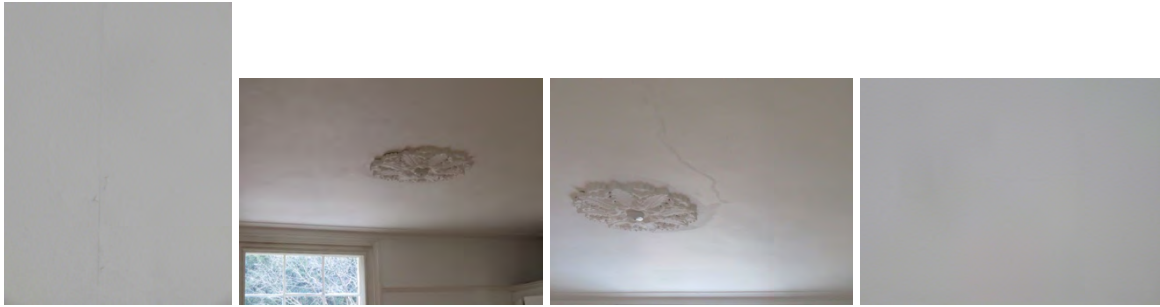
The lath and plaster ceilings exhibit significant areas of cracked and blown sections, particularly to the larger rooms within the house, as illustrated by reference to the following photographs.

In overall terms the lath and plaster ceilings and the cornicing remains in fair condition commensurate with its age and nature; however, we have known large ceilings of this type, age and nature to collapse and fail suddenly without warning. We cannot rule out the possibility of this occurrence in the future, although it is considered unlikely. Relatively crude repairs and making good of fractures within lath and plaster ceilings have been undertaken; however, these are unlikely to be of particular long term benefit. In our view, careful specialist restoration of lath and plaster ceilings and cornicing may extend their life expectancy and improve their overall condition.

Replacement of lath and plaster ceilings could be contemplated to upgrade the building so it is fully compliant with modern standards; however, given the listing and the age of the building, this may not be possible. Restoration of cornicing and ceilings are therefore recommended to conserve their integrity.

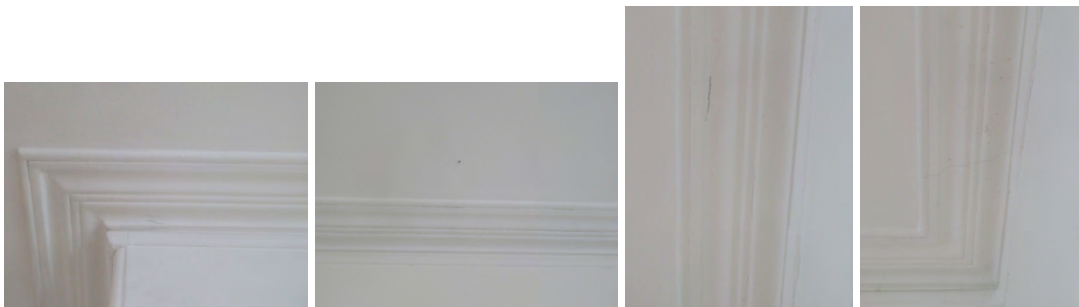
A number of original cornices are also retained and again cracked and deteriorated plasterwork was evident, as shown by reference to the following photographs.

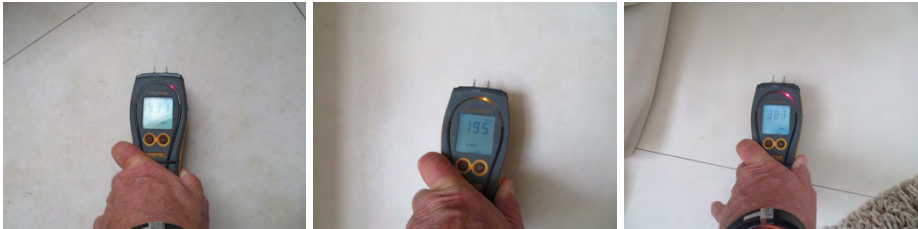
Moisture meter readings were taken to the ground floor slab and we did record some evidence of higher moisture content within the slab than we would normally anticipate, as shown by reference to the following photographs. The dampness is not visible and it is possible that the moisture meter is picking up dampness which exists below a damp proof membrane.

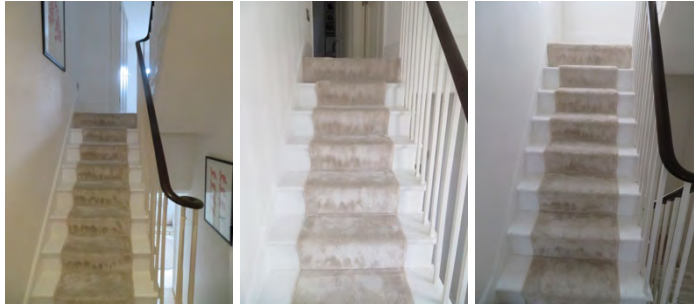
Access between the various levels of the property is gained via a timber staircase with the original staircase maintained to much of the upper parts, as shown by reference to the following photographs.

The staircase generally holds good alignment with little evidence of any undue movement or deflection and we are satisfied that it remains structurally stable. Some slight movement was evident at the junction of the string and the party wall; however, this is well within normally anticipated parameters and of no significant concern in our view. We were however unable to gain sight of the timber structure to the staircase and cannot confirm that this is in sound condition, free from rot, worm and beetle infestation. Some historic worm and beetle infestation may well be anticipated in a staircase and property of this type, age and nature.

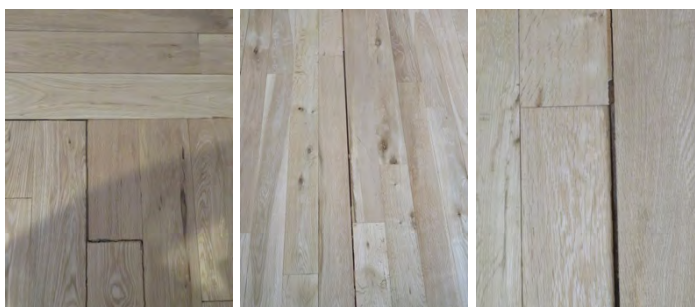
The quality of installation is not of the highest order and a number of the board joints are poorly adhered and working loose, as shown below. Repairs will overhaul and improve the overall condition of the floors; however, some older sections are of a type, age and condition whereby replacement in due course may well be considered prudent.

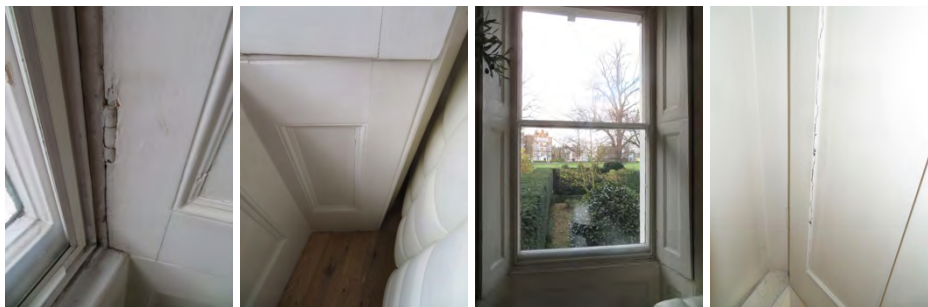
To the larger principal room's shutters have been retained, possibly being part of the original build of the house. The shutters remain in fair condition considering their age and nature; however, they are ill-fitting with paint bound hinges and split panels evident in many areas, as shown by reference to the following photographs. Further restoration will improve the overall condition of the shutters and return these to sound condition.

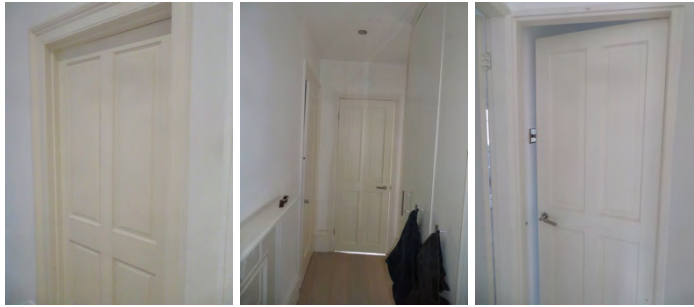
The doors internally within the property vary but in general these are timber panelled units possibly in keeping with the original installation within the house, as illustrated below. The doors do not provide any recognised fire resistance but, subject to maintenance of a suitable fire alarm system, remedial works or replacement is not essential in our view.

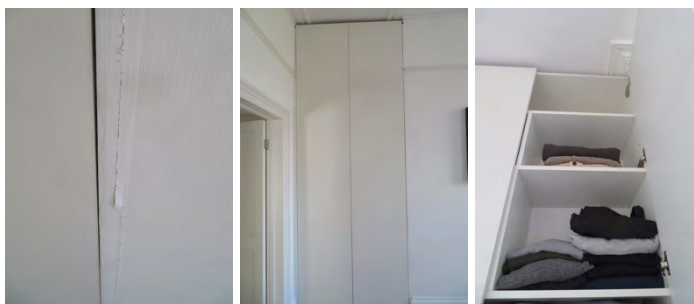
Secondary joinery components within the property remain in fair condition; however, the built in cupboards are in some instances of basic form, ill-fitting and there is evidence of deterioration at the junctions with plasterboard linings, as shown below.

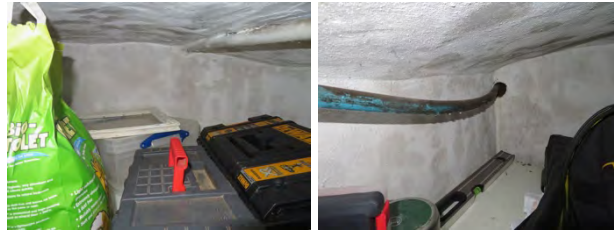
The underside of this area and the vault appears to have been tanked and rendered to prevent water ingress and it would appear that this has largely been effective; however, condensation and possible water penetration is evident, as shown by reference to the following photographs.

Failure of waterproof tanking and indeed the structure of such steps is not unusual in buildings of this age and nature. Condensation is clearly evident on the various pipes within the under stair area and the introduction of thermal insulation to these is strongly recommended. It may well be necessary to tank the underside area in due course if dampness continues, although in our view the area is predominantly dry bar substantial levels of condensation which have developed.

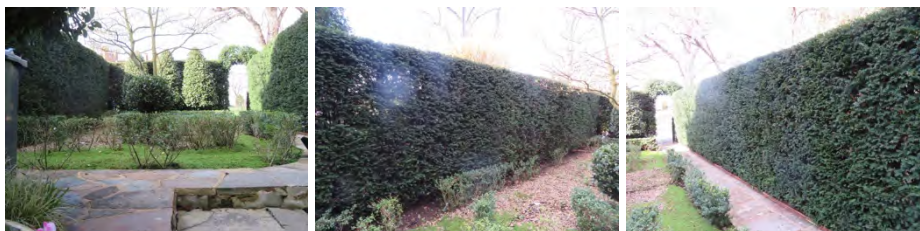
The front garden area consists of shrubbery and a flower bed area centrally either side of what appears to be yew tree hedges forming the boundary of the property, as shown below.

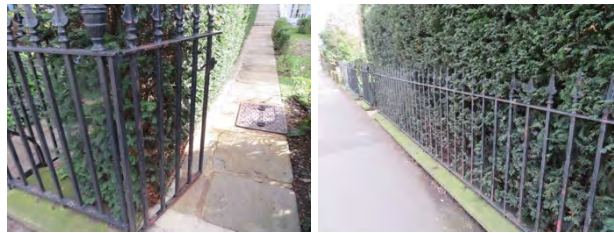
The boundary to the front is provided by means of a metal rail fence set within a masonry base, as shown by reference to the following photographs. This remains in serviceable condition.

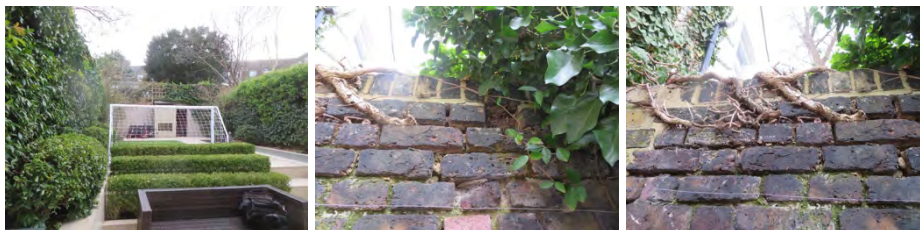
To the rear of the property the boundaries are again largely concealed by shrubbery. In the main it would appear that the boundaries are formed by means of solid 9" brick walls. These remain in fair condition but there is evidence of deterioration, creeper growth and loose and recessed mortar pointing in various areas, as shown below.

Raking out and repointing of much of the boundary walls may well be necessary as part of normally anticipated maintenance and careful pruning and cultivation of shrubs and removal of ivy may also benefit matters over time.

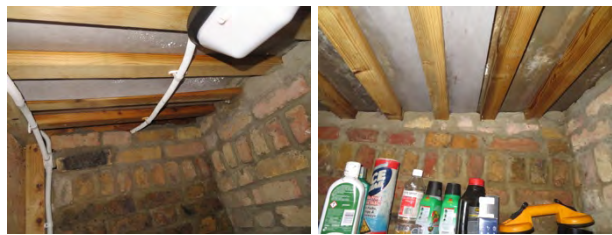
The storage sheds are formed by means of masonry and basic roofing above which is timber structured, as shown by reference to the following photographs. The roof to the rear is largely flat but is weathered by means of slate tiling which is inappropriate. Dampness was evident internally to the underfelt and leaks are likely to occur. Replacement of the roof with a flat roof structure is strongly recommended to enhance the beneficial amenity of the sheds. The storage sheds generally remain serviceable at this time.

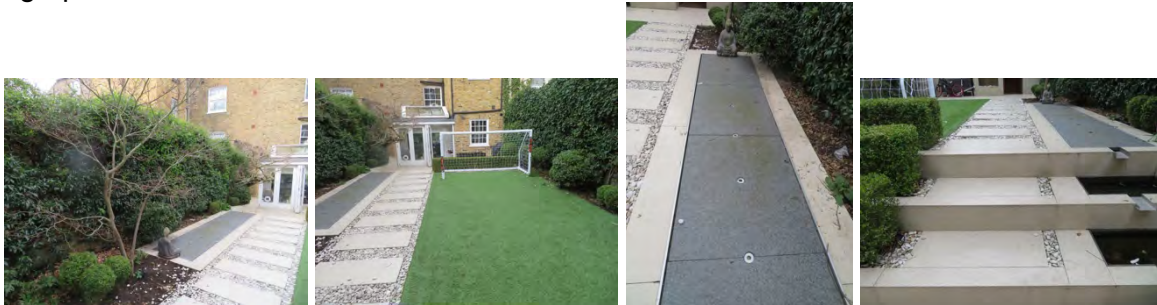
The garden area has been landscaped and designed and incorporates an area of synthetic grass bounded by paved walkways and a water feature, as shown by reference to the following photographs.

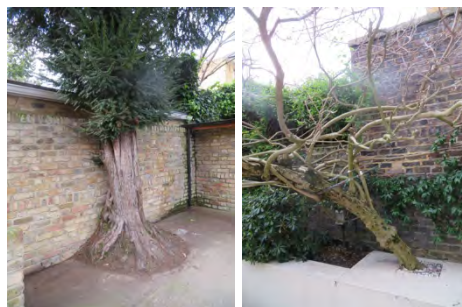
A number of mature trees and shrubs exist within the rear garden area and the demise of the building, as shown below. Regular maintenance and pollarding of the trees will be required. Growth of the trees could potentially undermine the structural integrity of the property.

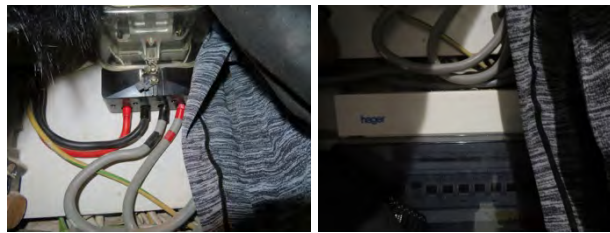
The electrical incoming main and meter etc were barely visible and were generally concealed by stored clothing and the like within the ground floor utility area; however, the incoming meter and fuse board are shown by reference to the following photographs.

The incoming electrical installations are earth bonded to adjacent water and gas pipework, as shown by reference to the following photograph. The electrical installations appear generally to be of relatively modern origin, although the fuse board is not now strictly compliant with current regulations. There is no immediate necessity to upgrade the fuse board; however, this perhaps should be contemplated in due course.

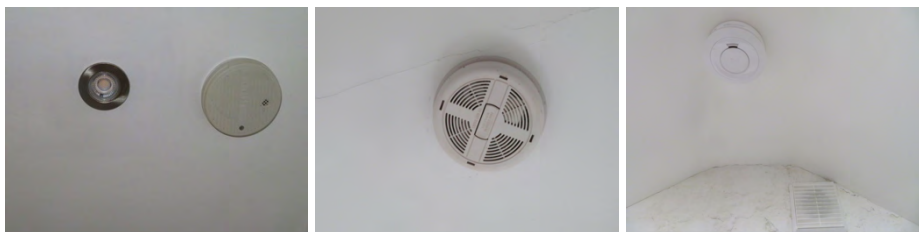
The property has a smoke detection system with hard-wired detectors recorded in various levels and locations, as shown generally by reference to the following photographs. The system may not be fully compliant with current regulations but is generally considered adequate and, if maintained in a good serviceable condition, will provide early warning in the event of the development of a fire which should facilitate escape from the property. Significant improvements are not required; however, testing of the system and upgrading it so that it is fully compliant with current regulations is strongly recommended.

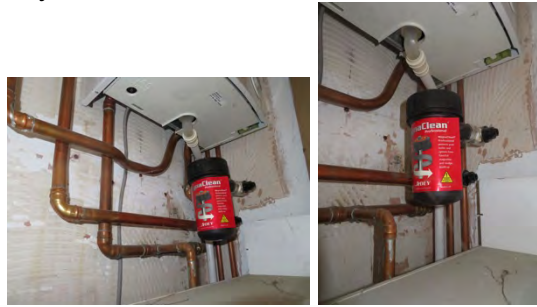
The boiler was in good and proper working order at the time of our inspection. The incoming cold water supply serving the boiler is fitted with a descaler in accordance with good codes of practice and the workmanship in the installation of the boiler and the associated pipework appears to be of good quality, as illustrated below. Regular servicing of the boiler will be necessary to conserve its integrity and maintain a good system.

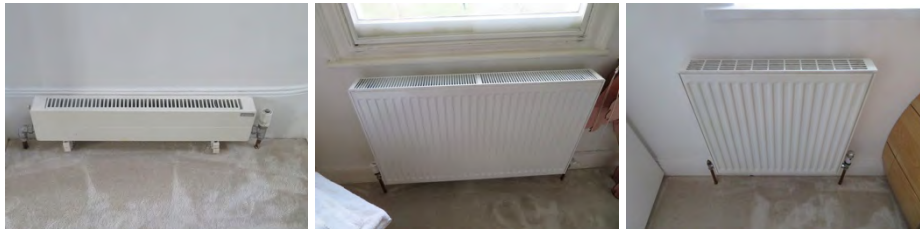
Copper pipework from the boiler runs to distribute hot water to the various radiators located throughout the property which are generally of good modern origin and illustrated by reference to the following photographs. A number of radiators are small in size and not located beneath windows which can reduce their efficiency and effectiveness.

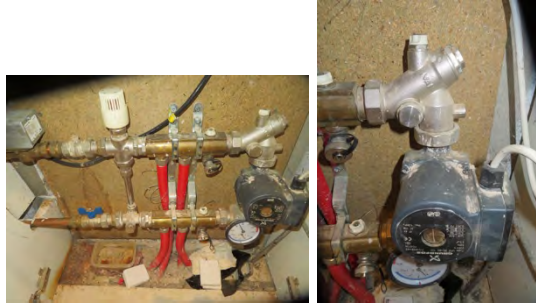
The pipework to the underfloor heating system was concealed from view and we have advised previously that damp readings within the floor structure could be attributable to leaks to the underfloor heating system, although we consider this unlikely. The underfloor heating manifold pump and pressure gauge etc, as illustrated below, suggested that the central heating system and the underfloor heating is in good working order.

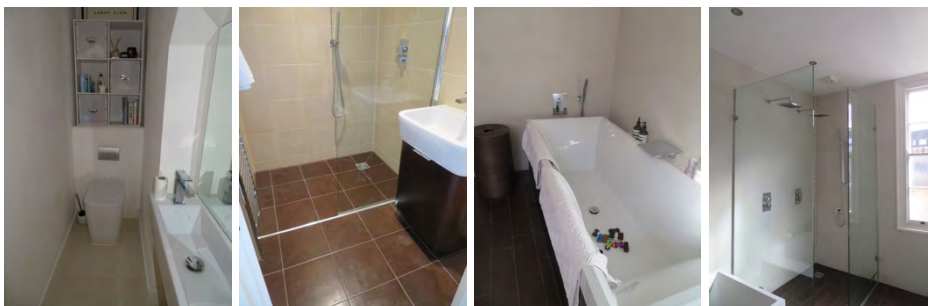
The property has a number of modern bathrooms and ensuite facilities, as shown by reference to the following photographs.

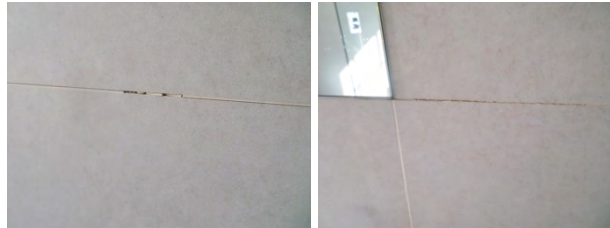
The quality of workmanship to the master bathroom is poor and there is evidence of loose tiles and poorly grouted sections, as shown by reference to the following photos. Repairs will be necessary together with cleaning and servicing to enhance the beneficial amenity of the bathrooms and conserve their integrity.

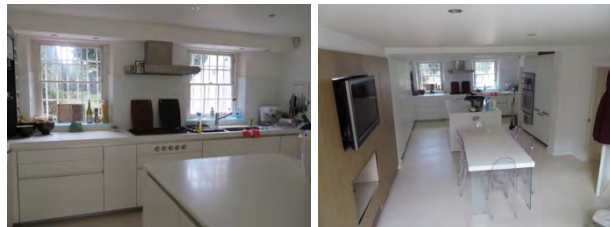
The kitchen to the house is a particular feature located at lower ground floor level, as illustrated below. The kitchen is of good quality and remains generally in good condition, although some recent works are not of the highest order. Significant improvement or upgrading of the kitchen could be contemplated but is not necessary in the near term, in our opinion.

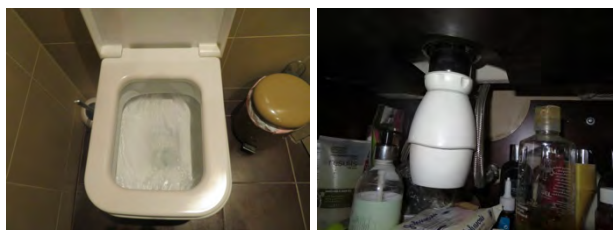
The toilets and sanitary facilities are generally free flowing and in good condition, as shown below.
